The paper was published in the proceedings of the 12th Australia New Zealand Conference on Geomechanics and was edited by Graham Ramsey. The conference was held in Wellington, New Zealand, 22-25 February 2015.

New Zealand natural hazards: Do we really need geotechnical professionals?

B. A. Curley, B. Simms and J. Kelly

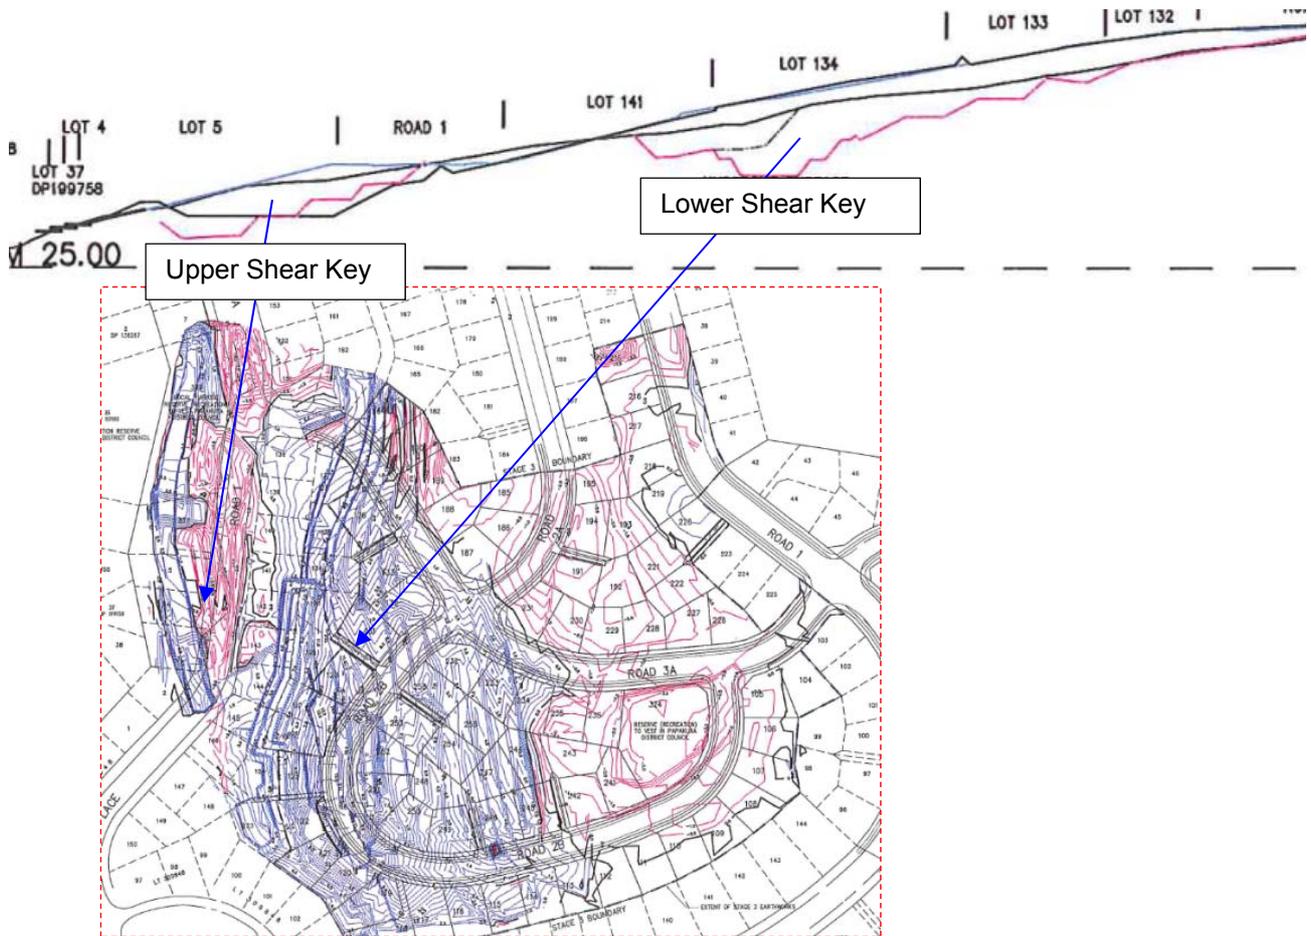
The development consists of 300 plus residential lots and involved significant bulk earthworks and land drainage (including dual shear keys) as depicted in Figure 1. The site is an irregular shaped block

Figure 1. Upper and Lower Shear Key and Earthwork / Subsoil Drainage Plan
