Abutment Stability Studies for the Gordon Arch Dam

D. T. ALLEN, B.E., M.I.E.AUST.
(Hydro-Electric Commission of Tasmania)

SUMMARY.— This paper deals with the foundation investigations that were carried out for a 460 ft. high arch dam on the Gordon River in Tasmania. A method was developed for computing the safety of an abutment block against sliding on two planes of weakness, each with wave angle shape, based on insitu observations and on an interpretation of the results of laboratory rock shear tests. This is followed by a brief description of the drainage measures adopted to improve the stability of the abutments.

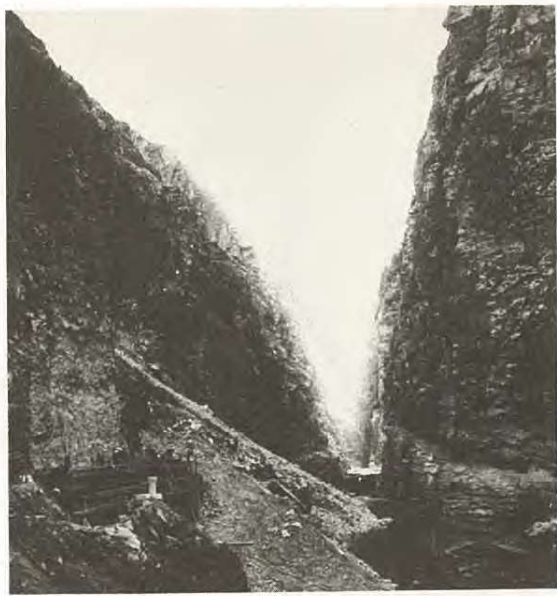
Fig. 1. - Gordon Damsite Gorge.
