Maroon Dam Embankment and Foundation

K. D. NUTT, B.E., M.I.E.Aust.

Senior Engineer, Irrigation and Water Supply Commission, Queensland

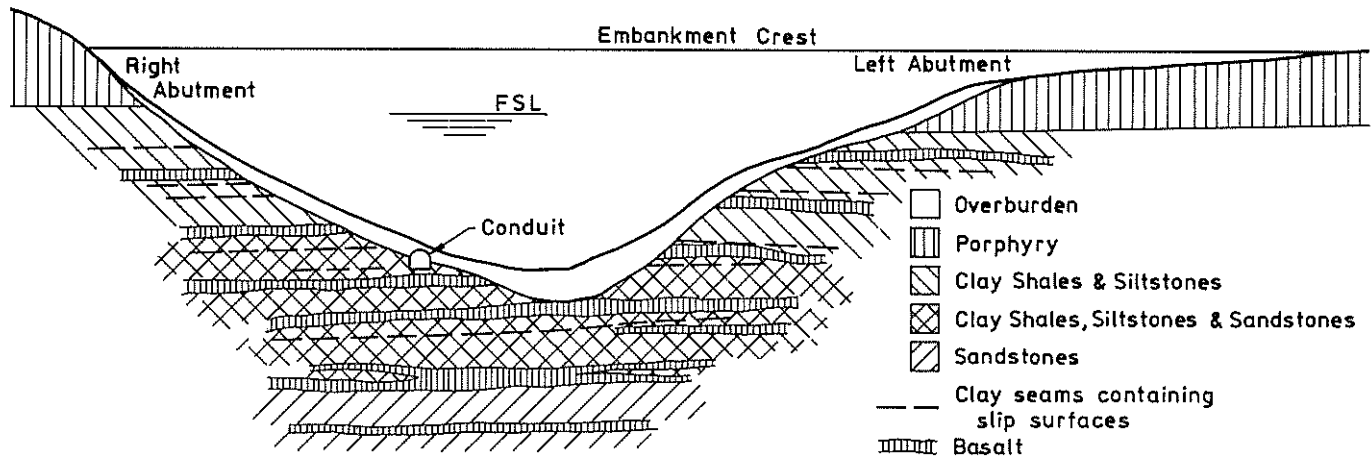
Fig. 1 Cross-section of foundations

the cross-section shown in Fig. 1.

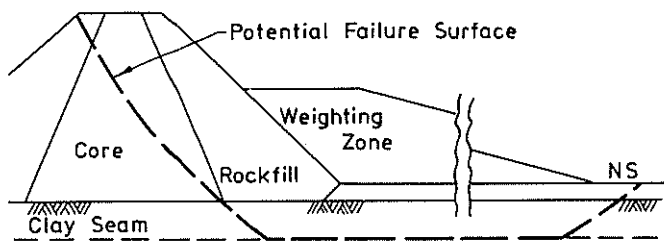
Fig. 2 Typical surface for analysis

the dam during investigation and re-design, an early decision was made to retain the original cross-section of the main zoned embankment and achieve stability by increasing the relatively inexpensive weighting zones. The method of analysis was an adaptation of the normal limit equilibrium methods in which total shear strength under ultimate conditions along selected possible failure surfaces is compared with shearing forces actually developed along such surfaces, with the low strength slip surfaces having a dominant role in determining the failure surfaces to be analysed, as shown in Figure 2.

The method of analysis developed applies the method of slices, and allows for the effect of interslice shears. The shears used affect the calculated position of the "pressure line" of

normal forces across interslice faces, and are adjusted to obtain a satisfactory pressure line. The factor of safety is dependent on the interslice shears adopted, but is not sensitive over the range of values which give reasonable pressure lines.

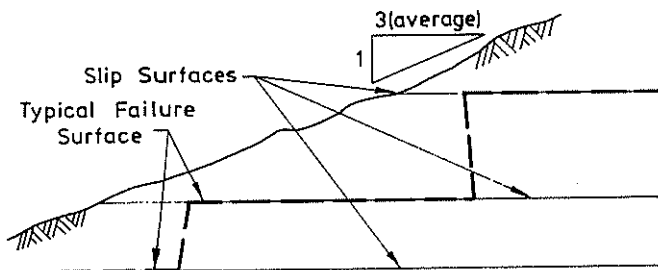
Fig. 3 Failure surface on abutment

Fig. 3 shows that the minimum ratio of length of failure surface through the rock to that through the seam is 0.33. Adopting a ratio of horizontal stress to vertical stress within the foundation of 0.6, and a ϕ' for the rock of 20°, it is seen that for a vertical force of P on the slip surface the normal force on the vertical plane in rock is $0.6 \times 0.33 P$ or $0.2 P$, and the total shear resistance is $P \tan 10^\circ + 0.2 P \tan 20^\circ = 0.25 P$. The value of ϕ' required to give a shear resistance of 0.25 times the normal force is 14°, but 13° was adopted for the stability analysis.

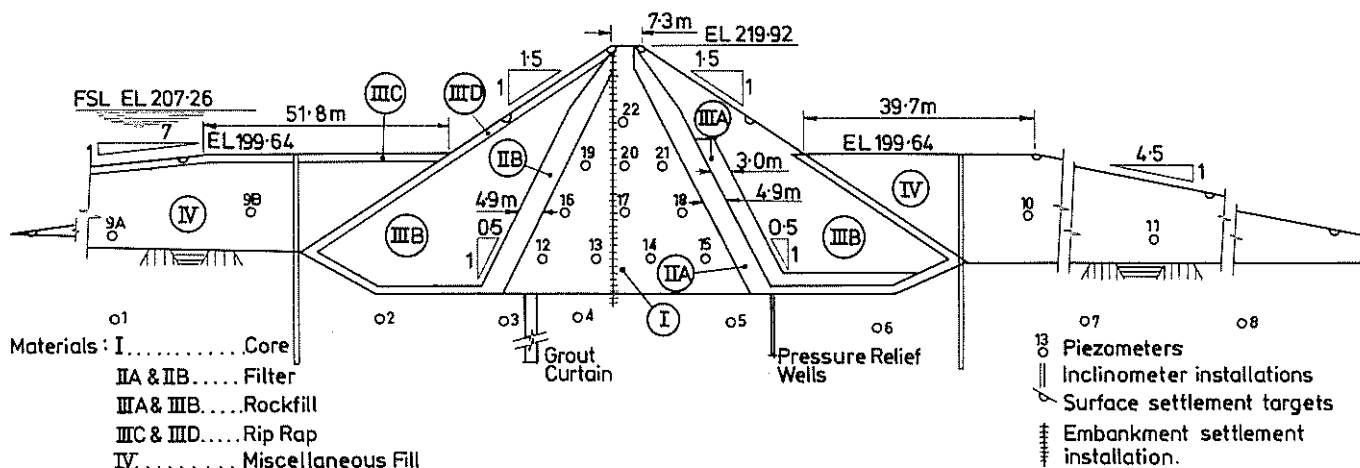
Fig. 4 Typical cross-section and instrument layout

The cross-section shown in Fig. 4 is that for the maximum section. The weighting zone berm widths and batters were maintained constant over the width of the dam, but the berms sloped upwards as foundation levels rose up the abutment, finally rising to El. 207.26 to join the natural surface. Fig. 4 shows also some of the drainage provisions intended to ensure that the foundation pore pressures would not exceed the design values.

Compared with the instrumentation provided for other Commission dams of a comparable size, that for Maroon is unusually complete, and it played an important role during the design and construction of the dam. Fig. 4 shows the typical location of instruments.
