# Retention for Major Excavations

Do Van Toan

**Keywords:** case study, basements, excavation, retention, deflections, groundwater

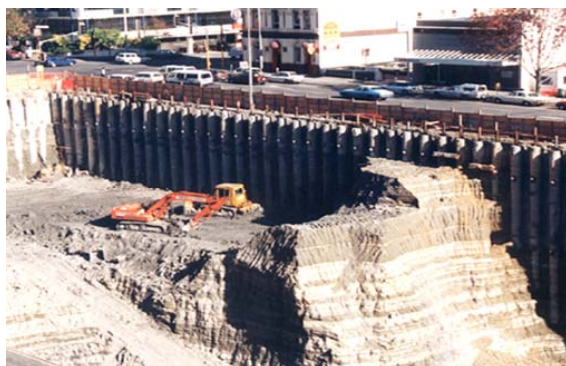
Figure 1: Sky City Ground Retention

A bottom-up construction was adopted with a semi-contiguous, anchored, 800 mm bored pile palisade wall, with piles at a spacing of 1600 mm (and some at 900 mm diameter at 2000 mm). The hydrogeology consisted of a series of cascading perched water tables each about 3 - 5 m deep with the regional water table just intersecting the base of the basement. With this groundwater condition a drained basement could be adopted, significantly reducing the cost of tanking and permanent retaining.
