The continuing problems associated with expansive and collapsing soils

Peter W. Mitchell
URS Australia Pty Ltd

ABSTRACT

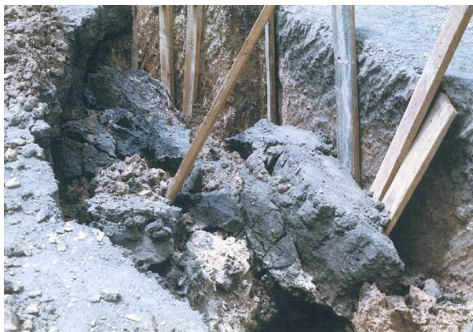
Figure 1: Instability of an excavation in expansive clay

Expansive soils are clays that undergo volume changes with a change in soil suction. Common problems associated with this soil type include the instability of excavations (Figure 1) and the cracking of buildings (Figure 2). Although this paper is confined to footing designs on expansive soils, design solutions to problems associated with other geotechnical structures such as road pavements, excavations and retaining walls on expansive soils are far from being resolved.

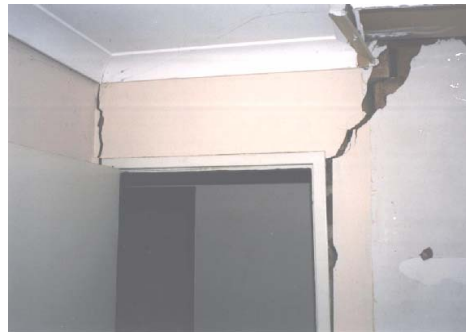
Figure 2: Expansive soil effects on domestic structure

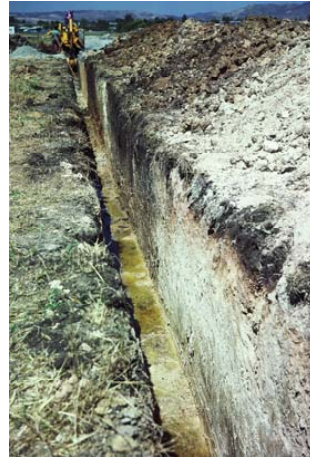
Figure 4: Gilgai structure in a Black Earth profile

It must always be appreciated that a thorough understanding of the geological background of a site is important in any successful footing design. This is especially the case for difficult sites such those containing gilgai (Figure 4), where the variable nature of the soil layering renders an investigation of the site by boreholes alone very difficult, and the non-homogeneity of the profile can lead to non-uniform soil distortions.

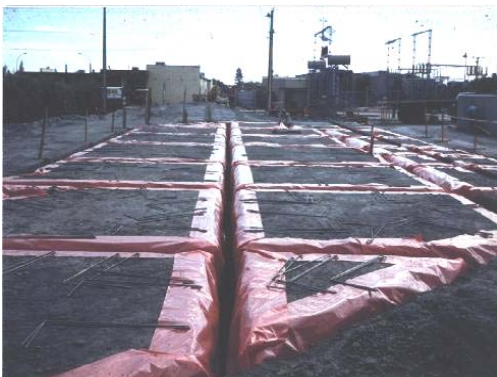
Figure 5: Gridded raft footing

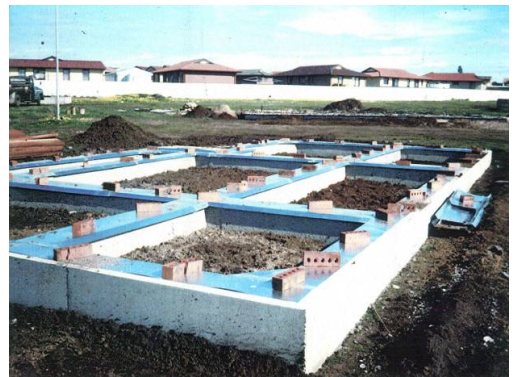
Figure 6: Gridded strip footing (for suspended flooring)

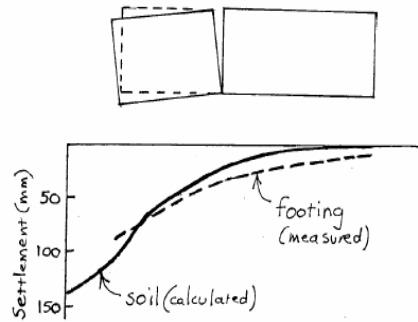
Figure 13: Inferred settlement profile induced by soil suction of Figure 12

Figure 13 shows the calculated deflected shape of the soil surface due to the soil suction distribution in Figure 12. The measured footing deflection is also indicated in Figure 13.

Although current design methods enable a footing to be designed to accommodate the soil movement and the measured deflected shape of the footing shown in Figure 13, the prediction of this footing shape at the time of design of the footing is not possible. In particular, the prediction of the pattern of the soil suction changes under the structure shown in Figure 12, and the prediction of the resulting angular distortion of the footing in the zone of severe soil suction changes, remains outside current knowledge.

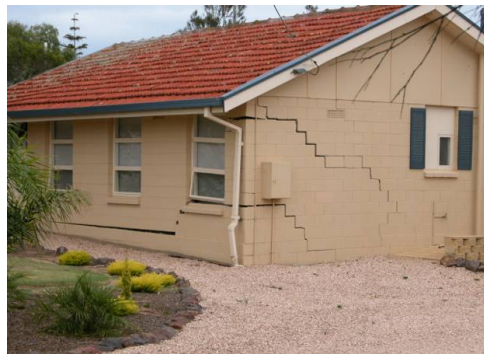
Figure 15: Example of house distorted by collapsing soil movement

Collapsing soils are soils that lose strength and settle when wetted up, as illustrated in Figure 14 (after Schwartz 1985). A typical distortion pattern of a dwelling undergoing corner settlement due to a nearby underground leaking service in collapsing soils is shown in Figure 15 (photograph courtesy of Mr J. Goldfinch). Examples of problems associated with collapsing soils have been described by Nuntasarn et al (2007), Jaksa (2007), Wawryk (1983a, 1983b), Stapledon (1971), Selby (1982) and Schumann & Chugg (1970).

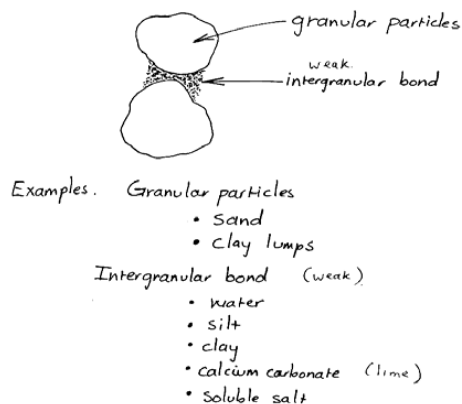
Figure 16: Structure of collapsing soil

A simplified representation of the soil structure of a collapsing soil is shown in Figure 16. Collapsing soils often comprise coarse granular particles (sand or clay lumps) with a weak intergranular bond that can comprise water, silt, clay, calcium carbonate and a soluble salt. With the introduction of water, a break-down of the intergranular bond occurs, resulting in a collapse of the soil structure.

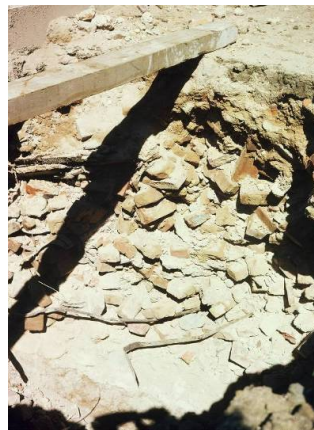
Figure 19: Human-induced collapsing soil

burrowing animals, earthworms or decayed roots leading to a type of biotic soil. A common collapsing soil occurring world wide is that induced by human activity, such as uncontrolled fill in Figure 19.
