# Seismic retro-fit of an historic earth dam using grouted stone columns

D. Avalue<sup>1</sup>, B. Kok<sup>2</sup>, and T. Lennie<sup>3</sup>

An earth dam in Victoria, constructed in 1885 as part of Melbourne's water supply system, has been in continuous use and will continue to form an integral element of the system. A safety review between 2004 and 2006 identified remedial works requirements to address a number of issues including embankment stability. Analysis of geotechnical information for the site, in conjunction with geological modelling, concluded there were layers and zones of soils that exhibited the potential for liquefaction under earthquake loads, thus constituting a significant risk to the stability of the embankment and the water supply. Design parameters were agreed and three areas were specified for treatment. Ground improvement options were assessed and the solution adopted was to install grouted stone columns. The design was undertaken, reviewed and accepted and the work carried out between July and September 2011. Grouted stone columns were formed using the bottom feed vibro system, conventionally used for the construction of vibro stone columns. A cement-bent

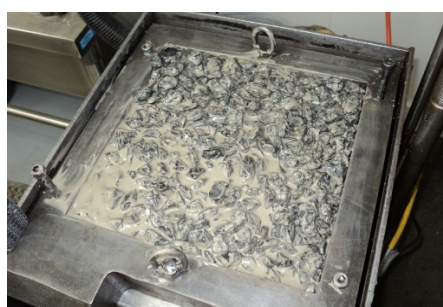
*Fig. 6: Shear Box Test on Grouted Stone*

Stone obtained from local quarries was tested for particle size, natural angle of repose, specific gravity, bulk density and void ratio. The selected stone was a basalt rock, crushed and screened to deliver a produce of between 20mm and 40mm particle size, although the specification was subsequently modified to include finer particles down to 5mm. Laboratory tests were undertaken on dry and grouted compacted stone in a 300mm shear box (Queensland Main Roads Test Method Q181C), for which the stone had to be further crushed to be less than 20mm – Figure 6 shows a test set-up with grouted stone and Table 4 summarises the results.

The grout comprised a cement-bentonite mix, which delivered a 28-day UCS of between 600kPa and 1.5MPa.

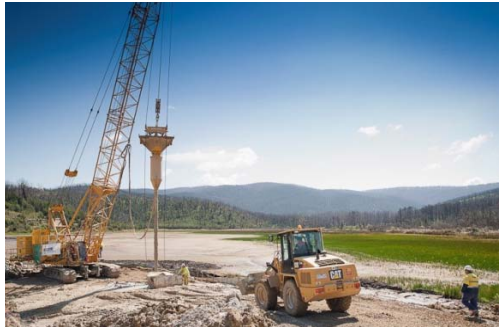
*Figure 7a: Installation Set-up*

GSCs are formed using the bottom feed vibro system. The rig, hopper and skip are shown in Figure 7a, and the vibro probe is shown in Figure 7b.

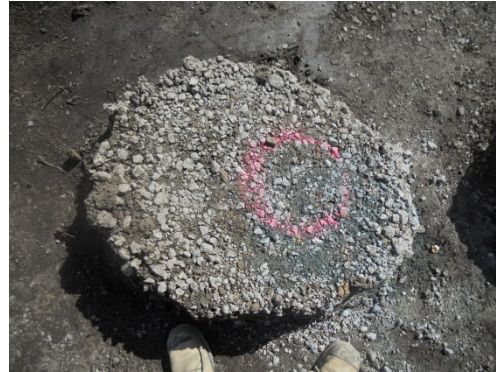
*Figure 8b: Top of Typical GSC*

Trial columns were installed in the area of Section 3 Downstream during the first phase of the three phases of work. These are shown in Figures 8a and 8b with their tops exposed.
