Case Studies of Geotechnical Risk Management of Excavations Next to Live Motorway Traffic

ABSTRACT

Upgrading existing motorways unavoidably involves construction under live motorway traffic. Geotechnical risks need to be managed to ensure the safety of the existing motorway. Three case histories involving excavation risk next to live motorway traffic are presented. Case Study 1 presents a 5.1m deep excavation to extend existing drainage pipes. Design options are compared and the associated risks and cost comparisons are highlighted. Case Study 2 presents a 7.7m deep excavation to facilitate the construction of a reinforced soil wall. The design involvement and risk management approach is discussed. Case Study 3 presents two shallow cuts up to 3.2 m to prepare the foundations of reinforced soil walls. Construction risks are highlighted.

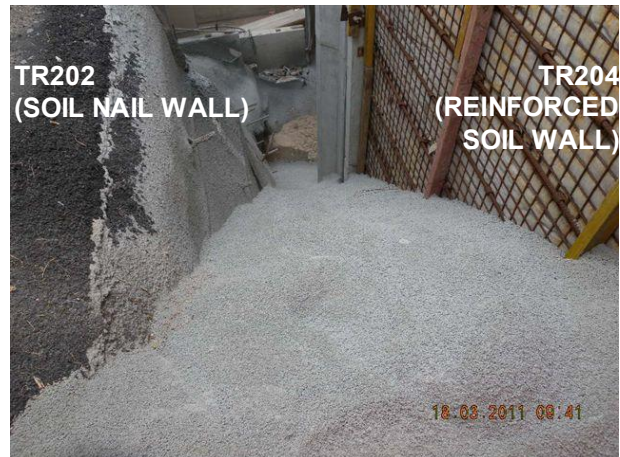
Figure 6. Gap between TR202 and TR204

The cut slope was in compacted embankment fill comprising stiff to very stiff clay. There was a gap up to 2 m wide between temporary walls TR202 and TR204. The gap was filled with clay and stabilised sand (Figure 6). The top 2.8 m high of TR204 has come out over the gap due to alignment change of the temporary traffic management design. If TR202 were totally removed, there would be an overhang from TR204 that would have to be supported.
