## International Society for Soil Mechanics and Geotechnical Engineering

### INSIDE THIS ISSUE

- 1 Message to ISSMGE Members
- 7 President Reports
- 9 IS Seoul report
- 13 Geotech Hanoi Report
- 20 ATC3 Bhutan Report
- 32 Submarine Landslides on the South-Eastern Australian Margin
- 46 Design of Transition Zone for Cement Deep Mixing
- 53 Geotechnical offshore site investigation and reclamation design at Port Kembla
- 67 Event Diary
- 73 Corporate Associates
- 75 Foundation Donors

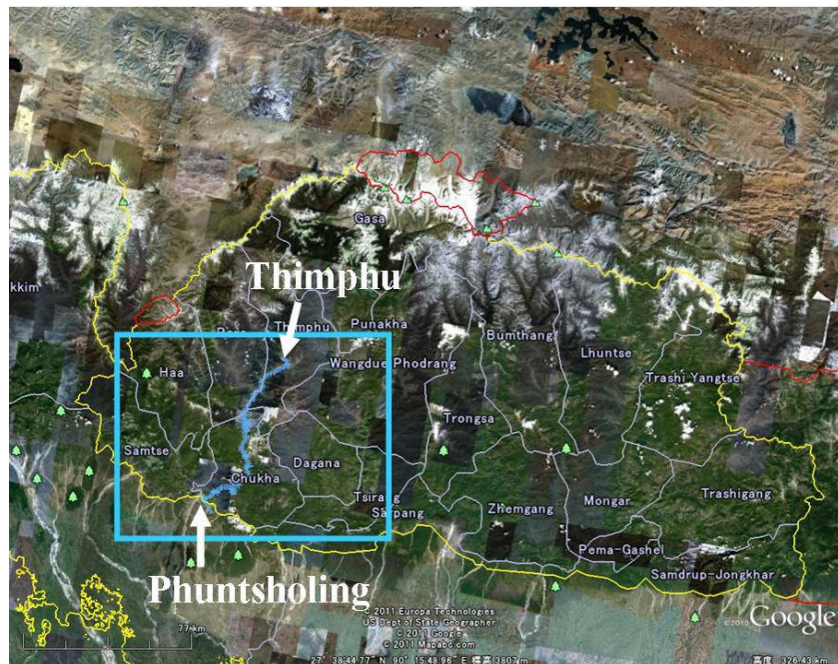
Fig. 1 Map of Kingdom of Bhutan.

Figure 1 illustrates the general idea of the Kingdom of Bhutan which ranges from the lowland at its Indian border to the top of Himalaya. The size of Bhutan is 38,400 km<sup>2</sup> in area and its population is 700 thousands. Because of the tectonic action between the Indian Ocean Plate and the Eurasian Plate, the geology in Bhutan is highly distorted and fractured, which makes mountain slopes highly vulnerable to instability problems. The precipitation rate is 3,000 to 5,000 mm in the southern lowland, 1,200 to 2,000 mm in the lower Himalayan slopes, 500 to 1,000 mm in the central mountain regions, and less than 500 mm in Himalaya. Most precipitation takes place during the monsoon season of June to September.

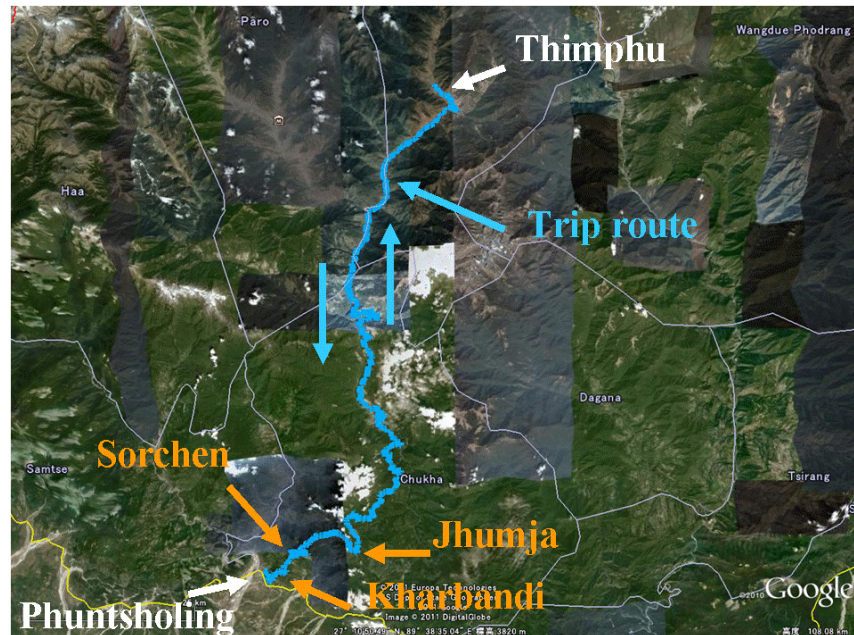
Fig. 2 Google map of the studied area (blue rectangle in Fig. 1).

Among many geohazards in this nation, 25 glacier lakes at high altitude are prone to breaching and flooding. The breaching event in 1994 caused debris flow in the downstream area, and the former capital of Punakha was affected. Although attempts are being made to construct drainage channels, working at high altitude is very difficult and risky. Because of the mission of ATC3, the present study was conducted on slope instability problems in the southern half of the country (Fig. 2).

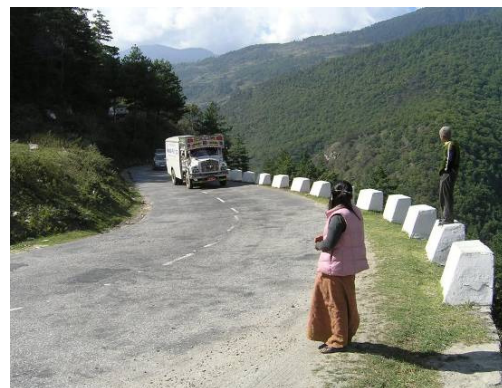
Fig. 3 The highway connecting Thimphu and Phuntsholing.

Technical visits were made of many sites of slope instability that is affecting the traffics of the nation's No. 1 highway between Thimphu (capital) and Phuntsholing (second biggest city at the Indian border); see Fig. 3. It appears that such metamorphic rocks as gneiss, schist, and phyllite with significant fissures and weathering are exposed to the air on the mountain side of the road and are causing instability problems at many places. Because the studied highway is the unique connection from outside to the capital, the slope instability is a substantial problem to the nation's economy.

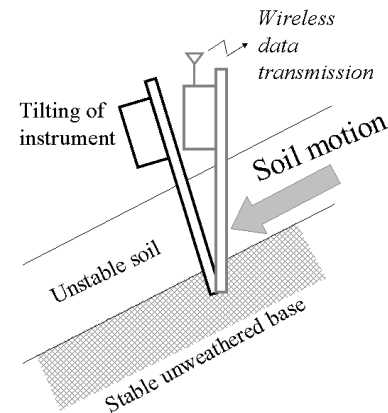
Fig. 15 Working mechanism of tilting sensor.

The proposed inexpensive sensor is intended to monitor movement of the surface unstable layer during heavy rainfall. For its working mechanism, see Fig. 15. Former studies (Farooq et al., 2004, and Orense et al., 2004) showed that soil exhibits minor deformation prior to the rain-induced failure. Thus, the developed sensor monitors deformation of slopes during heavy rainfall. The sensor is placed at the top of a rod which is penetrated in advance into ground until reaching a stable base layer. When the surface weathered soil starts to move during rain, the rod tilts and the tilting angle is monitored by the sensor. The recorded data is sent through wireless to an office and, if the extent of the data exceeds a threshold, caution or warning is sent to the local community.

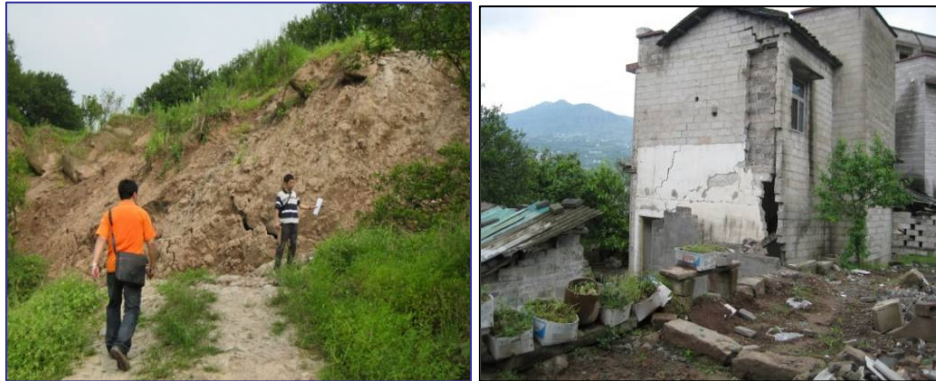
Fig. 17 Failed slope at Three Gorge Dam Reservoir

One of the monitored slopes failed on June 7th and 8th, 2009, during rain (Fig. 17). Fig. 18 shows the monitored records of tilting angles and precipitation. It is seen that the final failure (large angle) was preceded by minor rate of ground distortion. By comparing the recorded rate of tilting with the current proposal of threshold rates of tilting;

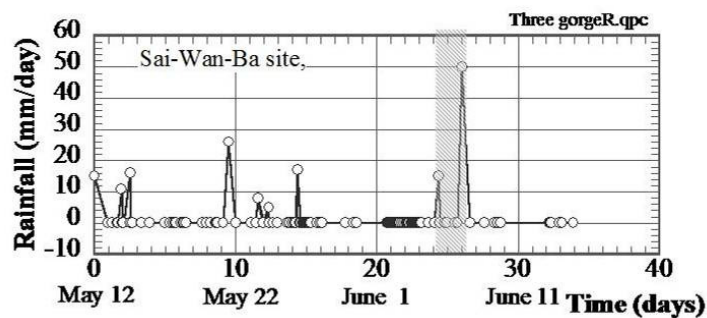
it is found that these warning thresholds are consistent with the records. However, it is thought that the threshold for the first caution is still subject to discussion.

(a) Rainfall records

(b) History of tilting angle

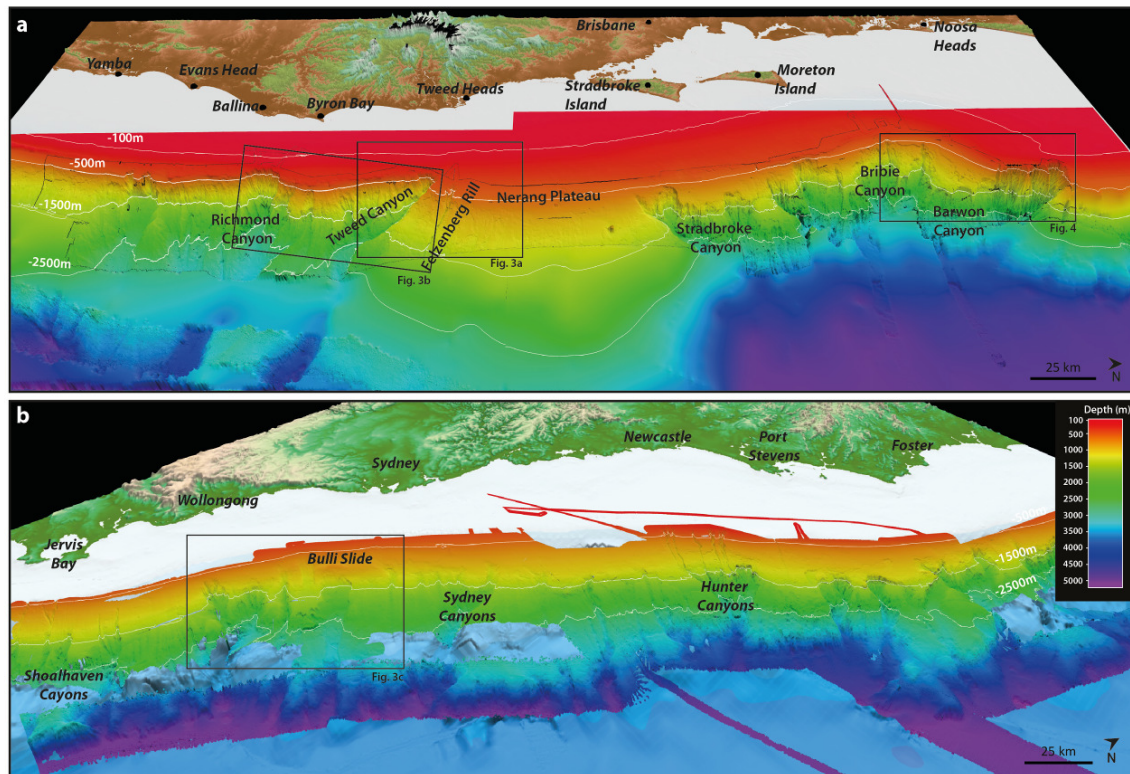
Figure 2: Bathymetric maps of the a) the southern Queensland / northern New South Wales continental slope and b) the mid New South Wales continental slope. Data for these maps were collected on two RV Southern Surveyor voyages: SS2008/12 off the southern Queensland / northern New South Wales coastline (Boyd *et al.*, 2010) and SS2006/10 off the mid New South Wales coastline (Glenn *et al.*, 2008). Insets mark the location of the close-up slopes images presented in Figure 3 and Figure 4.

Close inspection of the bathymetric data reveals several distinct large sediment slides varying in volume from <0.5 km<sup>3</sup> to 20 km<sup>3</sup> on the upper slope (water depths < 1200 m) of the SE Australian margin (Boyd *et al.*, 2010). The large slides typically comprise a distinct U-shaped trough in cross-section (3-6 km wide and 20-250 m deep) backed by an amphitheatre-shaped crestal zone. This slide morphology is similar to the classical circular failure profile described by Varnes (1978), but they are elongated in longitudinal profile. The sides and head walls of the scarps are relatively steep with slopes of up to 17°. The largest slides are the Bulli (Figure 3c) and Shovel Slides, near Sydney, on slopes of around 4.5° that are up to 13 km long and 5 km wide with volumes of 20 km<sup>3</sup> (Glenn *et al.*, 2008) and the Byron slide (Figure 3b), off Byron Bay, with a volume of 3 km<sup>3</sup> and slope of 6.5° (Clarke *et al.*, 2011). Sub-bottom profiling data from multiple sections across the continental slope and in particular across the slides show the sediment is built up of well stratified beds (Glenn *et al.*, 2008), which have been suggested to be evidence of past slide events. In most locations, sediments derived from the slides cannot be detected on the slope and it appears that the slide material has been transported to the abyssal plain. However, in a small number of locations (Figure 3a) where the slopes are less steep (< 2°), the slide debris flow deposits have remained on the slope and contain blocks up to 350 m wide and 50 m high.

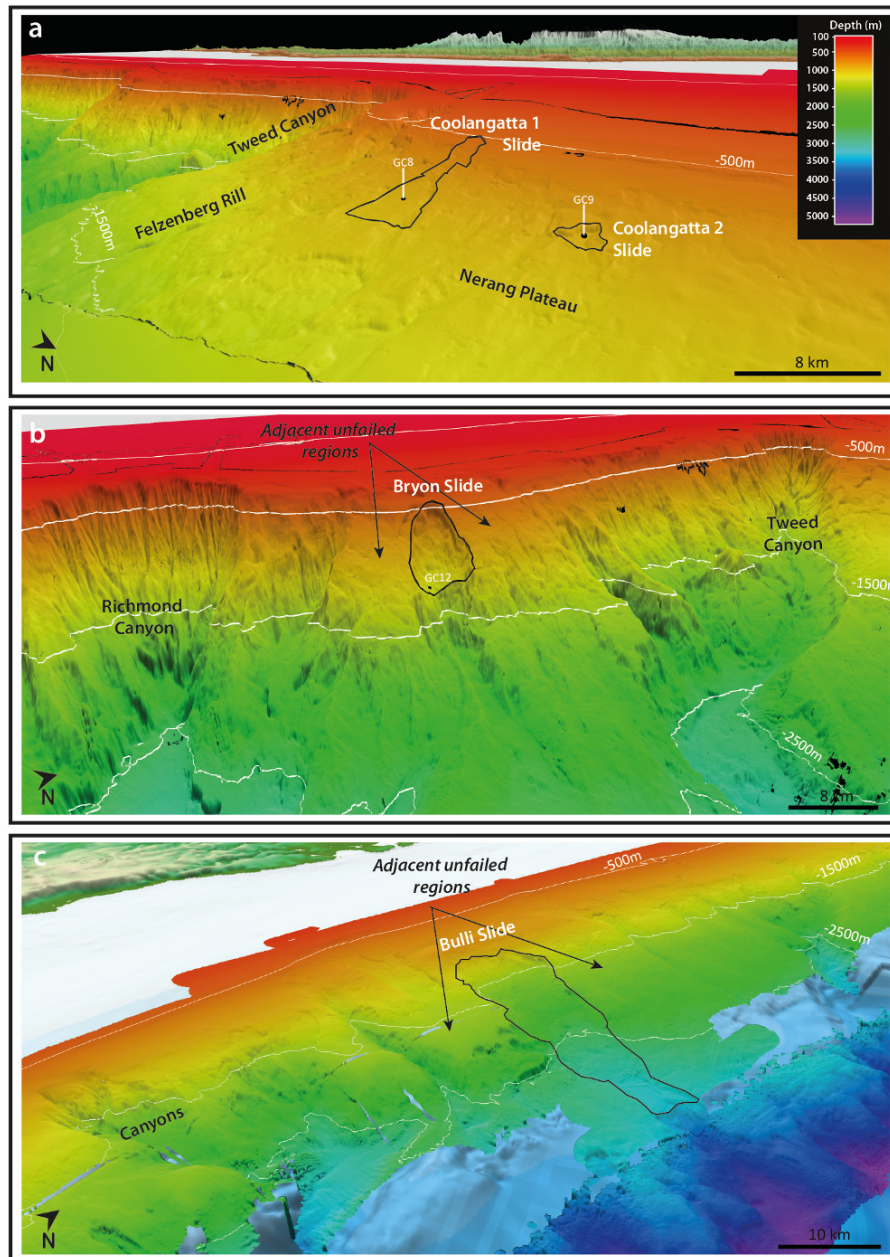
Figure 3: Digital elevation model (DEM) of the slope geometry for four slide sites (outlines denoted by black line): (a) Coolangatta 1 and Coolangatta 2 Slides, (b) Byron Slide, (c) Bulli Slide. Also shown are locations of the three gravity cores (GC8, GC9, GC12) referenced in this study, collected on the RV Southern Surveyor SS2008/12 voyage.

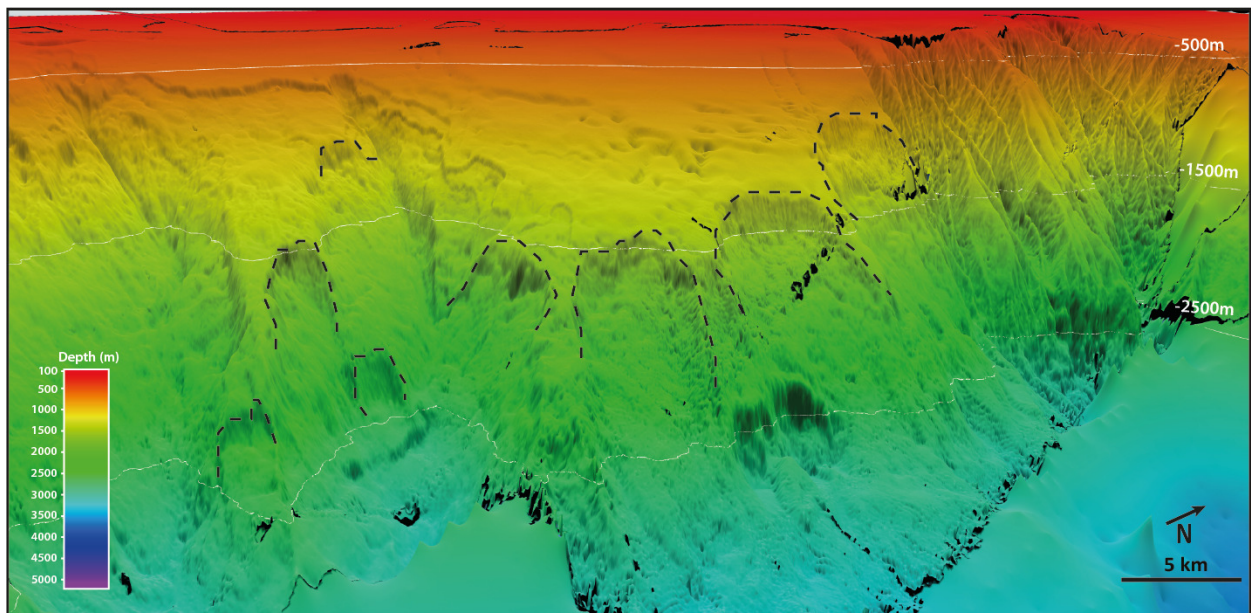
Figure 4: Digital elevation model (DEM) of a section of the mid-slope within the study area. Note the abundance of slump/slide scars presenting arcuate crests (crest outlines denoted by black dashed lines). Modified from Hubble, 2011.

Further observations from the bathymetry include the widespread slope failures on the mid-slope, shown in Figure 4, which demonstrates an average slope of around  $8^\circ$  and the widespread relatively shallow failures observed on the Nerang plateau shown in Figure 3a, where the average slope is  $< 2^\circ$ . There are also circular depressions, referred to as pock marks, off Newcastle which are believed to be associated with gas leakage from the underlying Permian coal measures (Glenn *et al.*, 2008).

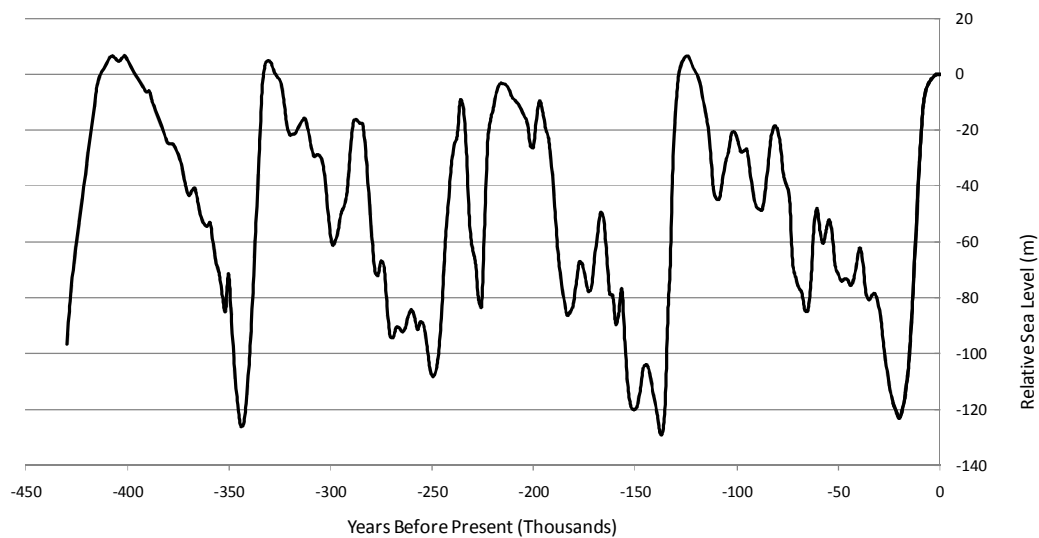
Figure 5: Relative sea level history (after Waelbroeck *et al.*, 2002)

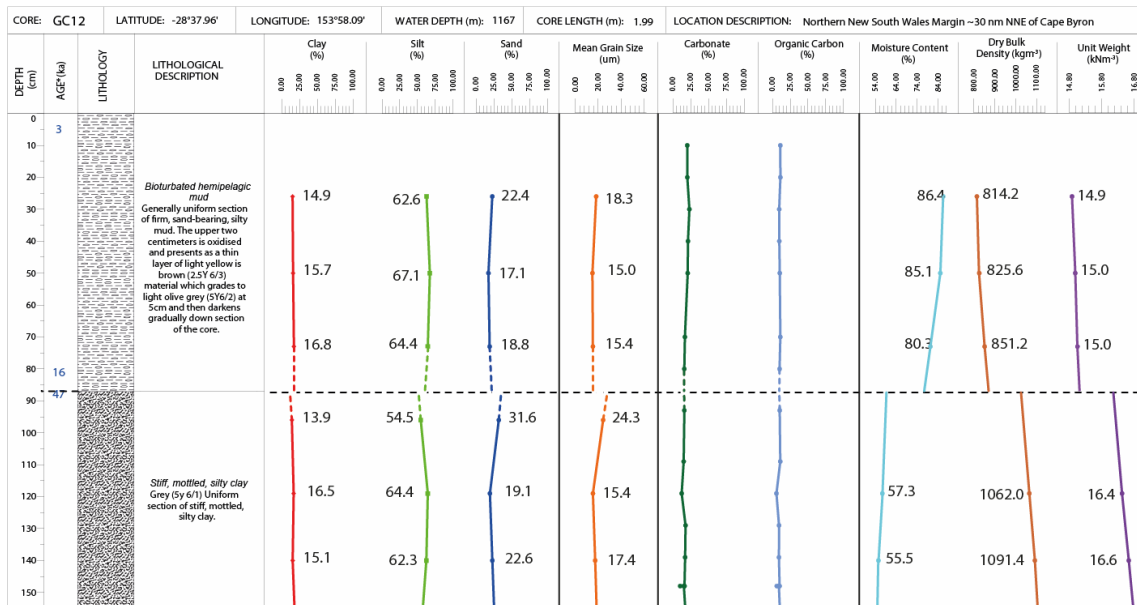
Figure 6: Characterisation of sediment from core GC12, showing physical properties with depth below seabed. Bulk radiocarbon dates are also shown. The presumed slide plane is indicated with a dashed black line at 87 cm depth below seabed (Modified from Clarke *et al.*, 2011)

Several of the gravity cores were obtained from within detected landslide features in an attempt to penetrate through the base of the slides to assist in constraining the slide depths and dates. In most locations this was unsuccessful as the recent sediment drape overlying the slide surface was thicker than the gravity corer could penetrate. However, in three locations off SE Queensland a distinct boundary in the sediments could be detected at depths between 87 cm and 220 cm. The sedimentological and geotechnical properties of the sediments and their variation with depth from one of these cores (GC12; see Figure 3b for core location) are shown in Figure 6. It can be seen from the figure that there is a distinct change in density and moisture content, as well as appearance of the material at a depth of 87 cm. It is also noticeable that this change in density is not associated with any significant change in the grading, carbonate content or organic content of the material.

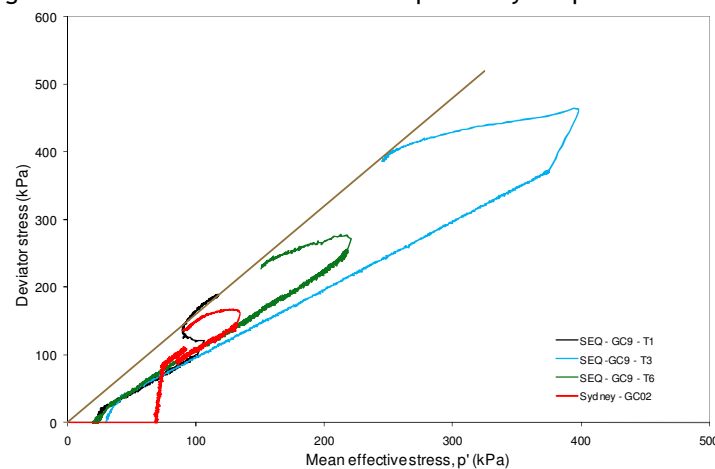
Figure 8: Stress-path curves from triaxial tests.

The responses of 3 specimens to undrained shearing in triaxial compression are shown in Figure 8, and the associated effective stress-strain curves are shown in Figure 9. To enable comparison of the tests the deviator stress and excess pore pressures have been normalised by the vertical effective stress at the start of shearing. Specimens GC9-T1 and GC9-T3 were adjacent specimens and have similar compressibilities, as seen from Figure 7, but they responded differently to shearing. Specimen GC9-T1 at the higher stress level ( $\sigma'_v = 620$  kPa) shows a more brittle response with the peak deviator stress attained at a very small strain, after which the resistance rapidly decreases to its ultimate value. In contrast, specimen GC9-T3 at the lower stress ( $\sigma'_v = 167$  kPa) does not reach a maximum until relatively large strain. From the pore pressure responses and the effective stress paths it can be seen that this difference is a consequence of a transition from dilative to compressive behaviour as the stress level increases. The more compressible (Sydney) specimen shows a response similar to the higher stress GC9-T1 even though the stress level ( $\sigma'_v = 220$  kPa) is similar to GC9-T3. The shear response of GC9-T6, which has similar compressibility to the Sydney specimen also shows the tendency for increasing brittleness with increasing stress level, however, this result is not considered reliable due to non-uniform deformation during shearing. This pattern of reducing dilation and increasing brittleness with stress level can explain why deeper failure surfaces develop.

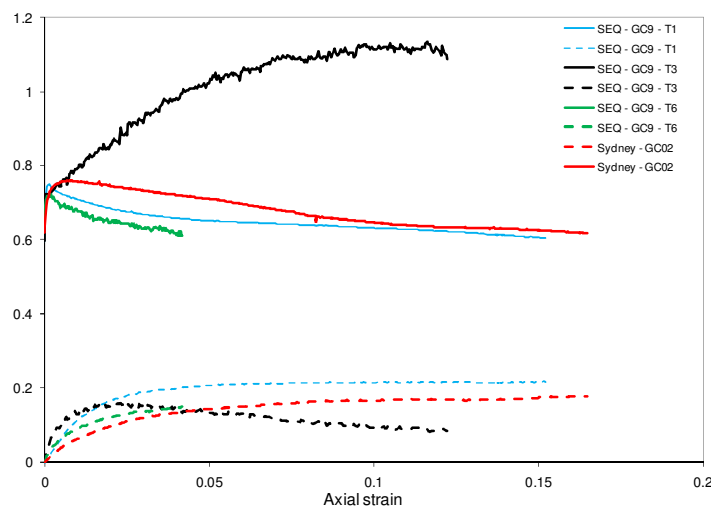
Figure 9: Normalised deviator stress and pore pressure responses from 1-D compressed specimens.

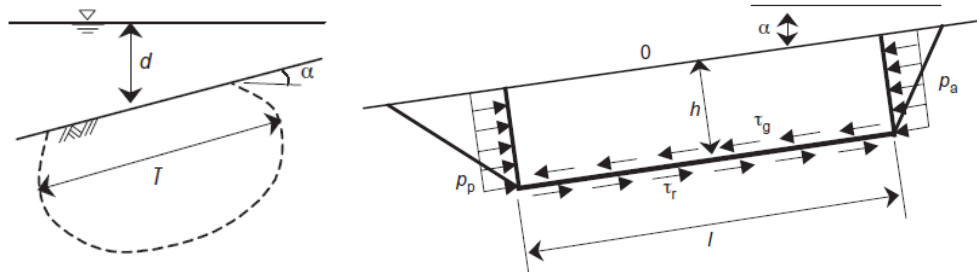
Figure 10: (a) Zone of elevated pore pressures, (b) Slope failure mechanism (after Puzrin *et al.*, 2004)

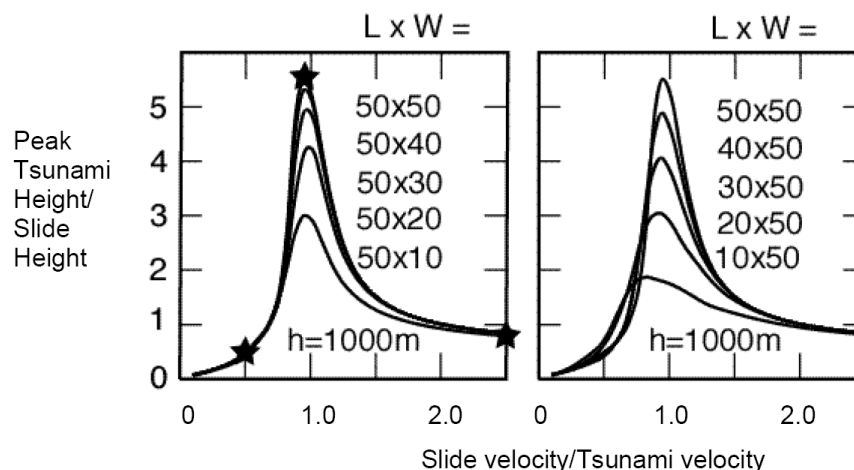
Figure 11: Effects of slide velocity and slide dimensions on peak tsunami height (after Ward, 2001).

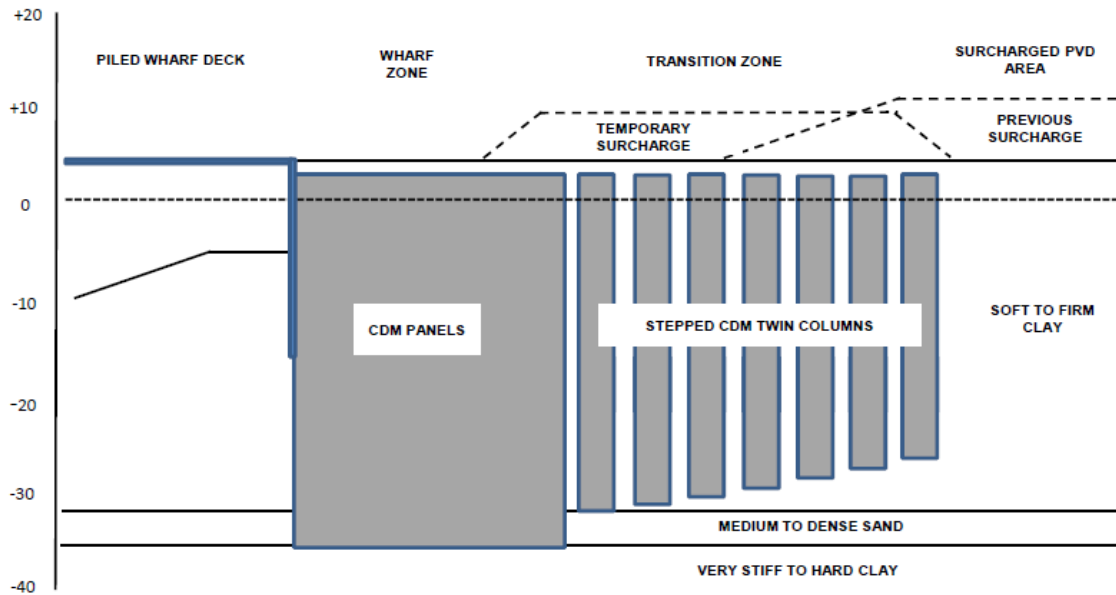
Figure 1 - Illustration of Ground Improvement Adopted in Transition Zone

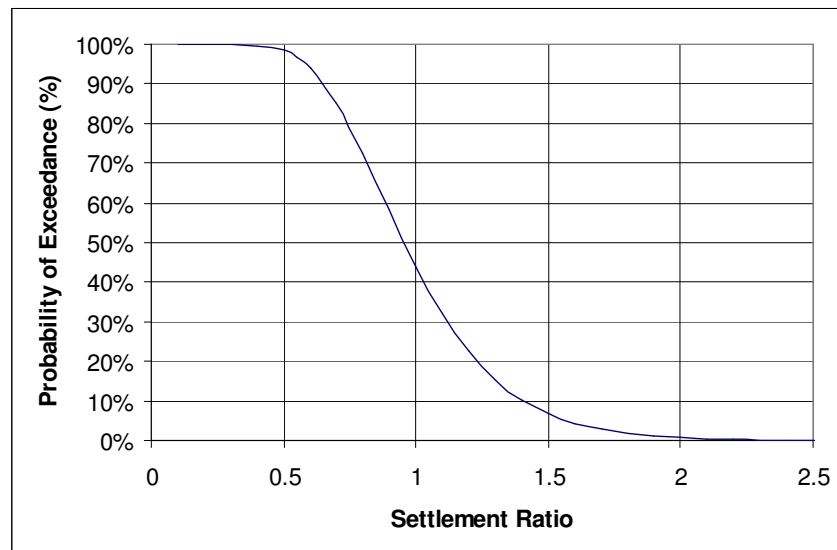
Figure 2 - Computed Probability Distribution of Settlement Estimate

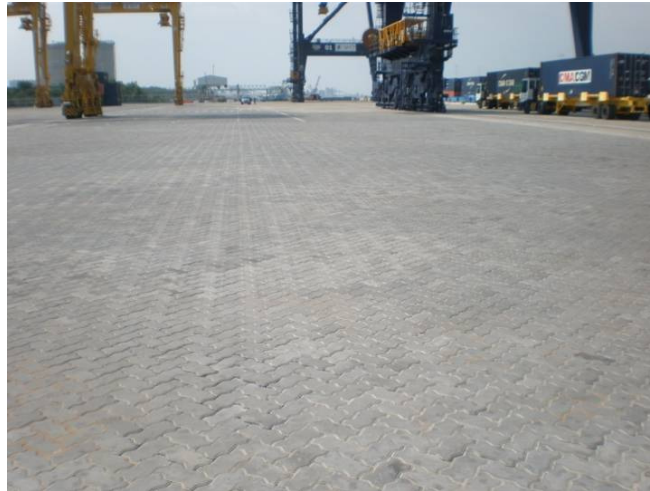
**Plate 1**  
Finished pavement  
surface during  
container handling

Unfortunately, the author was unable to obtain any monitoring data from our client on this project post-construction. However, verbal information from our client is that the container terminal is performing satisfactorily to date. Plate 1 shows the pavement condition during operation of the container terminal.

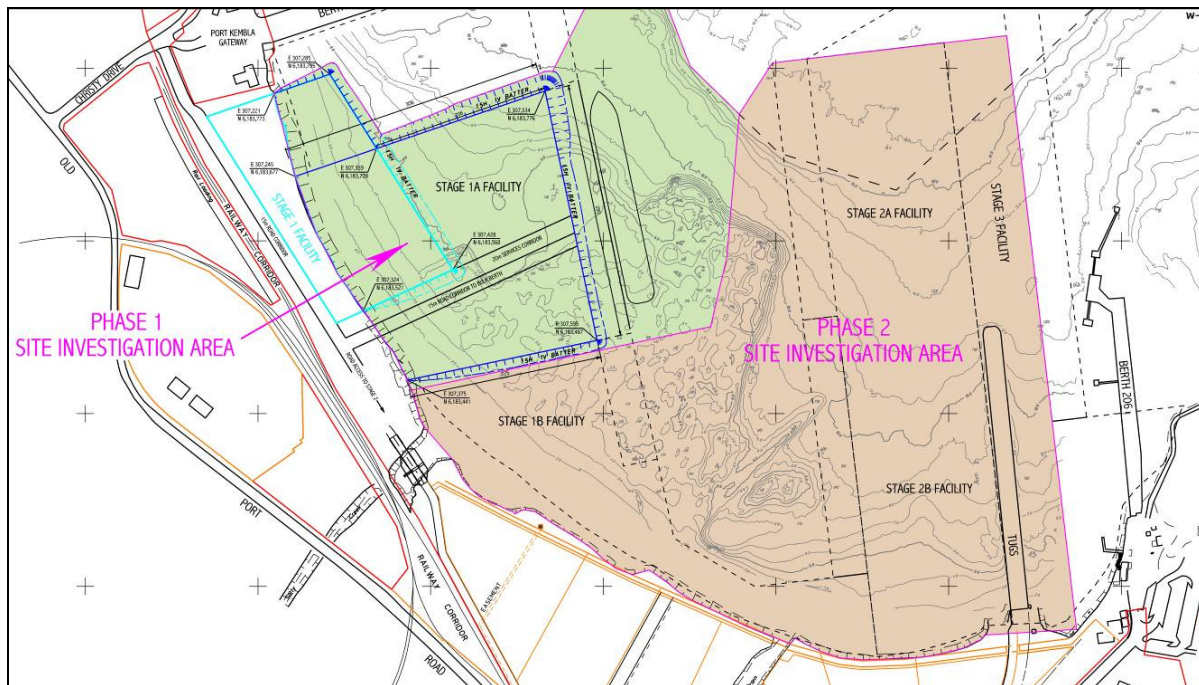
Figure 1: Port Kembla Port Corporation Outer Harbour master plan

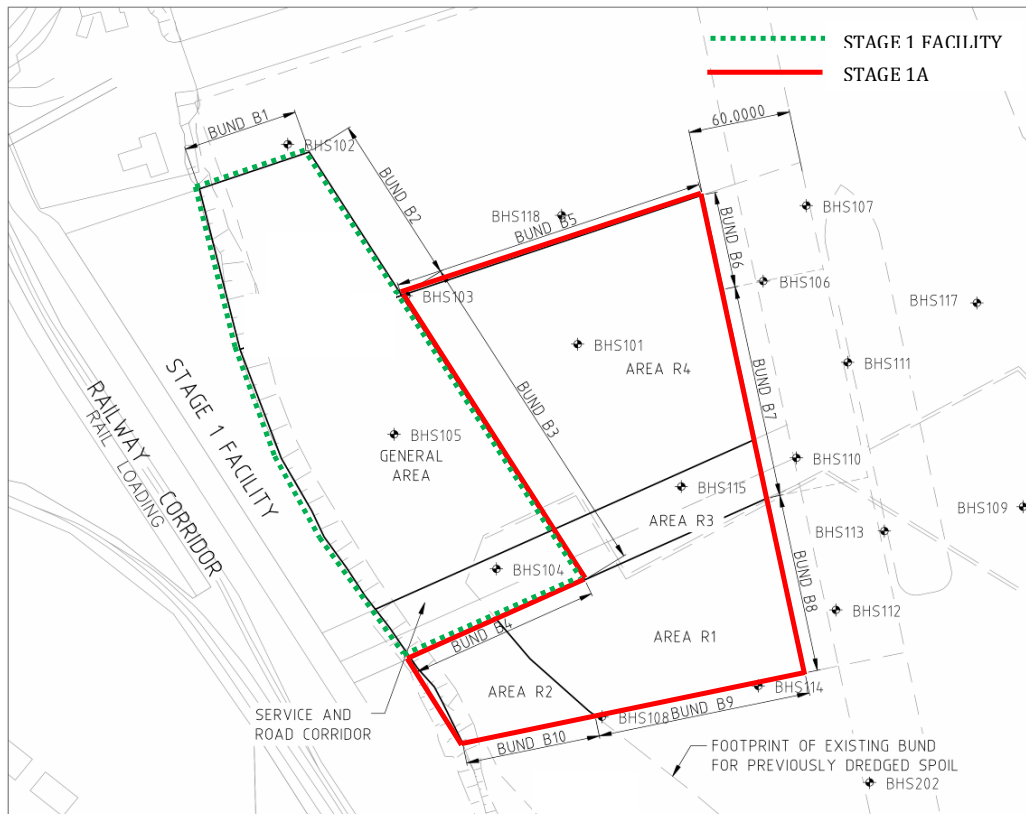
Figure 2: Geotechnical investigation location plan for Phase 1 investigations

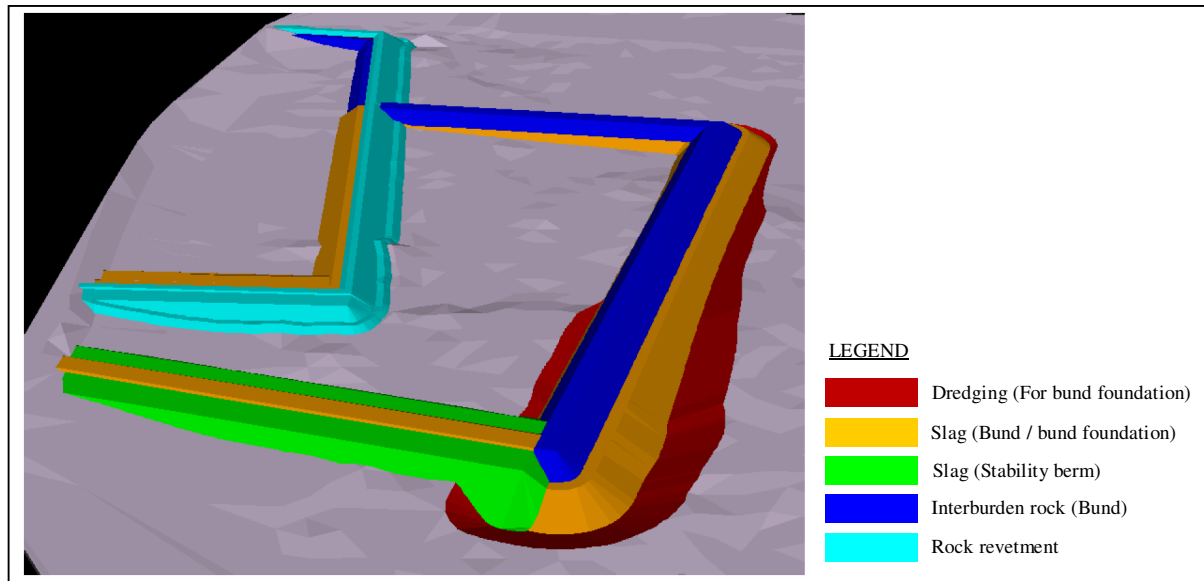
Figure 3: Perspective view showing completed Stage 1 and 1A bunds

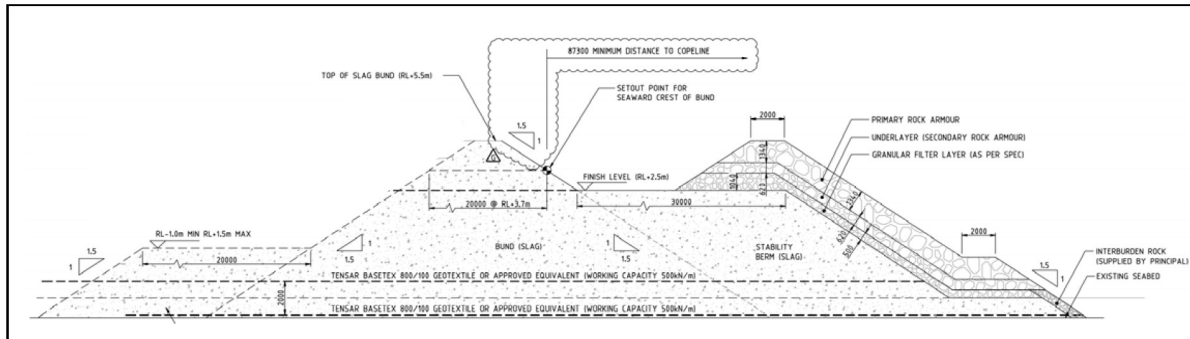
Figure 4: Typical section of bund for proposed variation design
