Progressive failure of slopes with sensitive clay layers

Dey R., Hawlader B.

ABSTRACT: Progressive failure of slopes can trigger large scale landslides. The presence of sensitive clay layers is one of the main reasons for progressive failure of a slope. The whole soil mass involved in a potential landslide might be of sensitive clay, while in some cases there exist only thin layers of sensitive clay interbedded with relatively strong soils. The movement of a slope might be initiated due to the presence of a weak soil layer, where the shear stress is increased or soil strength is reduced by various triggering factors. Once the failure/movement is initiated in a small zone, the imbalanced force is transferred to the surrounding soil in which slip surface might propagate in the form of a shear band through the sensitive clay layer even though the sensitive clay layer is relatively thin. The propagation of shear band in sensitive clay is also associated with post-peak strain softening behaviour of soil. In this study, upward progressive failure due to river bank erosion has been modelled using nonlinear post-peak strain softening behaviour. It is shown that the pattern of propagation

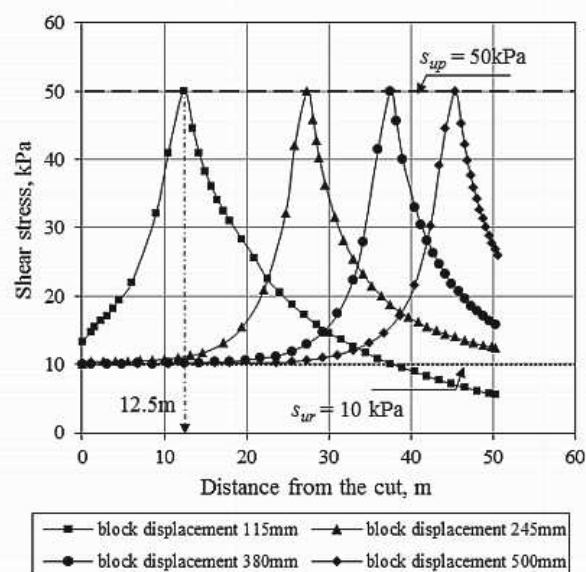
The Case-III is considered for further examination of the development of shear stress and mobilized shear strength along the potential failure plane. Figure 3 shows the variation of shear stress along the failure plane with movement of excavated/eroded block. Shear stress for four displacements (115 mm, 245 mm, 380 mm and 500 mm) are shown. In order to explain the process, consider the shear stress on the potential failure plane for the block displacement of 115 mm. The maximum shear stress (50 kPa) is developed at 12.5 m from the vertical face of the cut. The shear stress between 0 to 12.5 m is less than 50 kPa (i.e. s_{up}) and greater than 10 kPa (i.e. s_{ur}). That means, 0-12.5 m of the shear band represents the post-peak softening zone where the reduction of shear strength is occurred because of plastic strain as Eq. 2, and the mobilized shear strength is in between the peak and residual shear strength of the soil. In the right side of the peak (i.e. distance greater than 12.5 m) the shear stress is again reduced with distance. For this displacement of the block (115 mm), the shear stress in the

Figure 3. Shear stress along the potential failure plane

potential failure plane at a distance greater than 12.5 m is not increased to the peak, and therefore it represents the pre-peak behavior. At a very large distance, the shear stress is reduced to zero in Case-III as the ground surface is horizontal. The pattern of shear stress development for any other displacement of the block is similar as shown in Fig. 3. The location of the peak shear stress shifts to the right with increase in block displacement; that means a greater length of the potential failure plane is in post-peak stress-strain condition. For example, for 500 mm block movement the peak is occurred at 45.5 m and therefore 0-45.5 m is in post-peak condition with approximately 30 m in residual shear strength level. This process will be continued until the shear band propagation is ended for stable slopes as in Case-III. However, if the failure is occurred, as in Case-I and II, the large plastic shear strain will reduce the shear

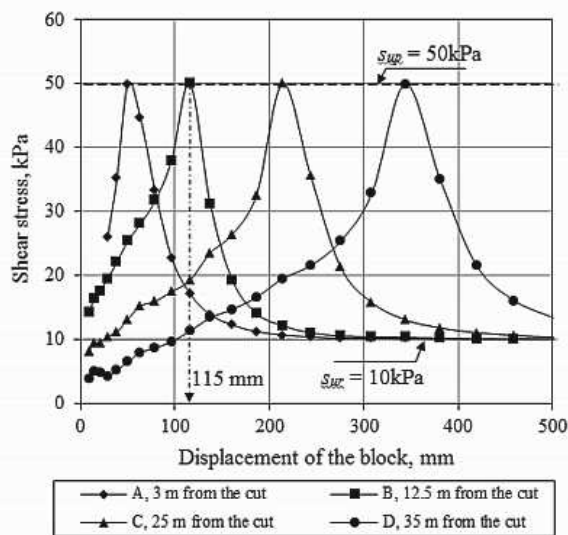
Figure 4 shows the variation of shear stress at 4 different locations A, B, C and D (Fig. 1) which are located from the vertical face of the excavated/eroded block at horizontal distance of 3 m, 12.5 m, 25 m and 35 m, respectively. Consider the soil element B at 12.5 m distance. The shear stress in this element is increasing with movement of the excavated/eroded soil block. When the block is displaced by an amount of 115 mm, the shear stress in this element is reached to the peak shear strength of the soil (50 kPa). However, at this displacement of the block, the element A is almost at the residual shear strength. On the other hand, the elements C and D are still in the pre-peak state. That means the shear stress is gradually transferred to the soil elements in the right with displacement of the excavated/eroded soil block. For the soil element under the slope of the river bank there is an initial shear stress. With movement of the block the shear stress is increased from that initial value. However, the initial shear stress is less in the elements far from the river bank. Similar variation in shear stress and mobilized shear strength are obtained for Case-I and II.

Figure 4. Variation of shear stress at four different locations from the cut
