Performance of Piled Foundations Used as Heat Exchangers

Loveridge F., Powrie W.

Faculty of Engineering and the Environment, University of Southampton, Southampton, UK

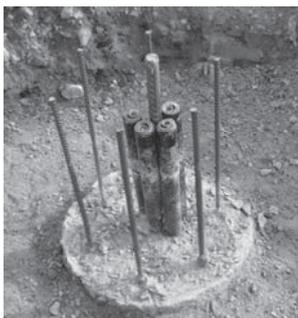
Figure 1. Typical pile heat exchanger at the site (after breaking down to pile cut off level).

The source side of the ground energy system comprises 160 pile heat exchangers and a field of 46 150m deep boreholes. The piles are 600mm, 750mm or 1200mm diameter and were constructed using contiguous flight auger techniques. Each pile was installed with a pair of plastic U-pipes, which were inserted into the centre of the pile (Figure 1) after the pile cage had been plunged into the concrete. The U-pipes were then connected together in series and usually joined into a single circuit with a neighbouring pile, before the pipework is continued to the header chamber and then on via larger pipes to the plant room for connection to the heat pumps.

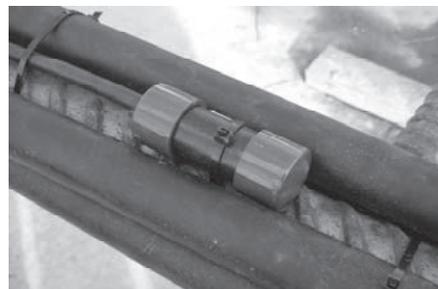
Figure 2. Base of the central thermistor string prior to installation of the U-tubes and steel bar.

One 1200mm diameter pile near the north east corner of the building was selected for monitoring. The pile was equipped with five thermistor strings. One of these was attached to the central bundle of plastic pipes, themselves inserted into the pile attached to a 40mm steel bar for stiffness (Figure 2). The U-pipes, the steel bar and the thermistor strings were installed to a depth of 20m within the pile. The other four thermistor strings were attached at equal spacings around the circumference of the steel reinforcing cage (Table 2). As the pile cage only extends to 8.5m below the pile cut off level it was not possible to extend the outer thermistor strings over the full 21m pile depth.

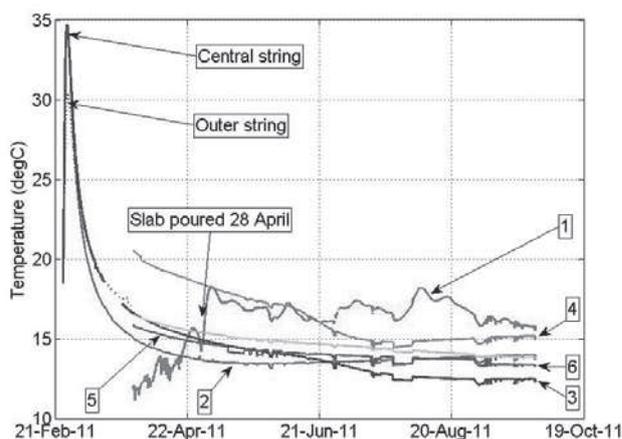
Figure 3. Initial pile temperatures during and after concrete curing (numbers refer to thermistor string levels).

These initial data are presented in Figure 3. It can be seen that during curing the pile reaches temperatures of almost 35°C at its centre, but that this reduces to approximately 30°C closer to the pile edge. In the main part of the pile, it takes over two months for the heat of hydration to dissipate fully and

temperatures to return to between 13°C and 15°C. The near surface monitoring points (thermistor level 1, Figure 3) are influenced by the ambient air conditions. Within one month (when monitoring of these points first commenced) the thermistors at level 1 are already showing daily and longer term seasonal fluctuations reflecting the local air temperature.

The level 1 thermistors also show a distinct increase in temperature at the end of April 2011, coincident with the date at which the floor slab for the building was cast. This temperature increase will represent the additional heat of hydration from the concrete slab. Following this time, daily variations of temperature are also reduced due to the additional insulation. It is also interesting to note these level 1 temperatures appear to remain elevated for some time after the slab is cast; although it is difficult to separate this effect from that of the surface air temperature which would also be increasing at this time of year.

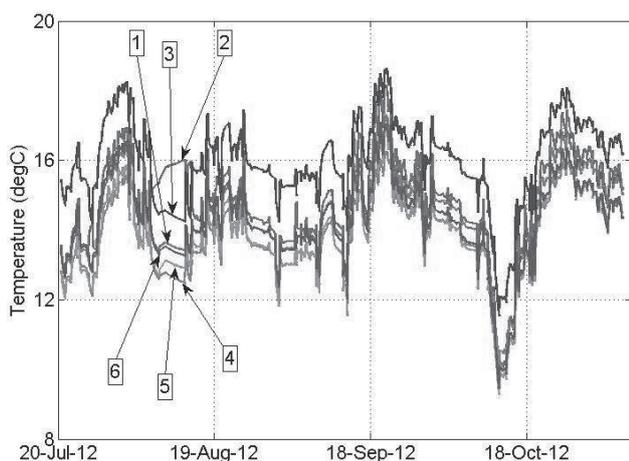
Figure 4. Operational temperatures from the central thermistor string (numbers refer to thermistor string levels).

Figure 4 and 5 present the temperature data from the central thermistor string and the outer thermistor strings respectively. The central thermistor string records a greater range of temperatures than the outer strings, with $\pm 4^{\circ}\text{C}$ and $\pm 1^{\circ}\text{C}$ variation from the initial ground temperatures respectively. The central string also shows greater short term variation compared with the outer strings. This is because the temperature change of the central thermistors will closely follow that of the heat transfer fluid circulating within the U-tubes. However, by the time heat flow from the fluid reaches the outer thermistor strings any very short term variations will have smoothed out.

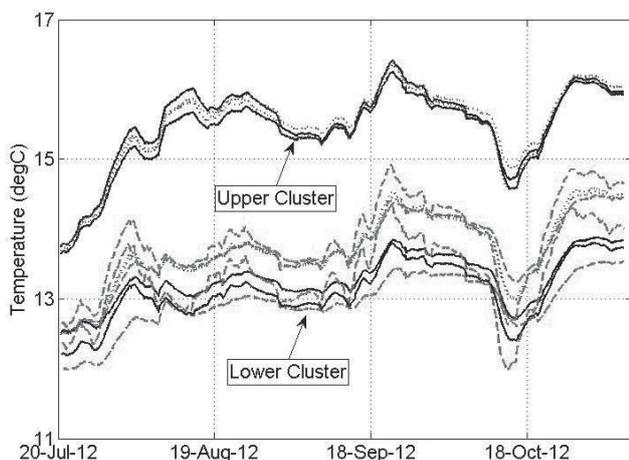
Figure 5. Operational temperatures from the outer thermistor string (dashed = thermistor level 1; solid = level 2; dotted = level 3).

It is also noted that the outer thermistor readings are grouped into two distinct clusters. The upper cluster is approximately 2°C warmer than the lower cluster, but follows a similar, although not identical trend. If both the U-tubes and steel cage were installed exactly centrally within the pile bore then, ignoring pile end effects and any variation in ground and concrete thermal properties, all the outer thermistors should read the same value. However, since an exactly central installation is not possible, it should be expected that there will be some variation in these values. However, what is surprising is that the upper cluster contains level 2 and level 3 thermistors from opposite sides of the pile, which should only have close to equal values if the cage and the pipes have been installed centrally. This could suggest that the readings in the upper cluster are erroneous.

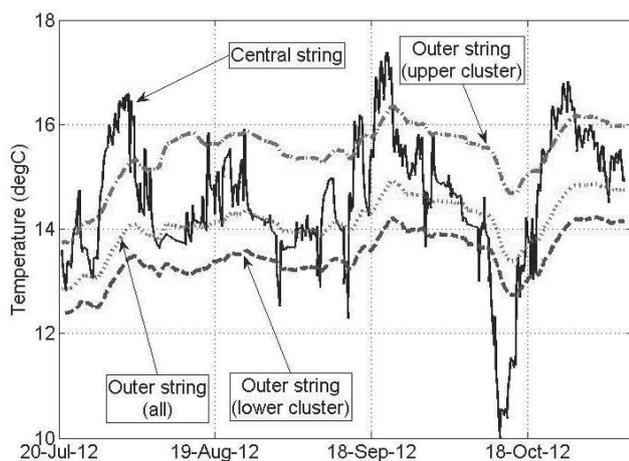
Figure 6. Mean thermistor string temperatures.

This view is supported by looking at the average temperatures for the central and outer strings (Figure 6). Temperatures are generally rising with time as heat is rejected to the ground via the pile. Therefore the temperatures closer to the pile edge would be expected to be lower than those in the centre next to the pipes. In this context the upper cluster appears to be erroneously high, while the lower cluster shows temperatures in a more realistic range.

There is, however, one clear example of heat extraction visible in mid-October (Figure 6). Here the central thermistor readings dip markedly to around 10°C on average. The corresponding change in the mean outer thermistor readings is much smaller, indicating that much of the heat energy required has actually been extracted from that temporarily stored in the pile concrete, rather than from the surrounding ground.

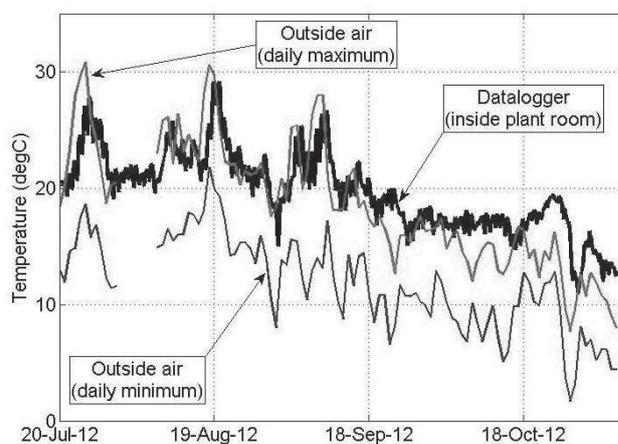
Figure 7. London air temperatures.

The general trend of increasing temperatures, despite the advent of cooler air temperatures as the autumn progressed (Figure 7) is a reflection of the complexity of both modern buildings and the heating-ventilation-air conditioning (HVAC) system in this building in particular. For a system where pile heat exchangers are either providing all of buildings heating and cooling demands, or covering only partial demand in combination with a traditional HVAC system, then the pile temperature would be expected to reflect the outside air temperatures and decrease throughout the winter months. However, in this case the energy needs of the building are being met by a combination of the pile heat exchangers, the borehole heat exchangers and a solar system. These means that the three components will be operated together to achieve the building heating and cooling demands and, for example, on some
