Slope stability associated with expansion of MSW landfill in China

Y.M. Chen, L. T. Zhan & W.A. Lin

MOE Key Laboratory of Soft Soils and Geoenvironmental Engineering, Zhejiang University, Hangzhou, 310027, China

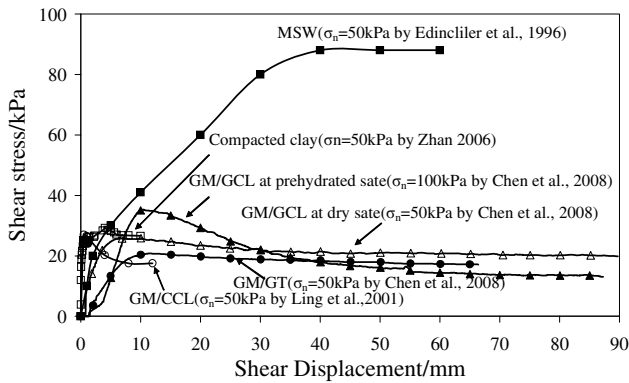
For a controlled landfill lined with a composite liner system, landfill failure tends to be controlled by the weak shear strength at soil-geosynthetic and geosynthetic-geosynthetic interfaces. Figure 4 shows a comparison of stress-deformation curves for different materials and interfaces, which are commonly found in landfills. The interfaces include textured geomembrane/compacted clay (GM/CL), textured geomembrane/non-woven geotextile (GM/GT) and textured geomembrane/geosynthetic clay liner (GM/GCL). It can be seen that the MSW, exhibiting a strain-hardening behavior, poses higher ultimate shear strength than the compacted clay and the interfaces. The peak values of shear strength of the interfaces are close to that of the compacted clay. However, all the interfaces show a strain-softening, and hence have lower shear strength than the compacted clay when the shear displacement is large. A difference in the shear strength is also observed among different interfaces, particularly at a large shear displacement. The GM/GCL interface at a hydrated state has the lowest strength and exhibits a more significant strain-softening at a higher stress level. This is attributed to bentonite extrusion from GCL to the interface.

Figure 4. Shear stress-displacement relationships for MSW, compacted clay and interfaces within composite liners

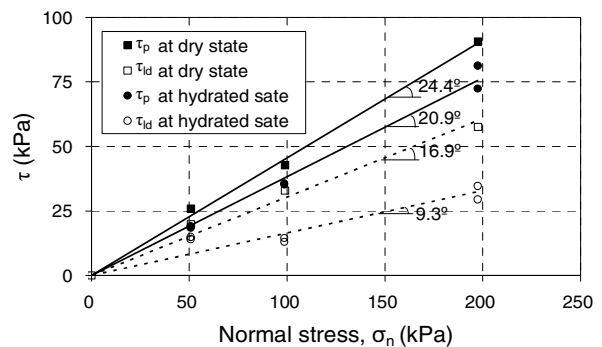
Shear resistance versus normal stress is plotted in Fig. 6 to show the effect of bentonite extrusion on changes in shear strength parameters. For simplicity, it is assumed that the cohesion intercept is equal to zero and a linear regression can be made for each of the shear strength envelopes. The values of interface friction angle at peak (ϕ_p) were 24.4° and 20.9° for

the dry GCL/GM interfaces and the hydrated GCL/GM interfaces, respectively. The values of interface friction angle at large displacement (ϕ_{ld}) were 16.9° and 9.3° for the dry GCL/GM interfaces and the hydrated GCL/GM interfaces, respectively. A comparison of the two shear strength envelopes corresponding to the large displacement conditions indicates that the bentonite extrusion at the large shear displacement caused a strength loss with a magnitude of 7.6° in terms of interface friction angle. The magnitude of strength loss is comparable to the combined effects of strain-softening, geotextile damage and geomembrane asperity removal on the post-peak strength reduction of the dry GCL/GM interfaces, which showed a magnitude of 7.5° in terms of interface friction angle. The influence of bentonite extrusion on the peak shear strength showed a magnitude of 3.5° in terms of interface friction angle. As compared with the peak strength envelope of the dry GCL/GM interfaces, the hydrated GCL/GM interfaces at the large shear displacement experienced a total strength loss with a magnitude of 15.1° in terms of interface friction angle. It is acknowledged that more data points would be beneficial in confirming the above quantification.

Figure 6. Shear strength envelopes for the GCL/GM interfaces
