# Monitoring and evaluation of movements in gravity quay walls

Antonio Soriano

This paper summarizes the observed foundation settlements of several recently constructed Spanish quays. When the quay walls are founded on soft soils, the settlements observed could be larger than 50 cm. The paper indicates the values of the ground deformations parameters obtained by the back-analysis of the observed settlements and compares those parameters with the original values used to predict settlements at the design stage. The predictions of the movements and the back-analysis have been made using numerical models. In addition, if the monitoring of the movements is good enough, it is possible to study the evolution of the consolidation of the natural ground under different loads.

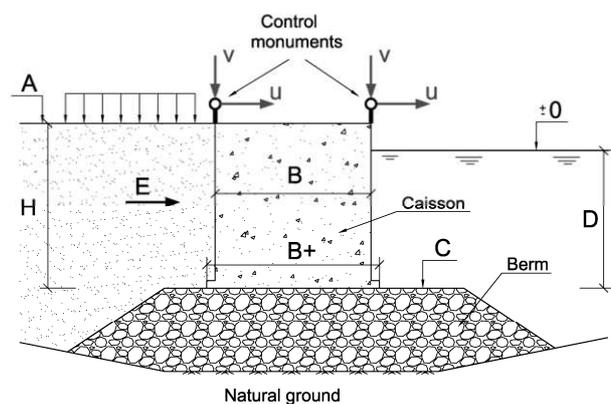
Figure 1.- Cross-section of a typical quay wall

Figure 1 shows the typical cross-section of this type of quay, including the position of the monuments used to measure displacements of the caisson crest.

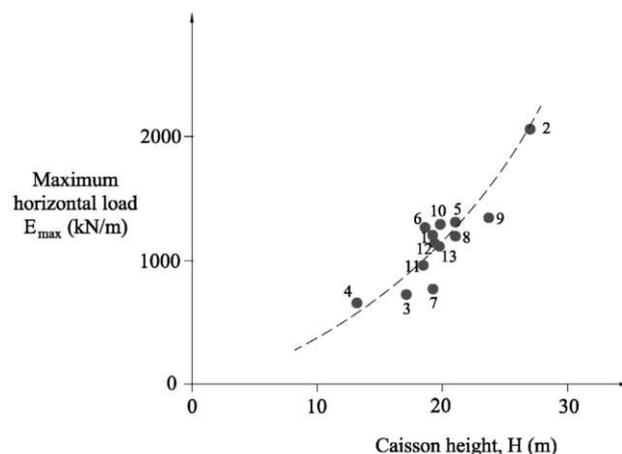
Figure 3.- Maximum horizontal loads on some Spanish quay walls

Figure 3 relates the maximum horizontal design load acting on the quay wall to the height of the caissons for the quays indicated in Table 1.

This figure shows a relationship between the height of the quay and the horizontal load. For a 20 m high caisson, the maximum horizontal load is about 1,200 kN/m.

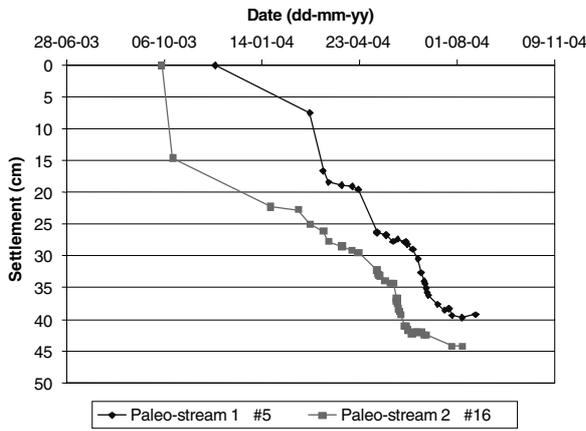
Figure 4.- Settlements at the Bajo de la Cabezueta quay

Figure 4 and 5 show the settlement and the horizontal movements of the caissons in the center of the two paleo-stream channels, when the caissons were founded on the rock-fill and during the fill of the back of the quay.

Figure 4 indicates settlements of about 20 cm when the caissons were founded and their cells filled. The other 20 cm were measured during the backfill stage.

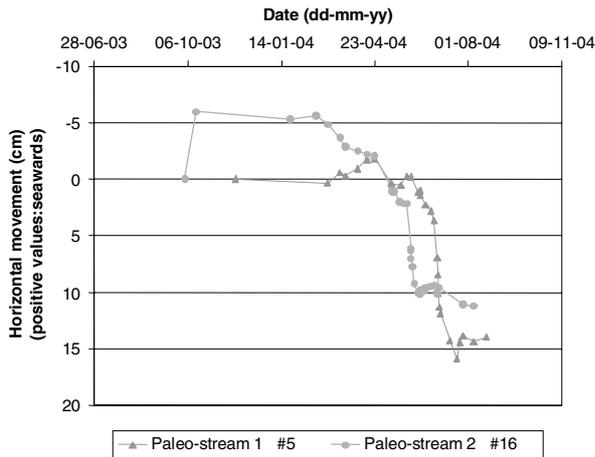
Figure 5.- Horizontal displacements at the Bajo de la Cabezueta quay

As can be seen in Figure 5, the top of the caisson on paleo-stream 2 initially moved landwards with the backfill operation. As the backfilling progressed, however, this displacement changed direction and the caisson crest eventually was displaced about 15 cm seawards.

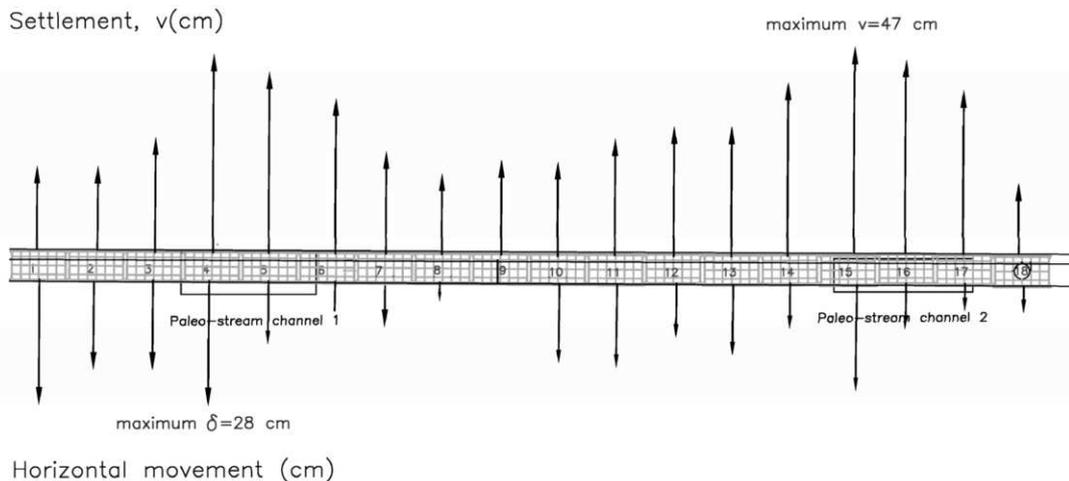
Figure 6.- Plan view with the maximum movements at the Bajo de la Cabezueta quay

Figure 6 represents a schematic plan view of the quay with the maximum values of the settlements and horizontal movements in each caisson.

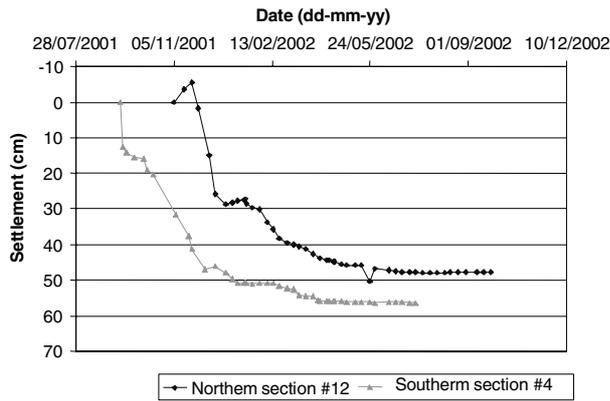
Figure 7.- Settlements at the León y Castillo quay wall

Figure 7 and 8 show the settlement and the horizontal movements of the crest of the quay caissons in both sections: in the north (over a layer of sand fill) and in the south (where the thicker supporting berm was placed on natural dense sand).

As can be seen, the thicker rockfill berm more than compensates the supposedly softer material underneath and settlements were similar in both cases (even lower in the northern section). The final value overall was about 50-55 cm. The horizontal movements measured were about 30 cm. This value includes the influence of the preloading applied to improve the geotechnical characteristics of the general fill.

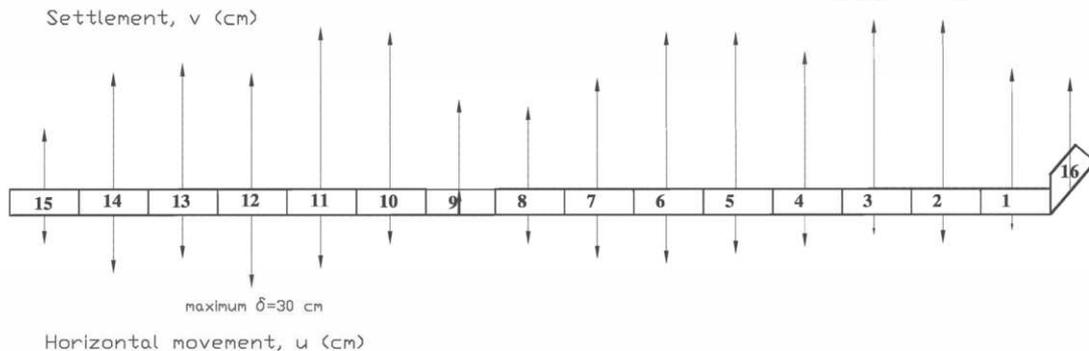
Figure 9.- Plan view with the maximum movements at the León y Castillo quay

To summarize the measurements, Figure 9 shows a plan view representing the maximum values obtained along the quay wall.

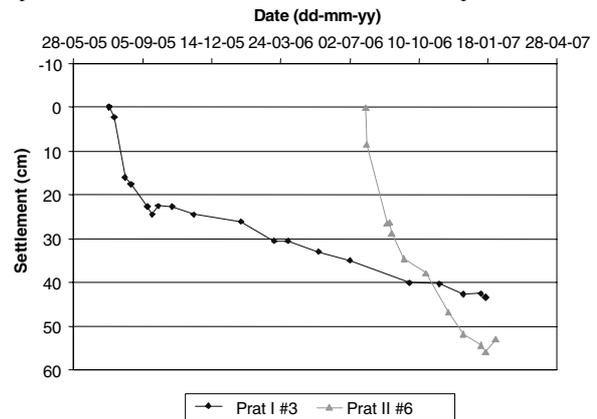
Figure 10.- Settlements at Prat quay wall

The settlement and the horizontal movements of the caisson crests in Prat I and Prat II are shown in Figure 10 and Figure 11. The curves represent values when the caissons were founded and during the backfill. Figure 12 represents the maximum displacements recorded for each caisson of both phases.

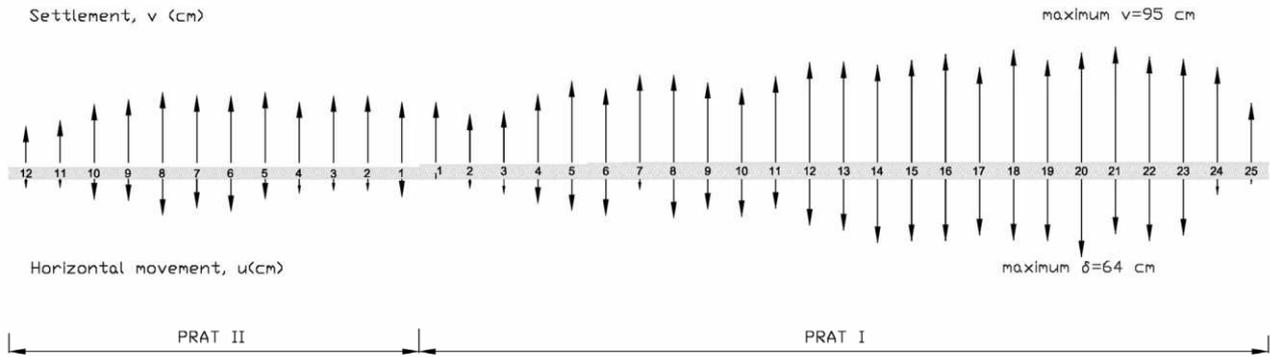
Figure 12.- Plan view with the maximum movements at the Prat quay

maximum v=70 cm

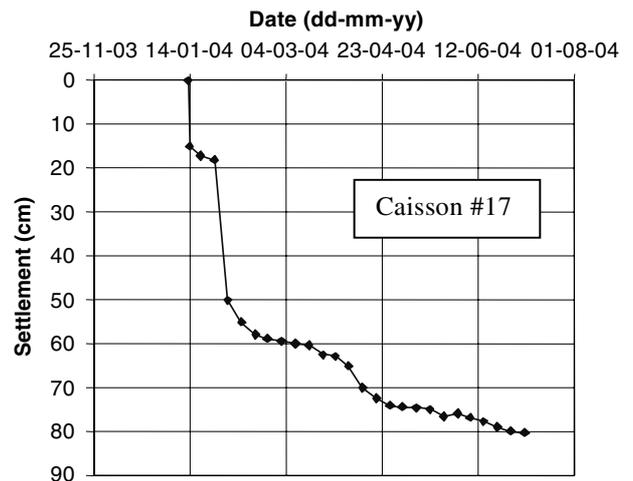
Figure 13.- Settlements at the Muelle n° 9 quay wall in Málaga

In this case, the control surveys only allowed obtaining settlements (see Figure 13), so there is no information available about horizontal movements.

As can be seen in Figure 13, the settlement -averaged over the four control monuments of the caisson- is over 80 cm.

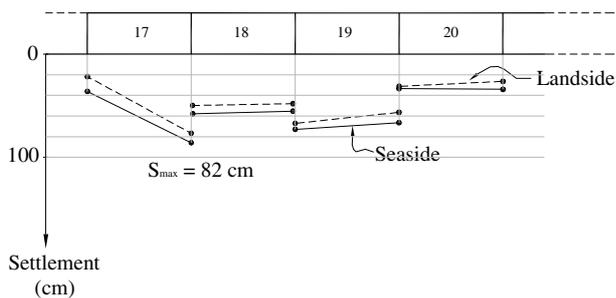
Figure 14.- Plan view of the Muelle nº 9 quay with the maximum settlement recorded

Figure 14 shows a plan view representing the maximum settlement measured on the quay wall.

These four caissons of the Málaga quay failed by deep sliding (through the base of the rockfill berm), due to some silty clays that were not well cleaned inside the dredging trench and due to overloading (loads were applied above the design elevation) during the process of backfill consolidation by preloading.

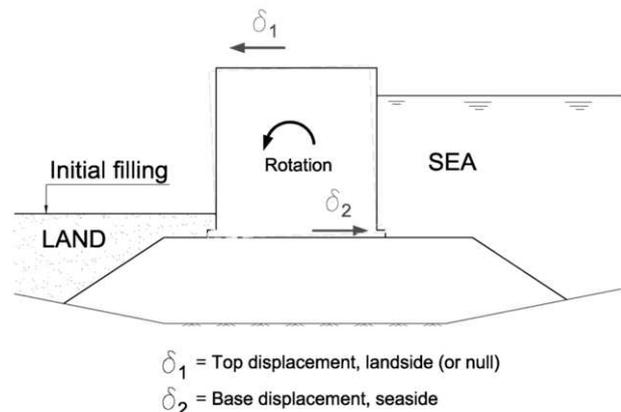
Figure 15.- Initial horizontal displacement

- In many projects, deformation moduli of supporting berms are actually lower than the values adopted in the design stage, especially when analysing settlements during the caisson's founding phase.
- It has been consistently observed that the beginning of the backfill operation induces a rotation in the caisson, manifested in the crest displacing landwards. See Figure 15.
- When the backfill is completed, the caisson crest is normally displaced seawards.
