Event tree analysis of the Åknes rock slope

U. Eidsvig, S. Lacasse and F. Nadim

International Centre for Geohazards (ICG), Norwegian Geotechnical Institute, Oslo, Norway

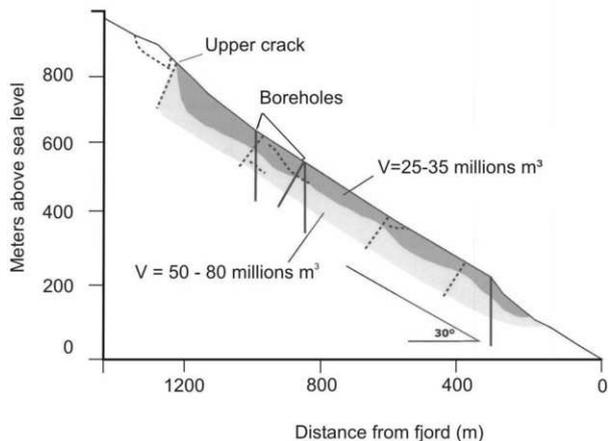
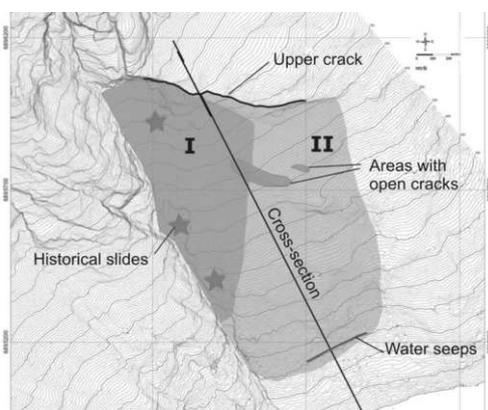
Area I: Slide volume 10-15 millions m³, displacement=6-10 cm/yr
 Area II: Slide volume 25-80 millions m³, displacement=2-4 cm/yr

Figure 1 Sliding volume scenarios: surficial area (top) and cross-section (bottom) (modified from Blikra et al. 2007)

Slope movements have been detected at Åknes down to 60 m depth. New borehole data suggest movements down to 100 m. Important uncertainties lie in the most likely failure depth and location, and whether the slide will occur as one large 30-60 millions m³ sliding event or a succession of several 'small' slide events. Figure 1 presents the Åknes slope and two slide scenarios. Figure 2 shows some of the displacements observed at the upper crack. The total annual displacements vary from less than 2 cm up to about 10 cm, with the largest displacements at the south-western part of the slide. The displacements appear to increase linearly with time, i.e. the displacement rate is constant.

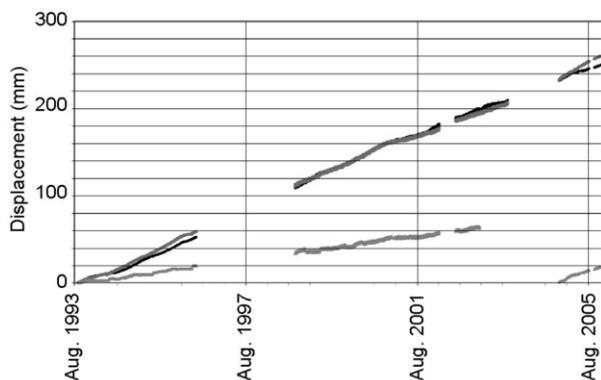
Figure 2 Displacements at slope top from 5 extensometers (Kveldsvik et al. 2006)

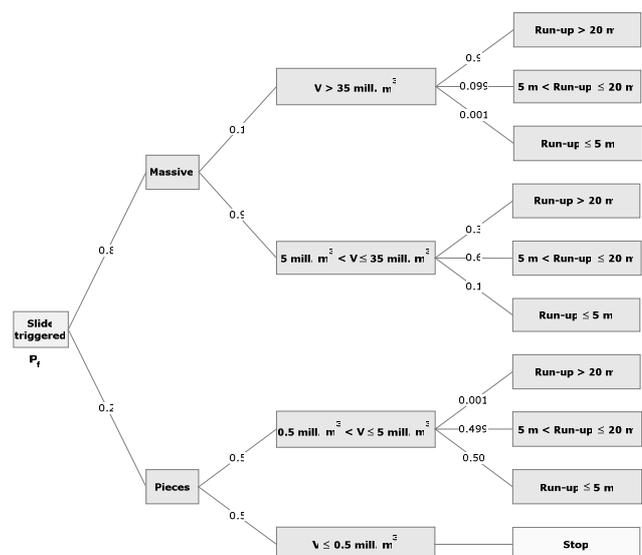
Figure 3 Event tree for tsunami propagation, given that rock slide has occurred ($V = \text{rockslide volume}$, $R = \text{run-up height}$)

The steps in the tsunami assessment (Figure 3) include: (i) rockslide is triggered; (ii) slide is in one massive volume or in pieces; (iii) volume of rockslide ($V \leq 0.5$ millions m^3 to $V > 35$ millions m^3); (iv) resulting run-up height on land ($R \leq 5$ m to $R > 20$ m). Rockslide volumes are based on ongoing measurements of displacements, including measurements in boreholes, and an existing block model derived from surface measurements, Kveldsvik et al. 2008.

The probability of having the rockslide triggered needs to be entered in the calculation of the total probability. For the sake of the example, the initial probability of the rockslide due to all plausible triggers is taken as $P_f = 10^{-3}/\text{yr}$. The probability of three different run-up heights was estimated, these are given in Table 2. The sum of the probabilities is $P_f = 9 \times 10^{-4}/\text{yr}$ for all run-up heights. As mentioned earlier, the values in Figure 3 and Table 2 are given for the sake of this paper, and not for extrapolation to the Åknes site. The problem is in reality more complex than shown in the examples. One needs, for example, to account for the relationship between the failure probability from the seismic trigger with the depth of the failure surface and possible volume of sliding rock.

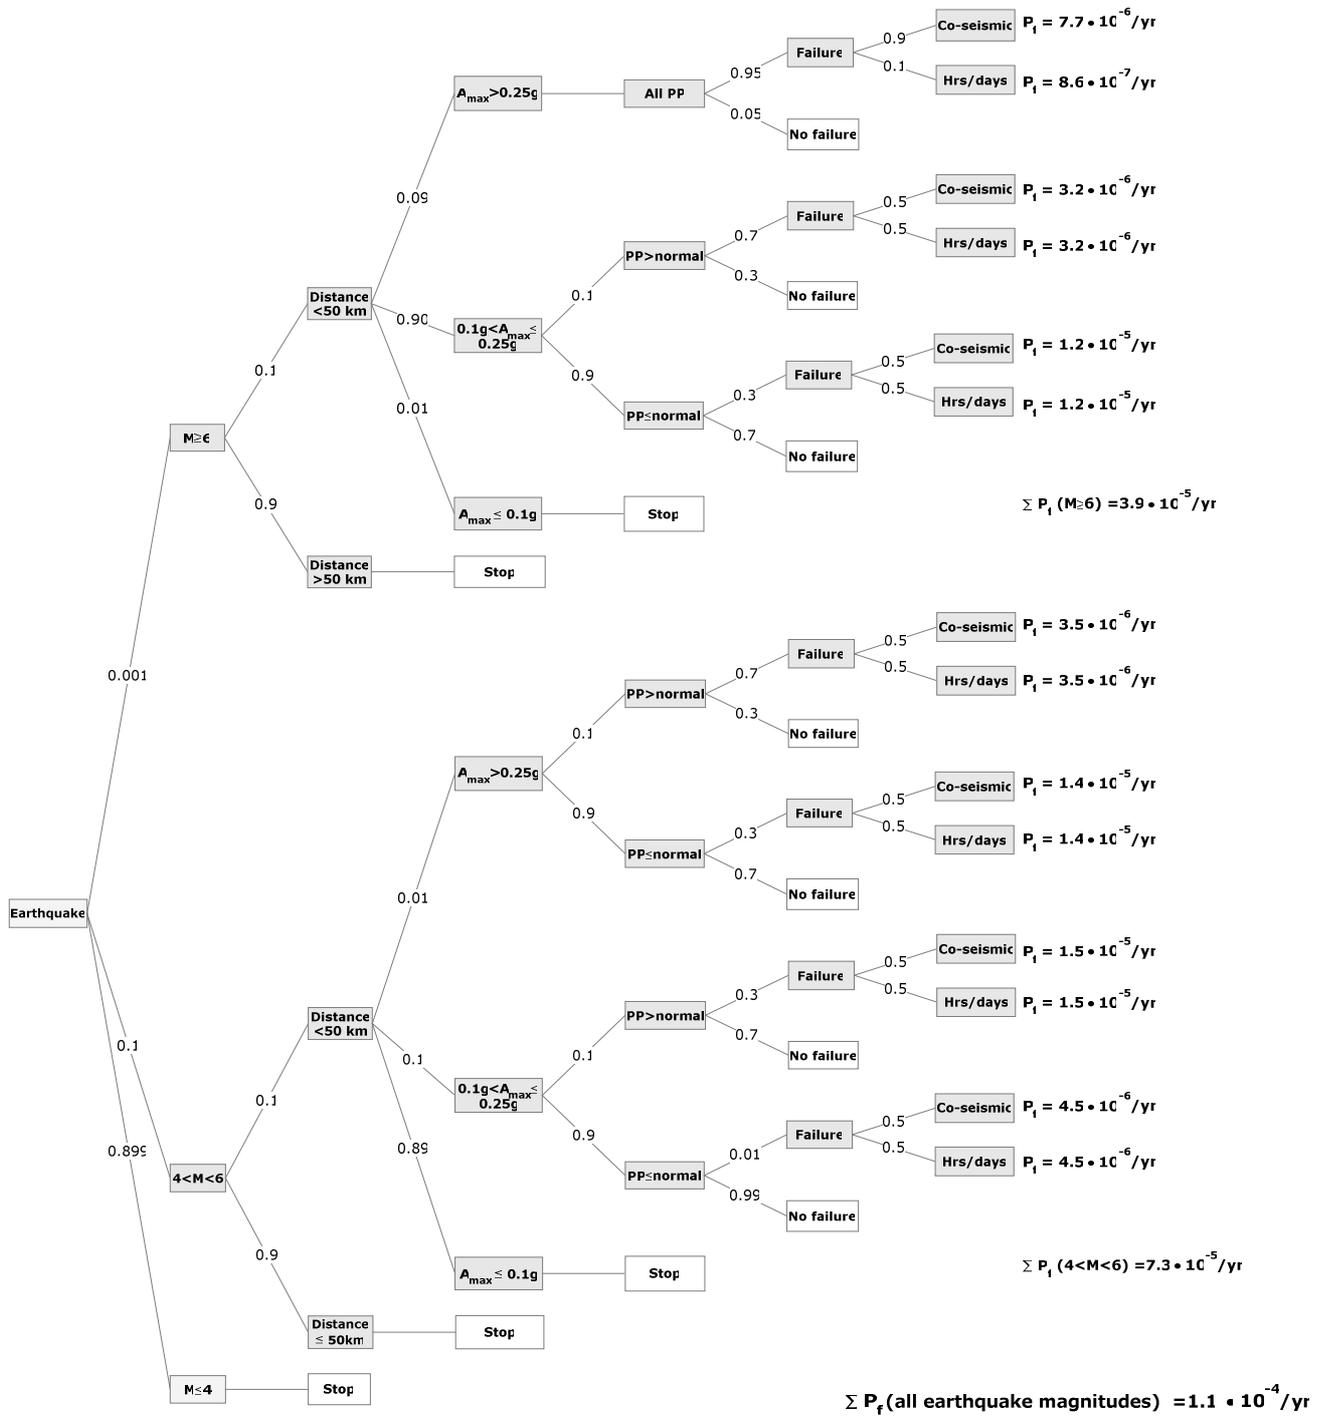
Figure 4 Event tree for earthquake-triggered rockslide (M , A_{max} = earthquake magnitude and maximum horizontal ground acceleration, PP = pore pressure)

The steps for the event tree in Figure 4 include: (i) earthquake occurs; (ii) magnitude of earthquake ($M \leq 4$ to $M \geq 6$); (iii) dis-

tance from earthquake epicenter to rockslide scarp ($D = \text{less or greater than } 50 \text{ km}$); (iv) earthquake acceleration ($A_{\max} \leq 0.1g$ to $A_{\max} > 0.25g$); (v) pore pressure (PP less or greater than normal); (vi) rockslide occurrence (failure or no failure?); (vii) rockslide occurs co-seismically, i.e. at the same time or within 10 minutes of earthquake, or earthquake may lead to a degradation process leading to slope failure at a later stage (co-seismic, yes or no).

The probability values in Step i)–v) are found from statistical data on seismic activity and meteorological conditions in the area. Probability values for step vi)–vii) are estimates based on expert judgment. Comparison between step vi) for branch $M \geq 6$ and for branch $4 < M < 6$, shows that the same peak acceleration could lead to different failure probabilities. This is due to the longer duration of a magnitude 6 earthquake compared to e.g. a magnitude 4 or magnitude 5 earthquake.

The failure probability is the summation of the failure probabilities, P_f , in all the branches of the tree. The aggregated annual failure probability in Figure 4 is $P_{f, M \geq 6} = 4 \times 10^{-7}/\text{yr}$ for $M \geq 6$ and $P_{f, 4 < M < 6} = 7 \times 10^{-5}/\text{yr}$ for $4 < M < 6$. The total probability of failure is the sum of the aggregated P_f for $M \geq 6$ and $4 < M < 6$, i.e. $P_f = 1.1 \times 10^{-4}/\text{yr}$. The values in Figure 4 are for the sake of this paper, and are not the estimated values for the Åknes site.
