Design and instrumentation aspects of a 40m high nailed slope

Alberto S.F.J. Sayão, André P. Lima & Fernanda O. Springer

This paper presents details of a monitoring program on a 40m-high nailed excavation in gneissic residual soil. Stability studies and stress-strain analysis of the nailed mass were fundamental for defining the most efficient and economical solution in terms of nails and excavation geometries. The nails are made of steel bars 25mm in diameter, placed in drill holes with variable lengths (15 to 24m), with vertical and in horizontal spacing of 2m. Instrumentation included inclinometer and tell-tales for monitoring horizontal displacements of the soil mass. Strain gauges were also placed on the steel bars for obtaining tension and bending along the nails. Design concepts and construction details are briefly described, together with details of the monitoring program and preliminary results.

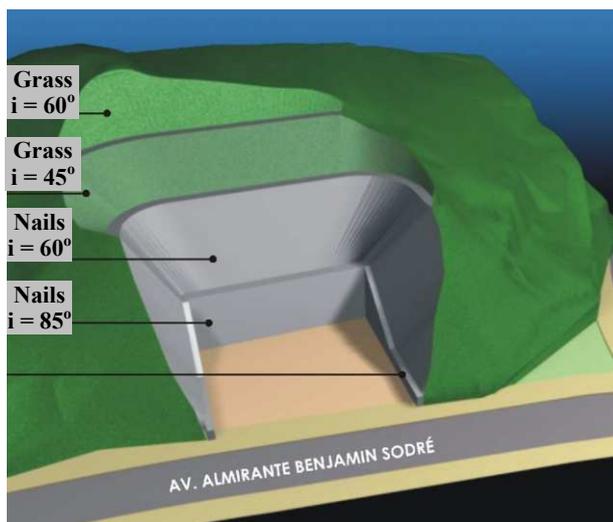
Figure 1 – 3D view of soil nailing design showing excavation stages.

The excavation herein described was required as preparation for the construction of a 8-storey high-rise building in an expensive waterfront area in the city of Niteroi, Rio de Janeiro State, Brazil. The geometry of the nailed excavation is illustrated in Fig. 1. The height of the main nailed wall is about 40m in length. Due to the U-shape of the excavation, lateral nailing was also required.

The first excavation stages required detailed planning for the access to the top of the slope of construction equipment, such as driller, earth-working machine and grout-injection pump. As shown in Fig. 1, the top two stages of the slope had their faces only protected by grass, with no reinforcement. The nails were installed only in the third and fourth excavation stages. A 2m uniform spacing between nails was adopted both in vertical and in horizontal directions. Fig. 6 shows a front view of the site at the installation of the second row of nails. These upper nails were 24m long, for reaching the active soil zone beyond the potential failure surface. Fig. 7 is a picture of the nailed excavation at end of construction. As the excavation progressed, nails were made progressively shorter. At the bottom, the nails were only 15m long.

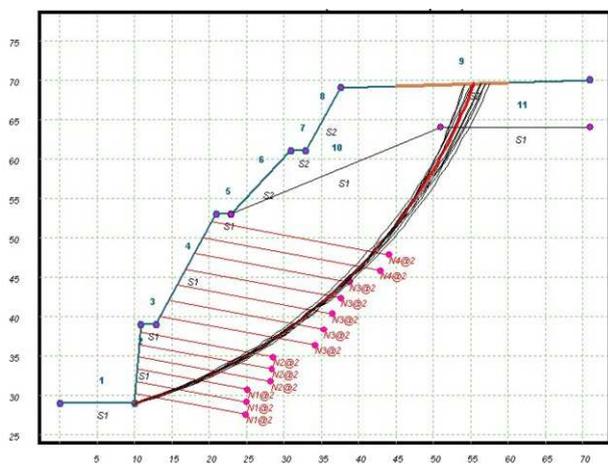
Figure 2 – Potential failure surfaces at end of nailed excavation.

Several design methods are available for estimating the stability of nailed slopes (Clouterre1991; Schlosser et al. 1992). Limit equilibrium stability studies were complemented with stress-strain analysis of the nailed mass for defining the most efficient and economical solution in terms of excavation and nails geometries (Lima et al., 2003a and 2004). As shown in Fig. 1, the excavation was designed with four stages, with only the lowest two stages being nailed. The stability studies indicated a factor of safety $FS = 1.51$ for the cross-section shown in Fig. 2 (fixed nails). If free nails were considered, FS would be a little lower ($FS = 1.45$). The strength parameters required for the stability analysis were obtained experimentally.

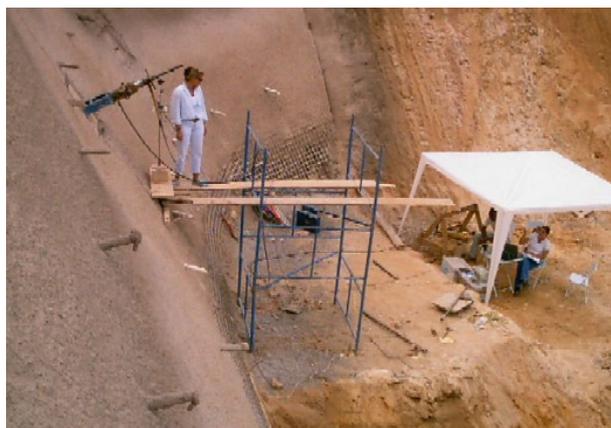
Figure 3 - Nail pullout testing on a platform during excavation.

In the field, several nails were instrumented and subjected to pullout tests under different conditions of curing time, grouting procedures and confining stress. The pullout tests were conducted by controlled loading increments in a site next to the excavation front. All tested nails were 4m long and were not used in the final configuration of the nailed structure. An average value for the interface strength q_s may be taken as 200 kPa. Fig. 3 shows a pullout test being carried out. As the excavation progressed rapidly downwards, a test on a nail with 7 days curing time had to be performed on a temporary platform.

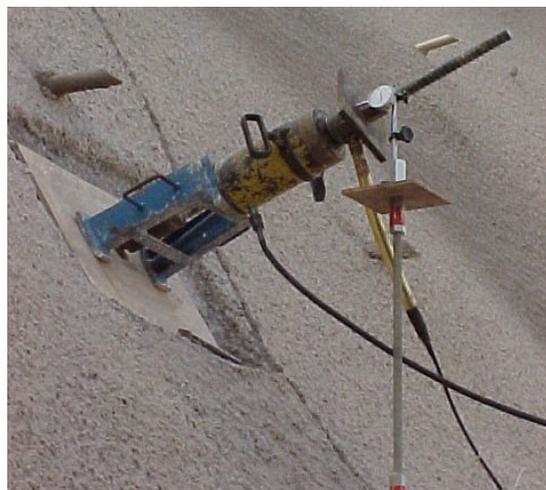
Figure 4 - Pullout test set-up.

Pullout loads were imposed with a hydraulic jack and monitored with a load cell at the nail head. Strain gauges glued to the steel bar provided information about the load distribution along the nail. Electronic readings were recorded with a data logger and a laptop computer. A dial gauge was used for monitoring the nail extension during the test, with reference to a stable point. Fig. 4 shows a closer view of the test set-up.

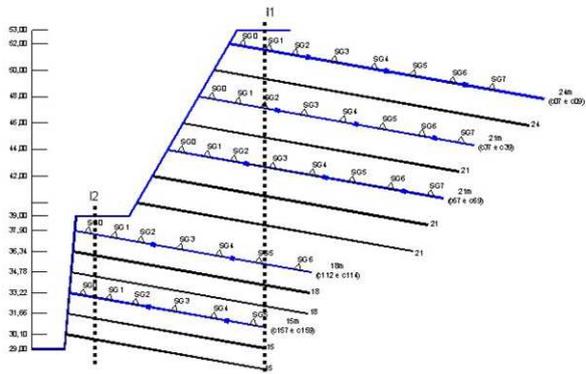
Figure 5 – Cross-section of excavation with instrumented nails.

Five rows of nails were instrumented in two central vertical sections. Instrumentation included strain gauges glued onto 10 bars for verifying the tension and bending distributions along the nails. The strain gauges were protected against mechanical and electrical damages during transportation and installation of the nails. The gauge positions along the nails in one vertical section are indicated in Fig. 5 (Lima, 2005). Horizontal movements of the nailed soil mass were monitored with tell-tales and inclinometers.

In a central vertical section, twenty tell-tales were installed in 5 different elevations close to instrumented nails. Along each elevation, the tell-tales were positioned at 1.5, 7.0, 14.0 e 28.0m. The deepest one (position 28.0m) was anchored in stable soil (beyond a potential failure surface) for reference.

Two vertical inclinometer boreholes, 28 and 15m deep, were drilled in the central region of the nailed mass, as shown in Fig. 5. Inclinometer readings were taken twice a week during construction. All electronic readings were recorded with a data logger and a laptop computer. Horizontal displacements (Δh) obtained from tell-tales compared fairly well with Δh obtained from inclinometer readings.

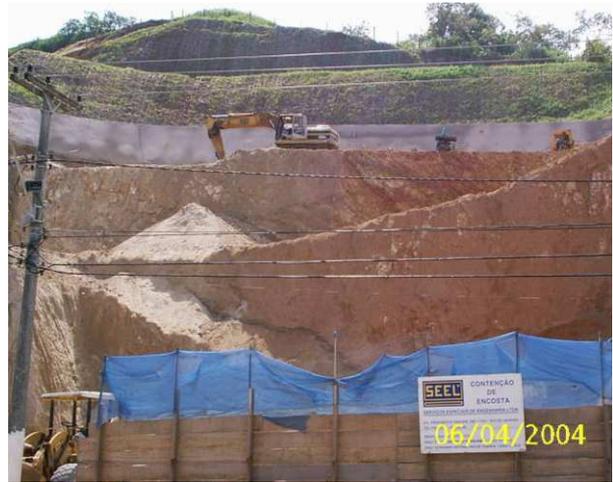
Figure 6 – First stages of nailed excavation.

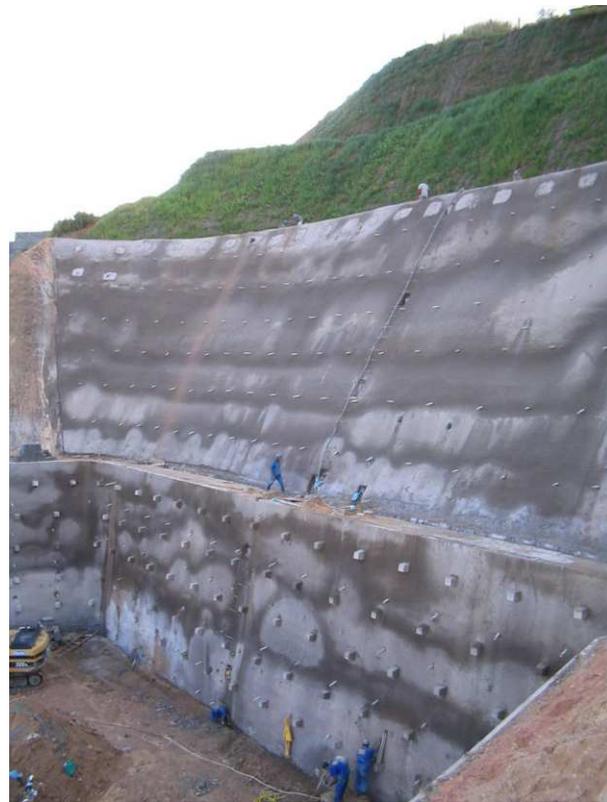
Figure 7 – Last stages of 40m high nailed excavation.

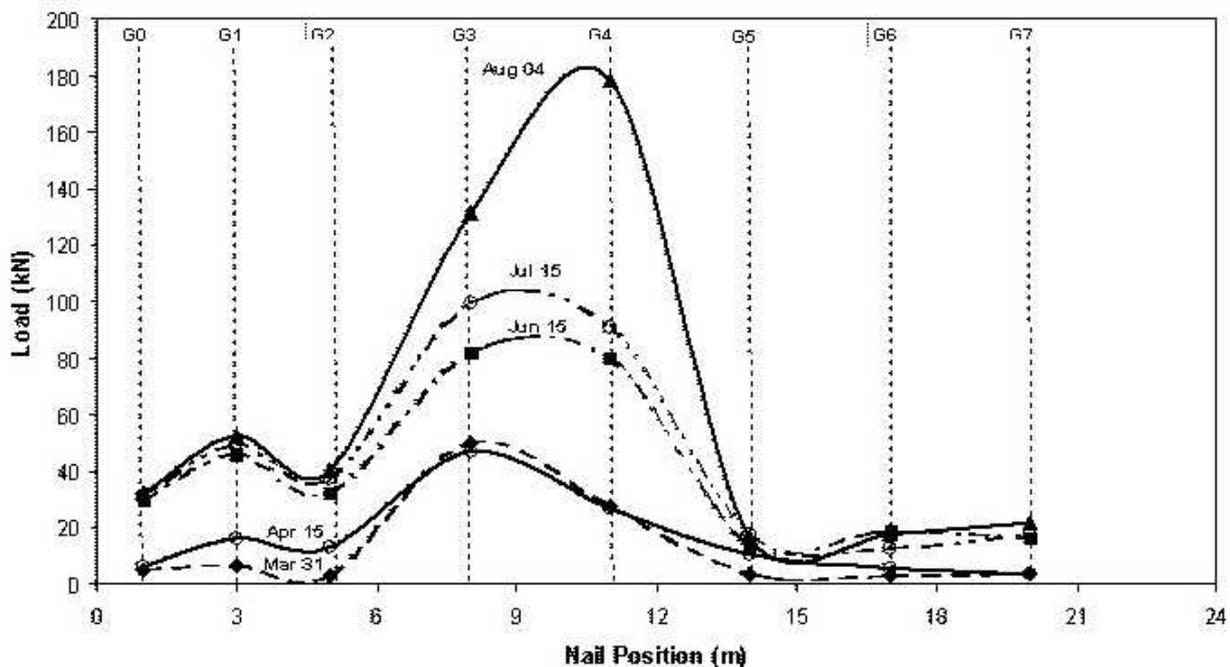
Figure 8 – Load monitoring along one nail during excavation.

Preliminary results from the monitoring program are presented in Fig. 8. A strain-gauged nail (Fig. 9) reveals a non-uniform load distribution along the bar. The central region of the 24m long nail, with larger tensile loads, corresponds to the probable position of a potential shear zone in the nailed soil. The load decreases to near zero at the inner end of the nail (position 24m). Fig. 8 suggests that the front end (position 0) has a positive load of up to 20 kN, due to the nail's fixed-end condition at the shotcrete face wall.

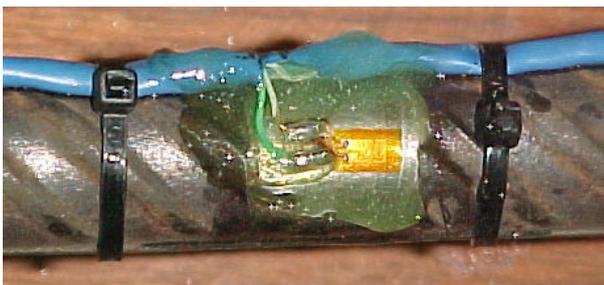
Figure 9 – Nail bar with a protected strain gauge and a grouting tube.
