# About necessity of arranging geotechnical protections at the objects of nuclear power

V.N. Zhivoderov

*The firm "OOO Transgidrostoi", Moscow, Russia*

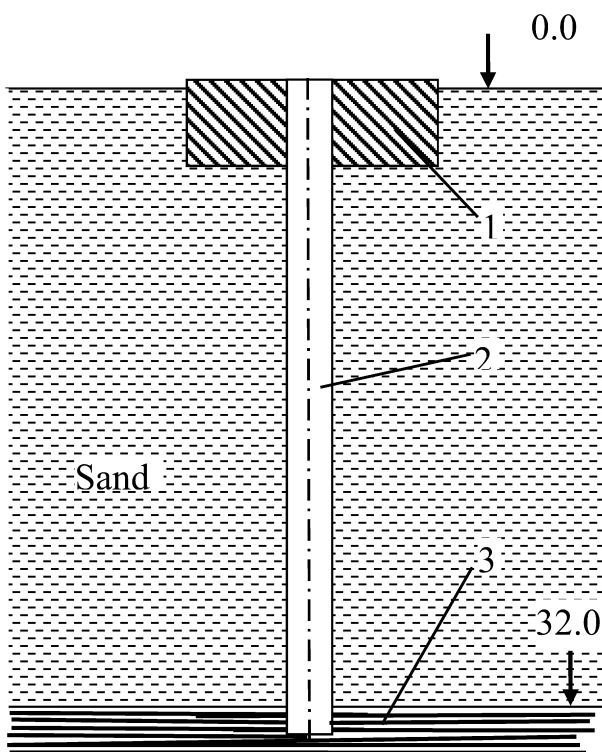
Figure. 1. The construction of the wall in ground: 1 – guiding pit, 2 – lumped clay, 3 – Jurassic clays

1. Arranging dams and dykings in low places of the terrain to avoid the contamination by a surface run-off of different water areas around the NPS site.
2. Reconstruction of the rain collector in Pripyat' town for accumulating and pumping-out potentially contaminated surface waters.
3. Construction of an anti-filtration "wall in ground" on the NPS site (2113 m long and about 32 m deep) to prevent

the propagation of contaminated underground waters (Fig.1).

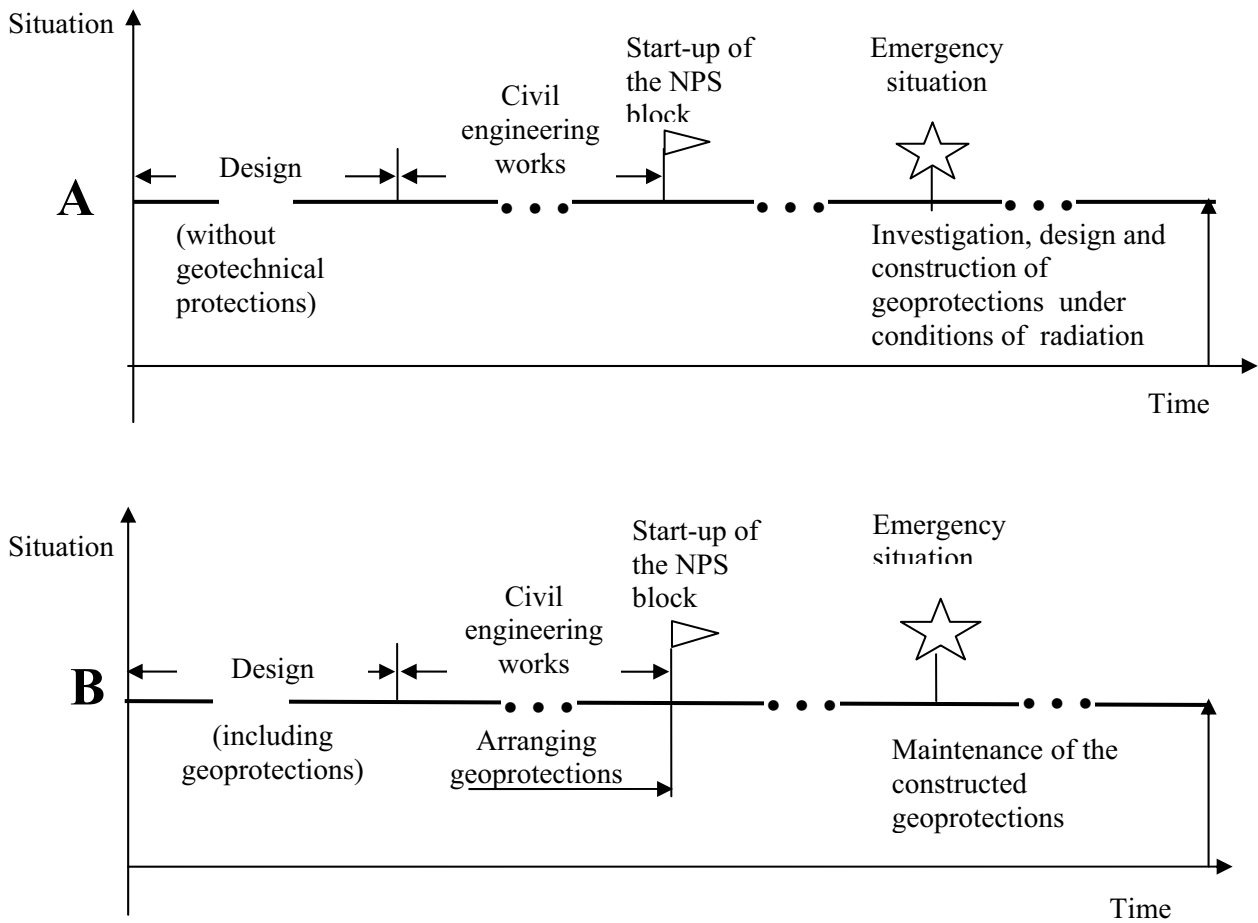
Figure. 2. The diagram of arranging geotechnical protections at nuclear power stations.  
 A - the existing sequence of constructing NPS (without geotechnical protections)  
 B - the sequence of constructing NPS proposed by the author

Therefore for each NPS on any geological base obviously the question must be studied: "What will happen, if the reactor falls under similar or even heavier conditions than those, which have led to the Chernobyl disaster?" This will enable one already at the designing stage to evaluate its possible radioactive consequences under specific hydro-geological conditions and compare them with admissible ones. And hence - to prepare beforehand and take necessary measures to protect the population and the environment (Fig.2).

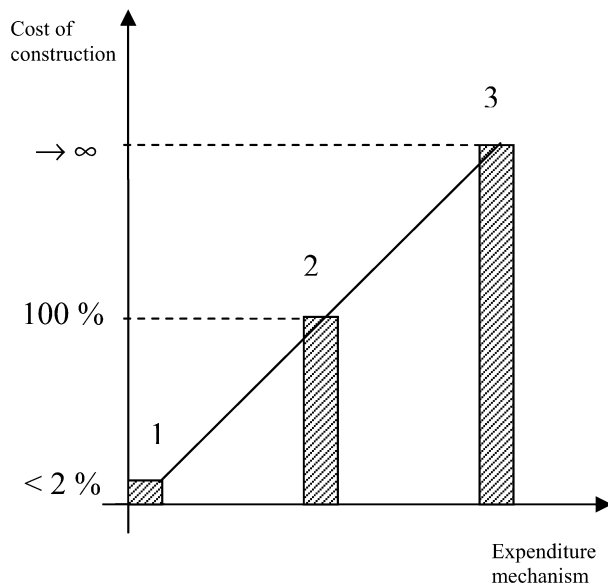
Figure. 3. Possible relationships of the cost of geotechnical protections when constructing NPS  
 1 - the cost of geotechnical protections  
 2 - the cost of constructing an NPS  
 3 - Expenditures for geotechnical protections under emergency conditions

Possible costs of expenditures for carrying out these works are insignificant (Fig. 3).
