The restoration of San Pedro Cliff at La Alhambra La restauration de la falaise de San Pedro à La Alhambra

J.L. Justo, J. Saura, N. Vázquez, P. Durand, C. Soriano & E. Justo
Department of Continuum Mechanics, University of Seville, Seville, Spain

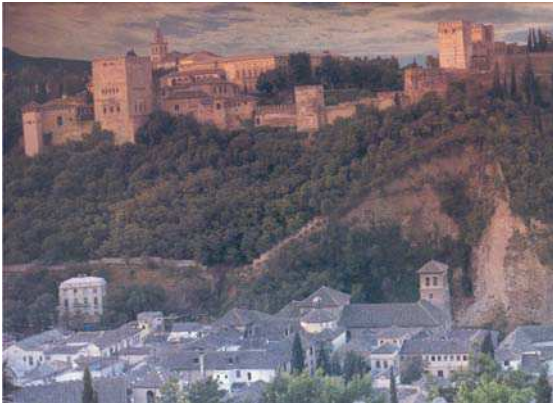
Fig. 1. View of San Pedro cliff below the Alhambra walls.

San Pedro cliff is a dihedral 65.5 m high (Fig. 1) that has progressed to place itself at 23.8 m from the *Alhambra* wall-palace that was granted a World Heritage award in 1984. Active normal faults, like the right hand side of the dihedral, have created an extension tectonic regime that loosens the ground and activates the ground falls. . The preservation solution proposed is a post-tensioned high elastic limit wire mesh and autochthonous vegetation

Active normal faults, like the right hand side of the dihedral (Fig. 1), have created an extension tectonic regime that loosens the ground and activates the ground falls. The fractures produced by the distending tectonic regime have favoured the attack of the slope of the Alhambra hill by River Darro during floods. Erosion and seepage coming from Alhambra palace have contributed also to the advance of the cliff.
