Deformation and failure characteristics of rectangular clay specimens under three-dimensional condition

T.Kodaka, Y.Higo & T.Takyu – Department of Civil Engineering, Kyoto University, Kyoto, Japan

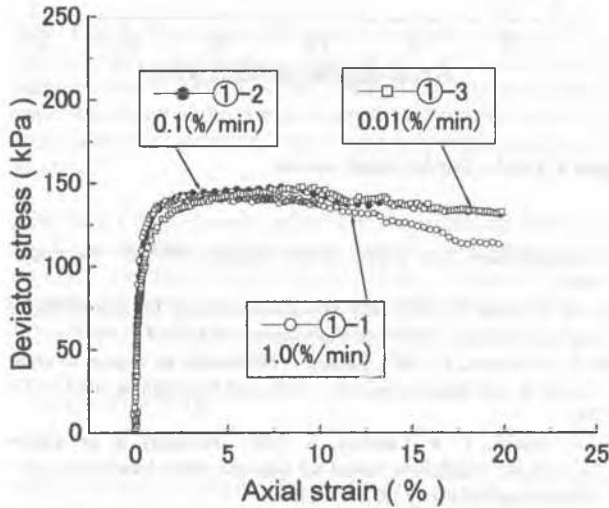
Figure 5. Stress – strain curves in CASE①

Three axial strain rate was used only in CASE 1 to investigate the effect of loading rate on failure mechanism of rectangular clay specimen. The local shear strain distributions obtained by the image analysis in digital photograph with different axial strain levels are shown in Fig. 3. Shear planes were clearly observed in any specimens and the local shear strain exceeds 100% near the shear plane. The sketches of specimens after testing as well as shear planes are shown in Fig. 4. In the case of middle and slow loading rate, i.e. CASE 1-2 and 1-3, two shear planes cut through the specimen crossing each other. It is, however, observed the different type failure pattern in the fastest loading case, CASE 1-1, which likes the buckling of column. Fig. 5 shows the relationships between a deviator stress and an axial strain, which were obtained using same shape specimens; CASE 1 4×4×12cm. In the initial part of stress - strain curve, the fastest case, i.e. CASE 1-1, shows largest deviator stress among

three cases. This tendency agrees with a traditional theory of time effect of clay. After peak strength, however, the deviator stress of CASE 1-1 rapidly decreases to be the smallest residual strength. The decrease of deviator stress of CASE 1-1 is more significant than the other cases. It seems to be due to the buckling failure pattern of the fastest loading case. Asaoka and Noda (1995) and Asaoka et al. (1997a) showed the following results by the triaxial compression tests and the numerical experiments of remolded normally consolidation clay. "Higher order bifurcation mode can be observed in the faster loading test cases, in which the deviator stress shows larger. In the slowest loading case, only 1st order bifurcation mode can be finally observed going through the mode switching, in which the deviator stress shows relatively small." The buckling failure pattern observed by the present test seems to be similar to 2nd order bifurcation mode mentioned by Asaoka and Noda (1995). However, the peak and residual strength of this failure pattern are not larger than that of shear failure pattern like 1st bifurcation mode.

Fig. 6 shows the stress – strain relationship and local shear strain in CASE②. Since the slenderness ratio is smaller than CASE①, unstable behavior shown in Fig. 5 cannot be seen in this case, and the stress – strain relationship is very stable even in a large axial strain level. It is observed two shear bands on a side surface of specimen as X character. This type of failure pattern can be considered higher order bifurcation mode compared with the single significant shear band failure pattern observed in CASE ①-2 and ①-3 (Ikeda and Murota 1997). Fig. 7 shows the stress – strain relationship and deformed specimen due to compression in CASE ③, which is observed the clear buckling pattern on the narrow side surface, i.e. 8cm height \times 2cm width (H/W ratio: 4). It is easy to understand that the deviator stress is unstable after peak strength and directly refracts the deformation of specimen. The relationships between deviator stress and axial strain are shown in Fig. 8 together with all cases. In all cases, changes of the stress-strain curves are related to the shear plane formation and progress. When the shear plane is observed, the deviator stress decreases. Fig. 9 shows the load - displacement relationships, which are rearranged instead of Fig.8. Deviator stresses in Fig.9 are just axial loads divided by their initial sectional areas. It can be seen that the load-displacement curves in the initial loading stage are almost unique curve in all cases, and then they diverge from a bifurcation point. After the bifurcation, the specimen that has larger H/W ratio presents more unstable behavior.

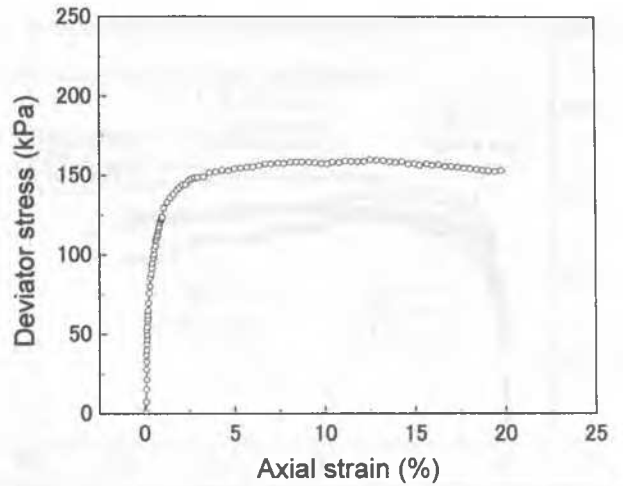
Figure 6. Stress – strain relationship and shear strain distributions in CASE ②

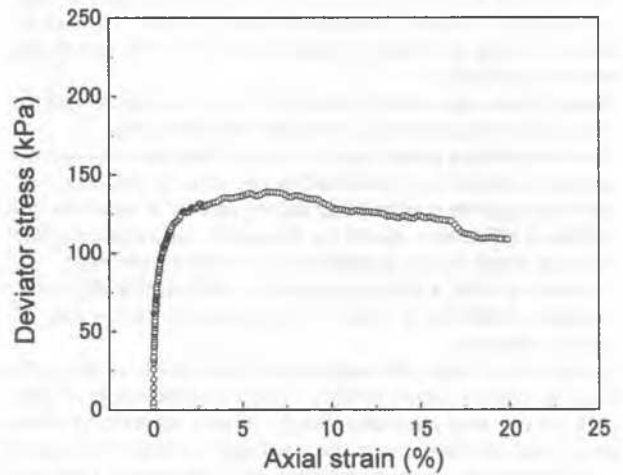
Figure 7. Stress – strain relationship and deformed specimen in CASE③

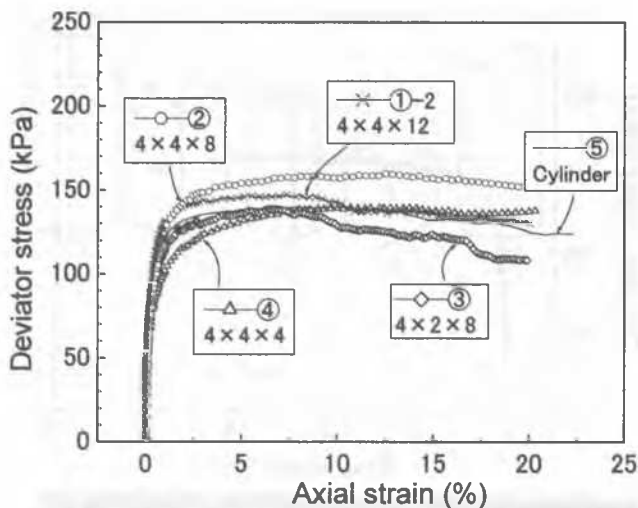
Figure 8. Stress – strain curves

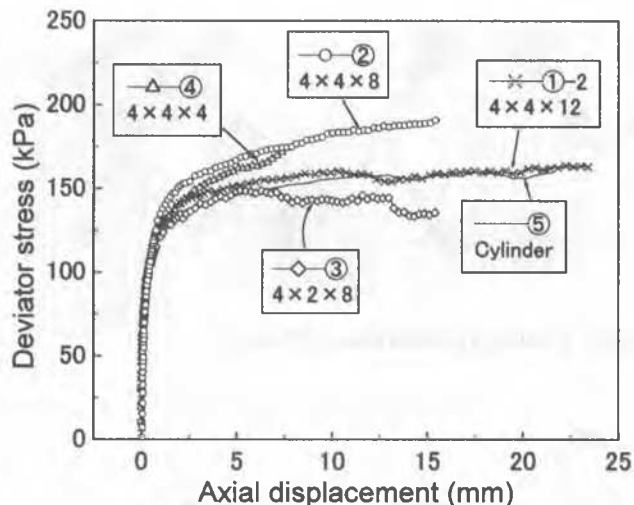
Figure 9. Load – displacement curves
