Use of in-situ flat dilatometer (DMT) for ground characterization in the stability analysis of slopes

G.Totani, M.Calabrese, S. Marchetti & P.Monaco – *Dipartimento Ingegneria Strutture Acque e Terreno, Università di L'Aquila, Italy*

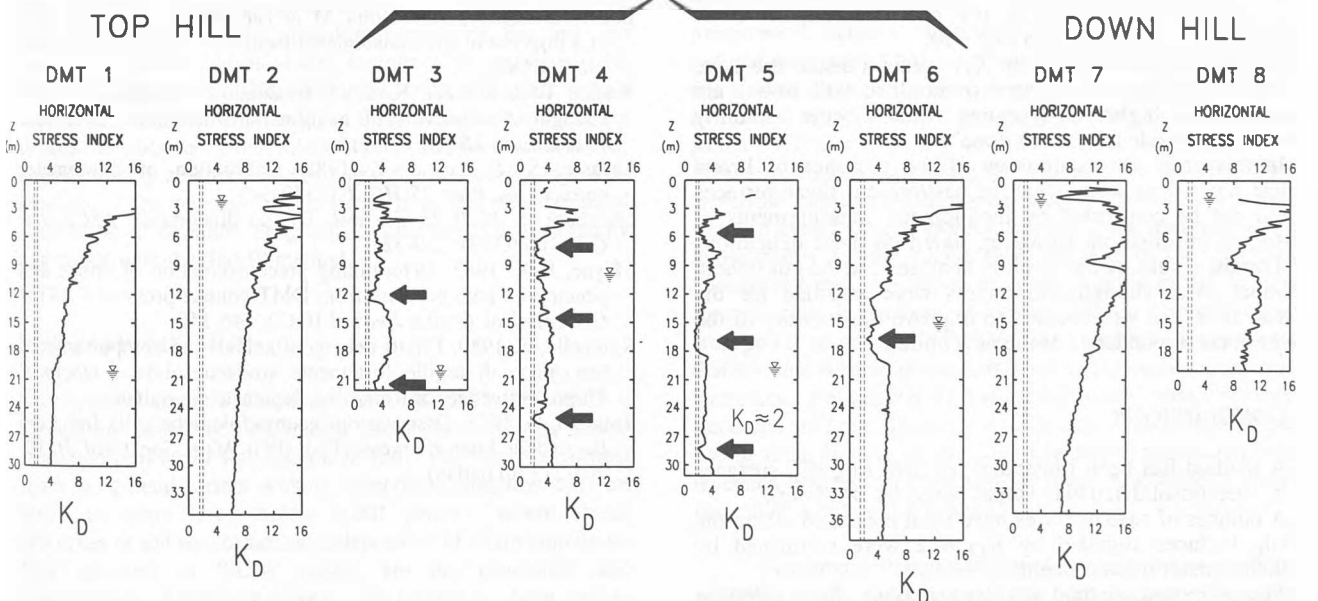
CHIETI HILL

Fig. 5. Chieti hill. a) Cross section of the studied slope with DMT- K_D and CPT- q_c profiles. b) DMT- K_D profiles with indication of $K_D \approx 2$ layers.

Eight DMT tests were performed along the longitudinal section of the slope, in combination with six cone penetration tests (CPT) and one borehole. The profiles of DMT- K_D and CPT- q_c (cone penetration resistance) are shown in Fig. 5 a.

The inspection of the DMT- K_D profiles clearly highlights the presence of several layers where $K_D \approx 2$ (pointed out by arrows in Fig. 5 b), concentrated in a soil volume located just across the slope where the new building is to be constructed (hatched zone in Fig. 5 a).

It should be noted that the K_D values outside the zone "plagued" by $K_D \approx 2$ layers (remoulded soil mass) are considerably higher, suggesting quite better stability conditions outside this "weak zone".
