LANDSLIDES IN SOILS OF DECOMPOSED ROCK DUE TO INTENSE RAINSTORMS

A.J. DA COSTA NUNES, Eng., Prof., President of Tecnosolo.
Federal University of Rio de Janeiro, Brazil.

SUMMARY - In tropical countries, specially in Brazil, many slides of special type due to the simultaneous occurrence of colluvial and residual soils, with blocks and fragments of rock, and excepcional rains have been observed.

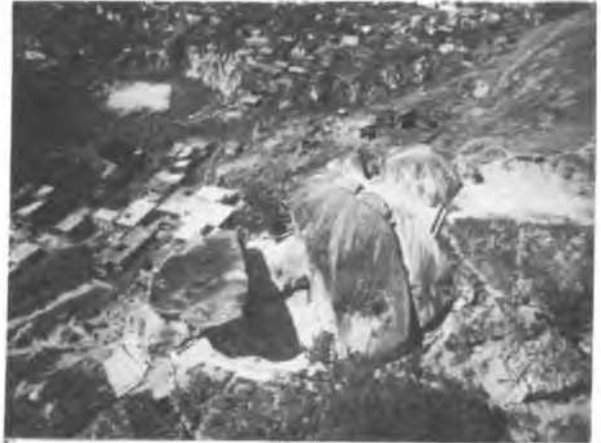
Photo
Photo 1
Residual slope with boulders
(Rua Ramiro Monteiro - Rio)

Schematically, it is found, starting from the sound rock, a zone of fractured rock, followed by a resistant soil that keeps, many times, the texture of the matrix rock, and involving frequently spheroidal blocks of rock, sometimes of great dimensions, or boulders (Photo 1).

By the future erosion, the boulders, chiefly those of the layer situated just over the sound rock appear at the surface (Photo 1) in sometimes unstable positions, as it happens frequently at the Brazilian cities already mentioned.

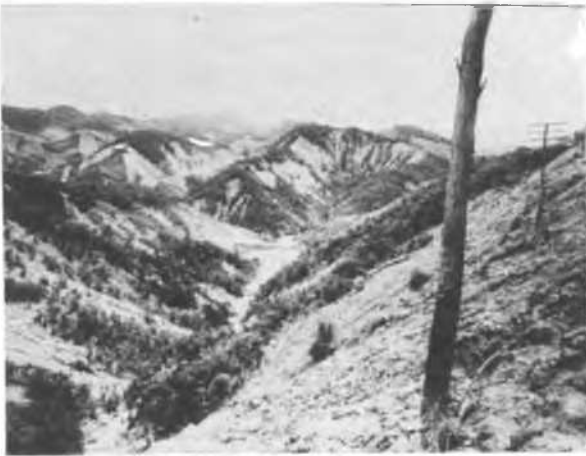
Photo 2

There were thousands of landslides and the mountains seemed to have been dilacerated (Photo 2).

General view of the slide area

It must be also noted that the region was enough protected by vegetation but the landslides reached the high part of the slopes (Photo 2) which were covered with natural forest or, at least, not touched in the last 70 years.

Due to intense rainstorms that fall on the high parts of steep slopes in predominantly silty soils, erosion grooves are dug and the adjoining soil collapses towards their bottom, more and more increasing the phenomenon which increases its area, as an avalanche, and presents the triangular form with a vertex at its higher part (Photo 2).

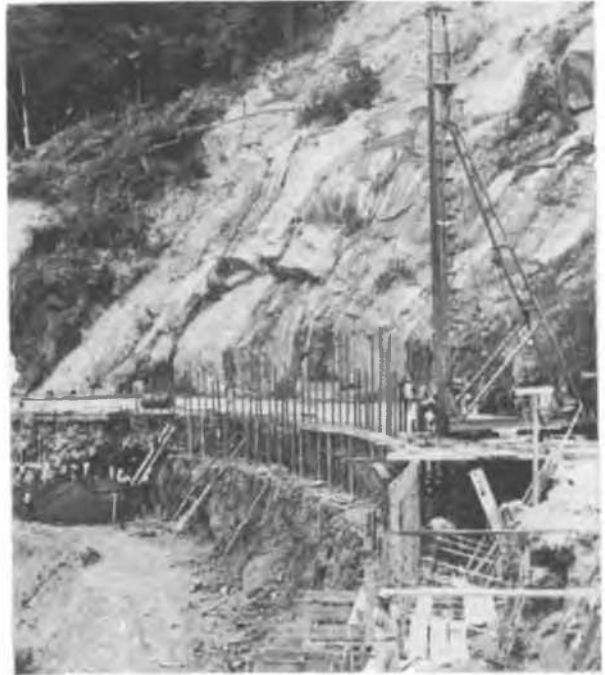
Photo 3

In other places the erosion left apparent the rock surface with unstable blocks amount the pavement (Photo 3).

View of the work in progress. In the background the unstable blocks uncovered by the erosion can be seen.

c1) curtain walls of rails or steel H-piles driven into the ground and completed through reinforced concrete (Photo 3).

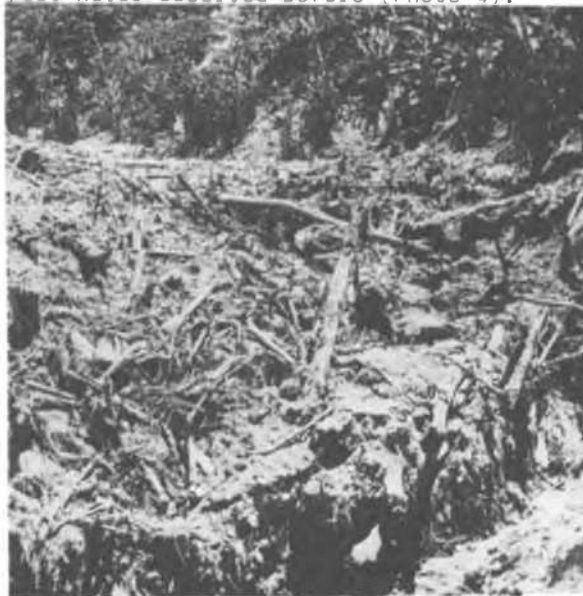
Photo 4

Afterwards, a selective secondary process of the materials, by their dimensions and specific gravity, starts: blocks of rock are less moved, some of them remaining "in situ" or a little dislocated in an unstable position; the earths are drawn to a great distance (5km or more in the case of "Serra das Araras") giving place to silting layers, many meters in thickness on the bottom of the rivers; and the trees are transported by flotation as far as the lowest part of the valley where, due to an accidental decreasing of the stream speed, all the wood is deposited, showing the characteristic aspect never observed before (Photo 4).

Debris carried by the flood after slides

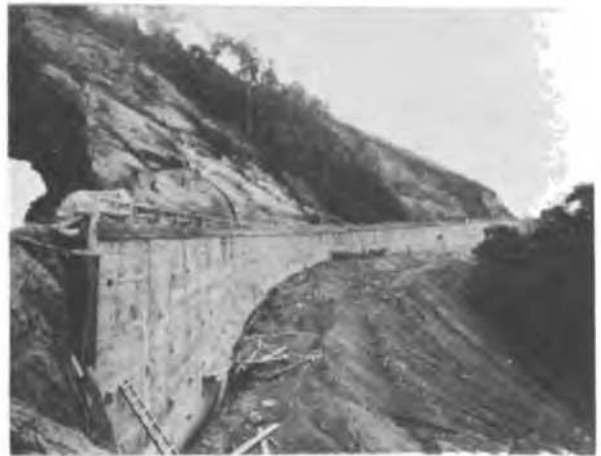
Photo 5

Really, the execution from top to bottom permits to build retaining walls in extremely narrow places and warrants the workmen who work protected by the curtain part already constructed (Photo 5).

View of anchored curtain during construction

c3) curtain walls of reinforced concrete poured from top to bottom.

This process was already described (Costa Nunes - 1965) and it has been developed in Brazil to retain slides.
