The paper was published in the proceedings of the 13th International Symposium on Landslides and was edited by Miguel Angel Cabrera, Luis Felipe Prada-Sarmiento and Juan Montero. The conference was originally scheduled to be held in Cartagena, Colombia in June 2020, but due to the SARS-CoV-2 pandemic, it was held online from February 22nd to February 26th 2021.

Historical Landslides in Western Sweden 1700–1799 AD

Anton Larsson

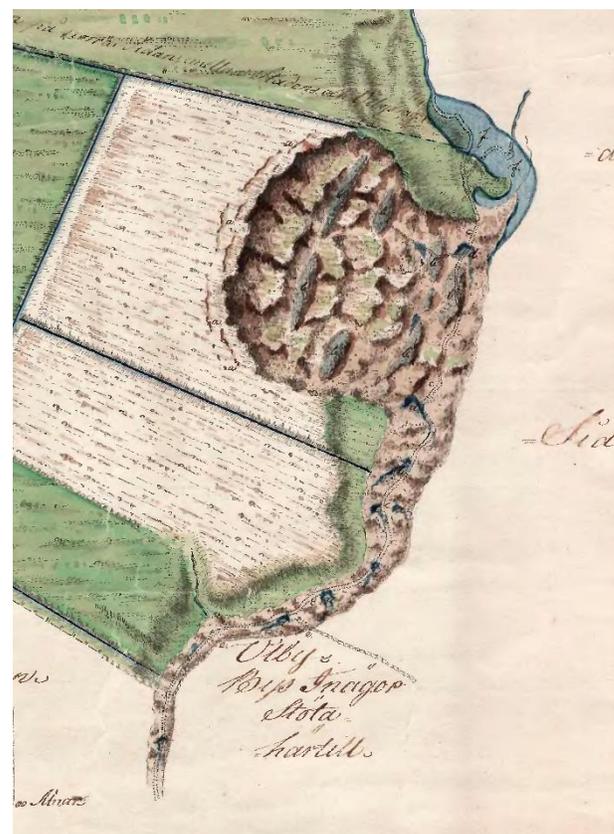
Figure 1. 1786 map of a rotational landslide that occurred at Västerhed, just north-east of Gothenburg, during the night between 3 and 4 December 1785 (Liedin 1786).

To illustrate the level of geotechnical detail sometimes provided in the historical material, a contemporary report of the 1785 Västerhed landslide (depicted cartographically in figure 1) will be presented in translation below:

“Among events that deserve the Public's attention and examination is undeniably the following: during the night between the 3rd and 4th of last December occurred, 1/2 [Scandinavian] mile from the city near Utby, on an outland there known as Västerhed, which now is said to belong to the city, an unusually large Landslip, which more resembles an earthquake; over 3 to 400 fathoms [534 to 712 meters] has it extended its length, and over 50 fathoms [89 meters] in width, and it appears, as if the coming spring flood will cause more to collapse, if not the Highest prevents the fall. Great tower of Clay, which appear like Pyramids of 10 to 12 per row, are found between mounds of cast-up turf and pieces of earth, and a large boulder which several Horses could not move, has been moved some 100 ells [59.3 meters] down with the soil.
