*The paper was published in the Proceedings of the 8<sup>th</sup> International Symposium on Deformation Characteristics of Geomaterials (IS-PORTO 2023) and was edited by António Viana da Fonseca and Cristiana Ferreira. The symposium was held from the 3<sup>rd</sup> to the 6<sup>th</sup> of September 2023 in Porto, Portugal.*

# Application of seismic refraction tomography for detecting a hidden potential fault

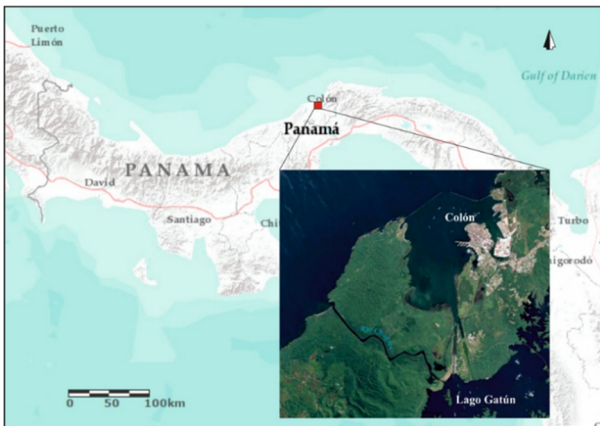
**Figure 1.** Localization map of the sector of study.

Fig. 1 and Fig. 2 show the location of the site close to the city of Colon, northwest of Panama, on the Atlantic coast side. The Isthmus of Panama is formed by the rigid block (often referred to as the micro plate Panama), located between the tectonic plates of Cocos and Nazca south, the Caribbean plate north and plaque South east America. It is part of the volcanic arc of Central America originated in the Miocene about 17 million years ago. The continuous movement of North America and South America, being at about 25 mm / year, is responsible for the internal deformation of the isthmus which translates into folds and interior faulting (Rockwell et al. 2010). The predominant directions of faults are parallel to the Panama Canal in the direction northwest-southeast and some direction Northeast-Southwest with high degree of dip (Pratt et al. 2003). Despite the complexity tectonism described, a very low actual seismic activity is recognized, although, such information creates a significant uncertainty in seismic risk assessment in Panama.

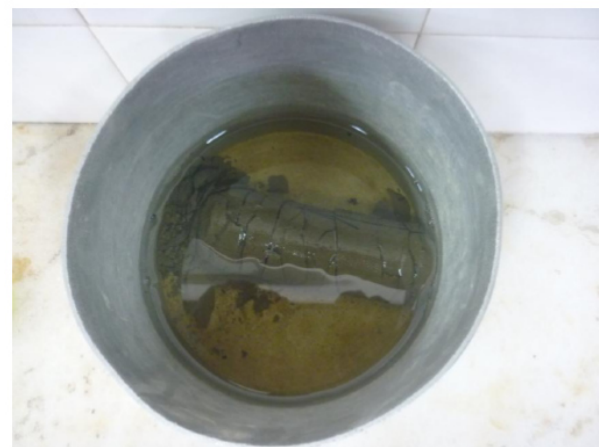
Fig. 3 shows this effect on a Gatun sample corresponding a depth of about 25 m. After being immersed for 24 hs, Fractures develop following predominantly horizontal planes, which probably correspond to the direction of the bedding planes.

**Figure 3.** Cracking effect on a sample from the Gatun formation, which results from saturation.

In sedimentary rock where diagenetic processes (causing structure lithification) have taken place at high pressures, as in the case of the Gatun formation, the effect of release in the confining pressure (either by sampling or excavation) may cause its destructuration in the form of microfissures (hair cracks). A decrease in water content (desiccation) tends to accelerate and magnify this microfissuring process. Besides, when the material is saturated in an unconfined condition, residual stresses in the formation relax and also cause massive fractures in the sample reducing shear strength, elastic module and wave propagation velocity.

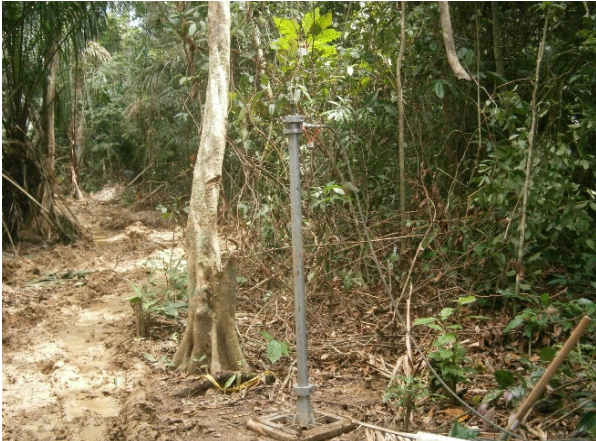
device from Geometrics was used. Each of the survey lines was performed using a total of 24 geophones with separations 5 m. The geophones were fixed to the soil by means of inserts of 8 cm in length. For each seismic line, 5 shots were made at both ends, at the quarters and at the centre. The energization for each shooting at each point was made using a pressurized gas gun system. This system allowed to increase the impact energy with respect to a manually driven mass and therefore increase the penetration depth (no explosives were allowed to be used at the site). Fig. 4 displays a picture of the gas cannon described here.

Figure 4. Gas gun used in this work.

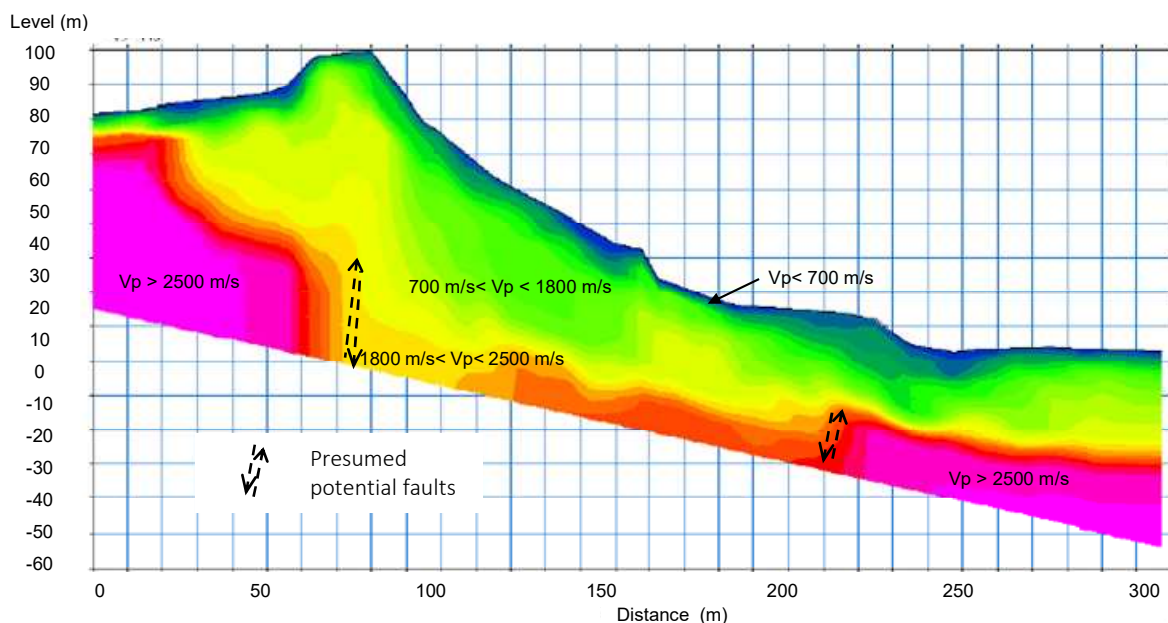
The tomography that results of the processing the central seismic section is shown on Fig. 5. Similar results were obtained for the others sections. The seismic tomography obtained presented a mean square error RMS lower than the desirable limit of 5%. Table 1 shows the correlation obtained between p-velocities and soil formation condition obtained from boreholes.

The tomography shows a profile of increasing wave velocity with depth. It is observed a surface layer with low p-velocities (less than 700 m/s) which correspond to destructured and sedimentary materials. This layer can be associated to colluvial deposits, originated from the deconstruction of the Toro and principally the Gatún formation.

Fig. 5. Tomography obtained from the processing of the centre seismic refraction line performed in this work.

On Fig. 5, it can be seen that the thickness of the top sedimentary stratum decreases from the higher elevations down (SW – NE direction). Velocities higher than 700 m/s were observed for in-site materials depending its different conditions respect to weathering and fracturing as described in the same Table 1. The p-wave velocity of the bedrock, corresponding to the Gatun Formation, ranges from 1800 m/s to 3000 m/s. Propagation p-velocities between 1800 m/s and 2500 m/s are associated to the weathered and fractured rock. Propagation velocities greater than 2500 m/s are attributed to a rock in good structural condition.

According to this analysis, it can be observed in the tomographic image of Fig. 5, that there is a distinguishable structural discontinuity or band in the bedrock, which occurs between distances 50 m and 200 m, approximately, where the rock material seems to be destructured to larger depth.

The geometry of this discontinuity could be attributed to different mechanisms. These include the presence of a shear band (fault), where the relative movement of the blocks results in a band of unstructured material and also have caused sliding of materials from the top down to the toe of the slope as clearly seen. A more accurate identification of the mechanism explaining the discontinuity requires supplementary studies which exceeds the purpose of this study. Nevertheless, the results suggested the convenience to relocate the spillway.

This work presents the result of the seismic survey using the methodology of the seismic refraction tomography for data acquisition and processing. The main finding of the work is the tomographic image of the cross section presented on Fig. 5. From this result, the following conclusions can be summarized:
