The use of CPT to evaluate the properties of a compacted embankment

Arthur Veiga Silvério Pinheiro¹, Graziella Maria Faquim Jannuzzi², Fernando Artur Brasil Danziger³
*Federal University of Rio de Janeiro, Rio de Janeiro, Brazil, arthurveiga@coc.ufrj.br¹,
jannuzzi@coc.ufrj.br², danziger@coc.ufrj.br³*

ABSTRACT: SPT is the most usual type of soil investigation in Brazil for onshore foundation design. The piezocone test is routinely used for the evaluation of geotechnical parameters for embankment design on soft clays. However, this test is not yet a regular practice for onshore foundation design. The present paper shows CPT tests for the design of shallow foundations on a compacted granular embankment, built on top of a sandy soil. Soil compaction quality and assessment of the corresponding parameters for the foundation design were evaluated. Very high cone resistance and sleeve friction values were obtained, indicating a relative density of 100%, even at shallow depths. The very high values obtained were attributed to high horizontal stresses developed during compaction.

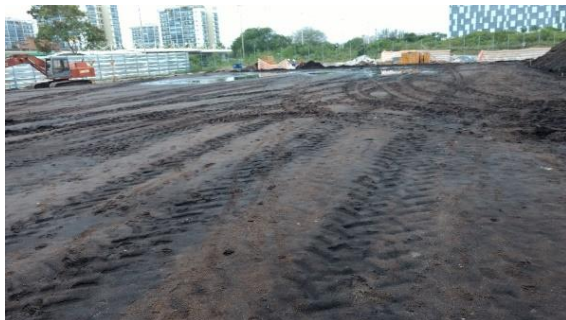
Figure 3. Embankment after completion.

Shallow foundations on a compacted embankment, about 3 m thick, directly over the natural material were designed. After the completion of the compacted embankment, CPT tests were specified by the designer and performed in 2017. Figure 3 illustrates the aspect of the embankment after completion.

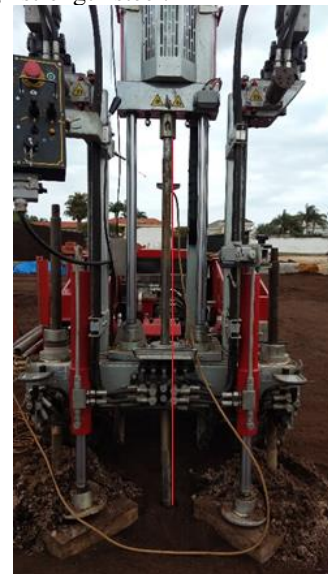
Figure 4. Beginning of the CPT-06 rod assembly buckling, even without pre-hole.

It is noteworthy to make some considerations regarding the operational issue of the CPT test in situations similar to the presented case. As mentioned, there were three limiting factors that should be analysed. The first is the capacity of the penetrometer rig, 170 kN (17 tf). The largest load component to achieve this value is the accumulated lateral friction along the rods, even in the present case of a relatively small rod length. In fact, when considering the measured values (presented below) of cone resistance q_c around 40 MPa, a tip load of 40 kN (4 tf) is obtained. Now assuming an average lateral frictional resistance of 200 kPa and 3 m rod length, a frictional load value of almost 190 kN (19 tf) is achieved, greater than the capacity of the rig. It should be noted at this point that even truck-mounted equipment has hydraulic systems limited to about 200 kN (20 tf), so it would also have difficulties in the present case. Regarding the reaction, a truck is more convenient than a rig, because the weight of a truck can be larger than the capacity of the rig. The failure of the anchor in the case of a small rig is relatively common in the authors' experience, and it is difficult to predict the corresponding capacity. The last of the limiting element is the rod, which showed a buckling tendency even in a test without pre-hole (Fig. 4), which represents an important limitation of the test since the rod used is the same used in truck-mounted equipment. In other words, CPT tests to be performed in soils with characteristics similar to those of the material analysed here, require special operational procedures, such as the use of rods with devices that allow water jets to be used above the test region during penetration as well as removal, and the use of special high strength steel.
