# Hong Kong's marine UXO. The prevalence, burial depth, associated hazard and identification of marine UXO

**ABSTRACT:** Unexploded Ordnance (UXO) are military munitions that have been primed, fused or otherwise prepared for use and have been fired, thrown, dropped or propelled but have not detonated either by design or malfunction. Hong Kong saw considerable military action during WWII, with as many as one-third of the munitions used failing to detonate as intended. These UXO remain hidden but probably embedded under, or near much of Hong Kong's current and proposed infrastructure. Victoria Harbour and her surrounding waters received the majority of this UXO - from a variety of sources from 1939 through to the 1980's. Seabed currents and human activity uncover and transport these UXO, and the source sand for modern day reclamations is extracted from these same areas.

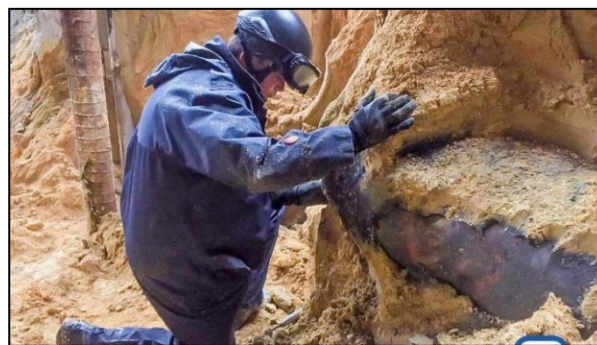
**Figure 1.** One of two WW2 x 1,000 lb AN-M65 bombs discovered on a waterfront construction site. January 2018, Convention Avenue, Wanchai (courtesy South China Morning Post)

The attack on the Japanese convoy moored in the harbor on 16 January 1945 dwarfed any other raid on shipping at Hong Kong during the war. Many of the wartime UXO in the harbour are therefore likely have been dropped during this all-day attack [5], and it is this bombing that probably resulted in the discovery of two unexploded 1,000 lb bombs at a Wanchai north construction site in January 2018 (Fig. 1).

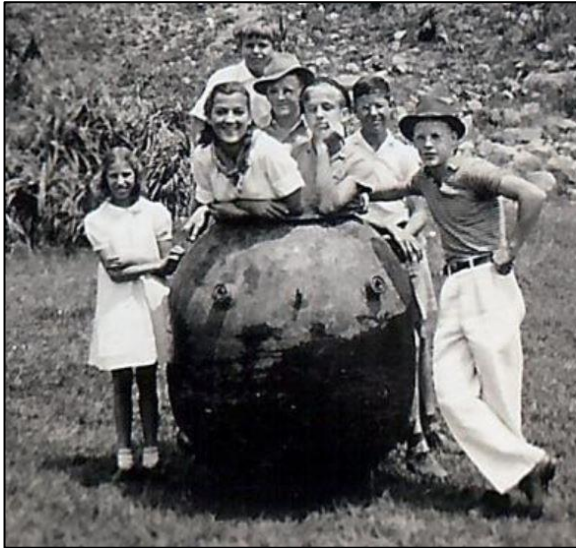
**Figure 2.** Naval contact mine, Cheung Chau 1940-41. (Courtesy Gwulo: Old Hong Kong)

The seabed is consequently littered with UXO including mines, torpedoes, shells, rockets and bombs (Fig. 2.) – either fired during action or dumped, often indiscriminately, after the conflict. Although the latter are described as “made safe” before dumping into the sea, this terminology has been applied arbitrarily.

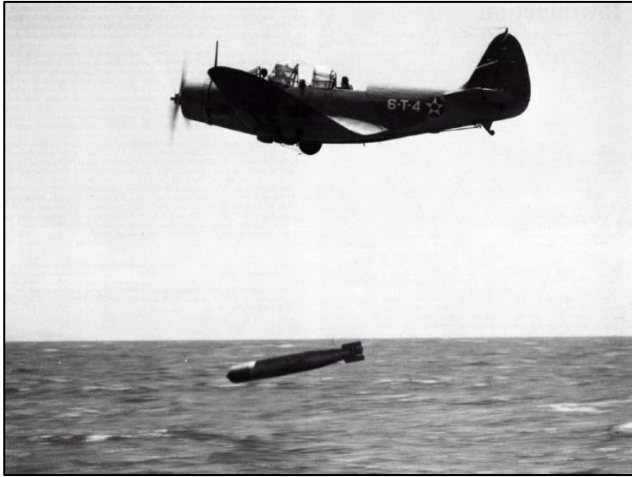
**Figure 3.** Ten Mk-13 air-dropped torpedoes, armed, undetonated and missing in Victoria Harbour. (Courtesy Gwulo: Old Hong Kong)

Larger UXO dropped in shallow water (less than 12m) may have penetrated and continue to reside some depth below the sea bed. This is almost certainly the case for ten US Mk-13 air-dropped torpedoes (Fig. 3.) that almost immediately became “mudders” – a term the crews used to describe live, undetonated munitions buried in soft ground. The quantity of UXO hauled in fishing nets, displaced by channel maintenance or removed by dredging is not well reported.

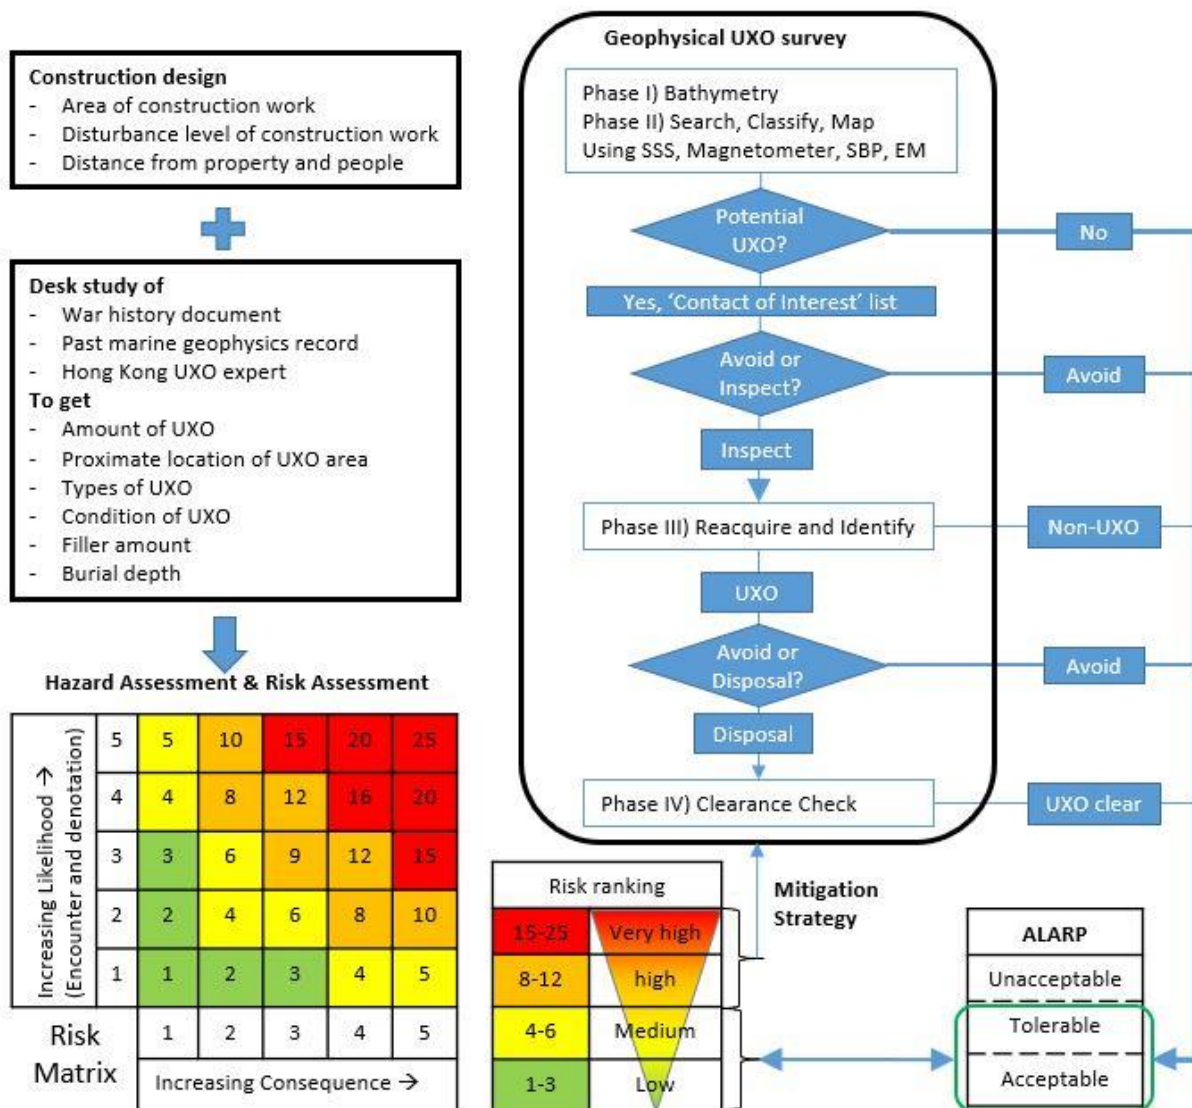
Figure 8. Risk Management Framework. Hong Kong Marine UXO  
Figure 9.

The possession of explosives is highly regulated in Hong Kong (the Firearms & Ammunitions Ordinance, Crimes Ordinance, Chemical Weapons Ordinance and the Dangerous Good Regulations). Other than this legislation, UXO contaminated areas are not managed proactively, but could be by their inclusion in the governments list of Scheduled Areas managed by the Buildings Department (under the Buildings Ordinance). Any UXO risk management framework should be prepared with this future possibility in mind (Fig. 8.).
