# Internal erosion in low plasticity cores of embankment dams

Diego Escudero & Ignacio González Tejada & Claudio Olalla

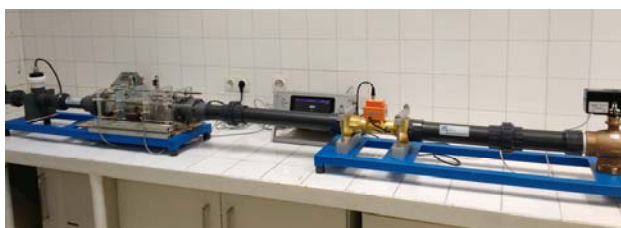
Figure 1 Photograph of the MHET, experimental device developed in the “Universidad Politécnica de Madrid”, (UPM).

The original design is detailed on Wan and Fell (2004). This device has been modified and improved to assess the erosion characteristics of soils in cracks in embankment dams: critical shear stress,  $\tau_c$ , and rate of erosion,  $\epsilon_r$ , in order to establish the Erosion Rate Index,  $I_{HET}$ . This erosive mechanism of concentrated leaks is considered to be the most feasible, due to the greater tendency of slightly plastic soils to crack.

The equipment developed in the Geotechnical Laboratory of the UPM, is based on the original design and considering the possible scarcities that have been appearing in the specify literature. (Wahl, et al. 2008, Sam Lim 2008, Haghghi et al. 2013). The main improvement of the original design is the

incorporation of a turbidimeter to instantly measure the eroded soil and consequently the evolution of the crack. Another relevant singularity is the use of a motorized valve for the monitorized control of flow rates and water head. (See Figure 1)
