Liquefaction risk assessment of airport infrastructure using geological data and remote sensing techniques

Keywords: Liquefaction; airports; runways; risk analysis; remote sensing.

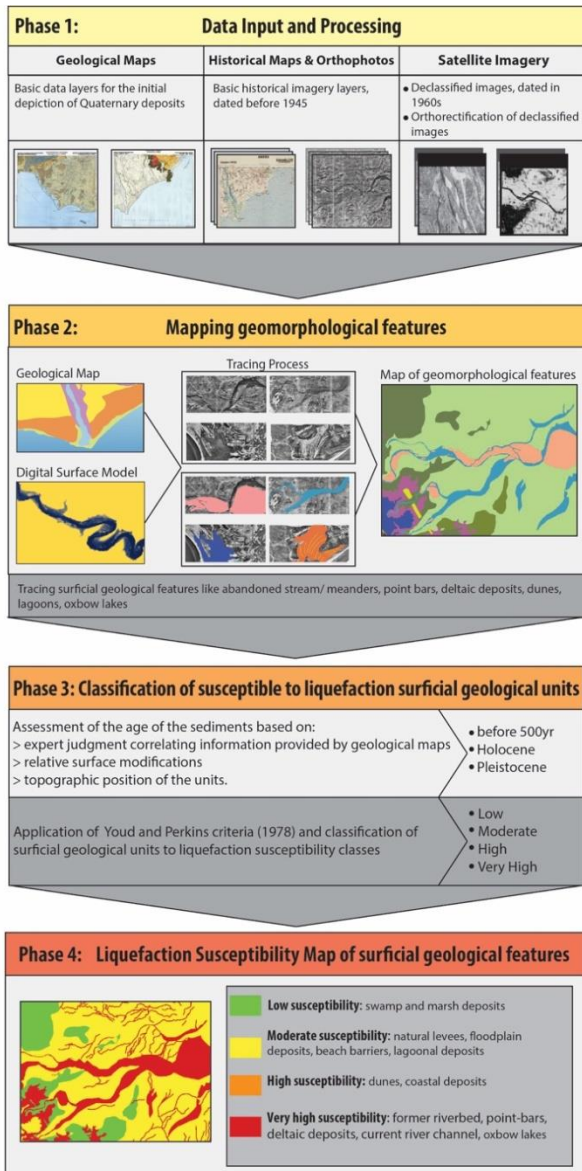
Figure 1. Methodology for assessing liquefaction susceptibility (Taftisoglou et al. 2022).

Considering the significant influence of depositional processes on the susceptibility of sediments to liquefaction, we have developed a methodology that enables the identification of surface geological units prone to liquefaction. This method involves creating a geomorphologically oriented map by integrating geological and remote sensing data, as outlined in the study by Taftoglou et al. (2022). This procedure includes four phases (Figure 1).

In phase 1 geological and historical maps of the area, orthophotos and satellite images are collected in order to examine the geological formations and the geomorphological evolution of the plain. By combining these layers of information with the local topography (DEM) the mapping of geomorphological features is conducted in phase 2. Geomorphological formations, such as abandoned stream/meanders, point bars, oxbow lakes, dunes and lagoons are detected and traced during this step and a new geomorphological map is compiled. In phase 3 the classification of surficial geological units susceptible to liquefaction is performed. In particular, data provided by the geological maps and the new geomorphological map are used to define the age (<500yr, Holocene, Pleistocene) and the depositional environment of the geological units. Subsequently, the criteria by Youd and Perkins (1978) are applied to classify the geological units according to their susceptibility to liquefaction. In phase 4, a liquefaction susceptibility map is compiled, including four classes (Low, Moderate, High and Very High), where coastal and fluvial deposits are classified as high to very high susceptible units.

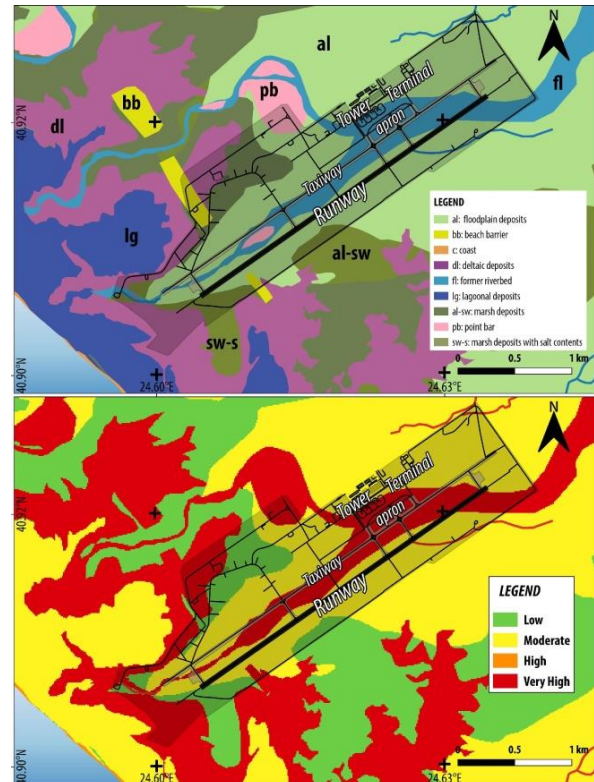
Figure 2. New geomorphological map and liquefaction susceptibility map of KVA.

Another important observation was the extensive river network in the west side of Nestos plain, where old estuaries of Nestos river were formed. The airport was built during 1980s in this area, where land reclamation and modifications had already been occurred. Focusing on this location, the new geomorphological map reveals that a significant part of the airport's facilities and runway were built on an abandoned river branch of old estuaries and deltaic deposits (Figure 2). After the application of Youd and Perkins criteria, it was clear that part of the runway, taxiways and apron are located on a very high susceptible zone.

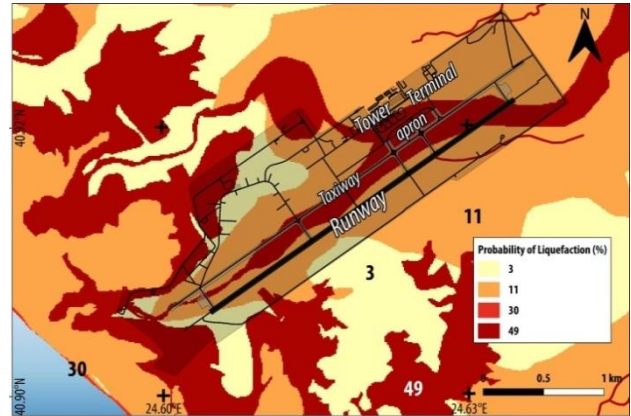
Figure 3. Probability of liquefaction in KVA area.

The HAZUS (FEMA, 2022) methodology was adopted to evaluate the probability of liquefaction and the PGD based on the results described in section 2.1 and a representative seismic scenario based on SHARE and GreDaaS databases of seismogenic sources (Caputo et al, 2012; Giardini et al, 2013). An event of Mw 6.3 in the closest seismogenic source of Kavala-Xanthi-Komotini fault was selected and the ground motion map (PGA) was produced using REDAS software (Papatheodorou et al., 2023). Subsequently, the probability of liquefaction was assessed for each susceptibility category, taking also into account the amplitude of the ground shaking at the airport location (PGA=0.36g) and a groundwater depth of less than 6m. In particular, the probabilities for high and very high susceptibility classes were estimated to be 30 % and 49%, respectively (Figure 3).

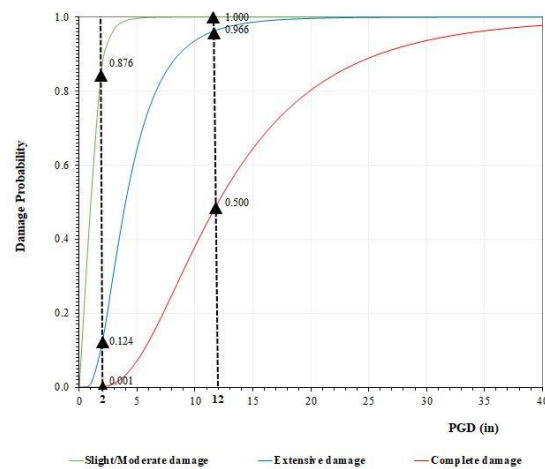
Figure 4. Fragility curves for the runway, taxiways and apron as a function of PGD (FEMA, 2022).

The vulnerability of the runway (3,000x45m), taxiways (4,000x35m) and apron (96,000m²) is assessed based on the fragility functions that are included in HAZUS methodology (Figure 4). The probabilities of exceeding slight/moderate, extensive, and complete damage level were assessed for PGD values of 5.08 cm and 30.4 cm, as the runway, taxiways and apron are located on the moderate and very high susceptibility classes. Based on the probabilities of exceeding each damage state and a repair ratio of 0.1 for slight/moderate, 0.4 for extensive, and 0.8 for complete damage, average loss ratios of 0.125 and 0.590 were calculated for the two PGD values (Argyroudis, 2022). The reconstruction cost was considered equal to 180€/m² for the runway and 160€/m² for the taxiway and apron (Markovich, 2011). By multiplying the construction cost, average loss ratio and the corresponding area, the direct losses were estimated (Table 1). The total loss for this seismic scenario is assessed equal to €22,2 m. Yet, this is a conservative estimation assuming that liquefaction affects the entire runway, taxiway and apron. In reality, it is expected that ground failure due to liquefaction will likely be more localised, resulting in damage to a portion of these infrastructure.

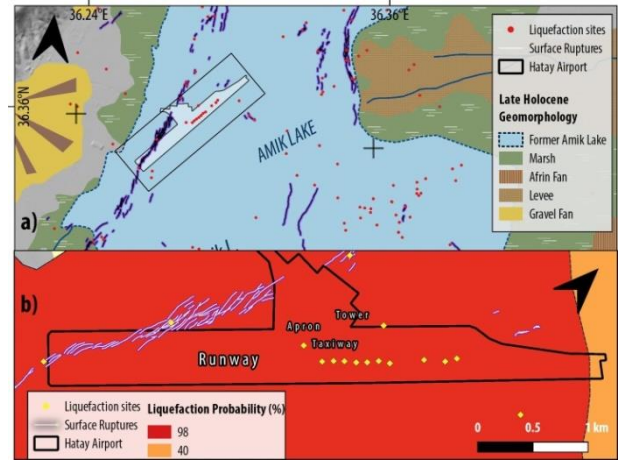
Figure 5. Liquefaction manifestations at HTY, after the 2023 earthquake doublet.

HTY is located in the western part of Amik plain; on the formerly Amik Lake. During the 2023 earthquake doublet of Mw 7.7 and Mw 7.6 on East Anatolian Fault Zone (EAF) extensive liquefaction was observed over the former Amik lake floor, striking also HTY. In particular, the eastern part of the airport was affected by liquefaction shaking deformation phenomena (ground oscillation-lateral spreading) and or possibly triggered shallow slip of pre-existing neotectonic fault traces (Taftsoğlu et al., 2023). Ground cracks and soil craters were detected on the runway and its closer area leading to closure of the airport for six days. In contrast to the east side, ground cracks of significant length in the western part of the airport were observed, related to surface fault ruptures of an unknown EAF segment, which cross Amik plain through this area. The results of FEMA's are consistent with the observed damages in this area, with almost all airport infrastructure classified to as highly susceptible to liquefaction, with probability of 98% and PGD of 15.2 cm (Figure 5).
