Small- and full-scale test programme on uplift induced slope failure

C. Zwanenburg*

Deltares, Delft, The Netherlands; TU Delft, Delft, The Netherlands

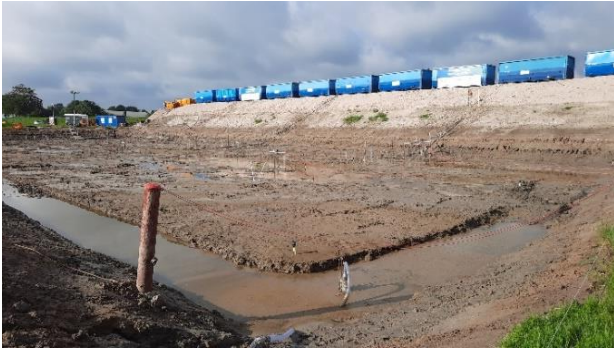
The instrumentation of the main field trial was placed in three rows, containing 12 pore pressure transducers in the sand layer, 30 in the cover layer, 3 in top layer directly below the dike body, 7 open standpipes to measure the hydraulic head in the dike body, 15 inclinometers to measure horizontal displacements, 9 extensometer measuring vertical deformations at three different depths. Additionally, surface deformation was measured at 96 positions using a total station. Figure 6 presents an impression of the test set-up at the start of the main field trial.

Figure 6. Impression of the main field trial.

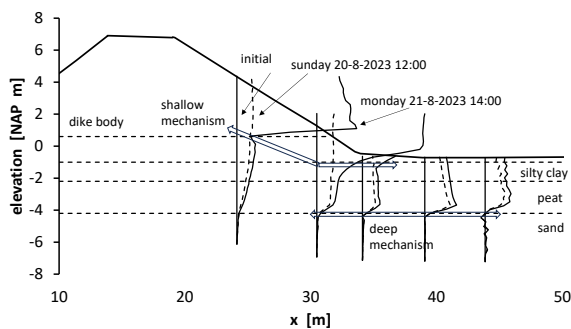
Figure 7. Horizontal displacements during the test.

Figure 7 shows the horizontal displacements measured during the test at the centre cross section. The horizontal displacement measurements at all but the left-most location clearly show a horizontal displacement at the interface of peat and sand. During the test the horizontal displacements developed uniformly over the cover layer thickness. This corresponds to mechanism *d* in Figure 2 and numerical analysis given by Figure 3. At these positions, the horizontal displacements are ranging between 0.05 to 0.10 m.

In the last stages of the test, starting on Sunday 20 August 2023, the last part of the sand core was filled, which caused a shallow failure plane to develop. The three instruments on the left side clearly indicate the position of the shallow sliding plane.
