Centrifuge tests on the uplift and deformation patterns of clay cover layers in deltas

C. Cengiz*

Deltares, Delft, The Netherlands

The paper was published in the proceedings of the 18th European Conference on Soil Mechanics and Geotechnical Engineering and was edited by Nuno Guerra. The conference was held from August 26th to August 30th 2024 in Lisbon, Portugal.

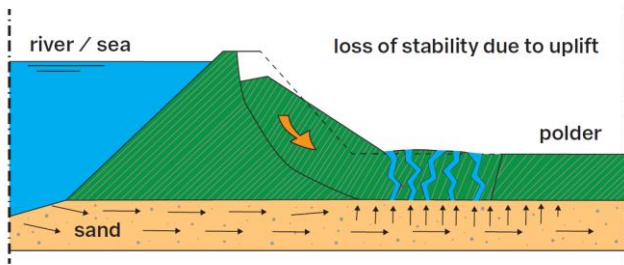
Figure 1. A sketch of buckling or uplifting mechanisms over a dike clay cover.

To address the risk of bursting, the current assessment and design approach involves a simple rule: for top layers with a thickness of 4 meters or less, no shear strength is assigned when the safety factor is 1 or lower. This particular rule is based on expert judgement without extensive support from calculations, experiments, or empirical data. However, it is widely believed that this approach errs on the side of caution and tends to lead to designs that are overly conservative. The above-mentioned risk is especially pressing in the Eastern part of the Netherlands, where the Holocene top layer is commonly situated on top of a relatively rigid and permeable Pleistocene sand layer. It is plausible that high-water levels in adjacent rivers and estuaries may generate locally high pore pressures directly under or beside a dike. Consequently, the effective normal stresses at the layer interface decrease, eventually to zero, giving rise to uplift and sliding failures (Van et al., 2005). A pictorial description of the problem is illustrated in Figure 1.

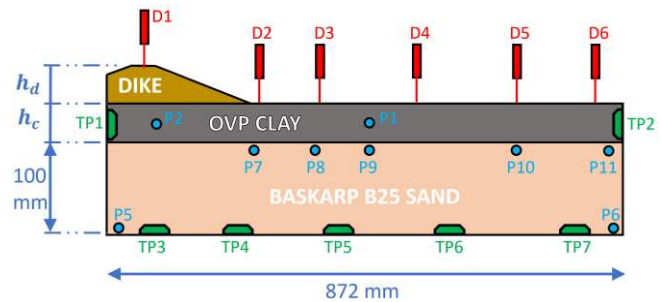
Figure 2 illustrates a sketch of the experimental setup together with the soil layers, instrumentation details, and the model-scale dimensions.

Figure 2. A sketch of the experimental setup.

layer. An array of eleven pore water pressure sensors is distributed over the model, abbreviated as P in Figure 2. Notably, P5 and P6 indicate the pressure head of the influent and effluent flow. P7 to P11 measure the porewater pressure at the sand-clay interface. Finally, P1 and P2 give important insight into the pore water pressure within the OVP clay cover layer. Surface vertical deformations are monitored by six hard sensor points instrumented with DCDTs. These sensors are essentially similar to Linear Variable Differential Transformers (LVDT), but they do not incorporate any spring-loaded system, preventing jamming under the action of a centrifugal acceleration field. Beyond the conventional instrumentation, the deformations are monitored with a camera system, enabling post-testing digital image correlation analyses. Due to the large aspect ratio of the transparent window, a total of two cameras are used for monitoring the entirety of the model. A photograph of the intact dike is shown in Figure 3.

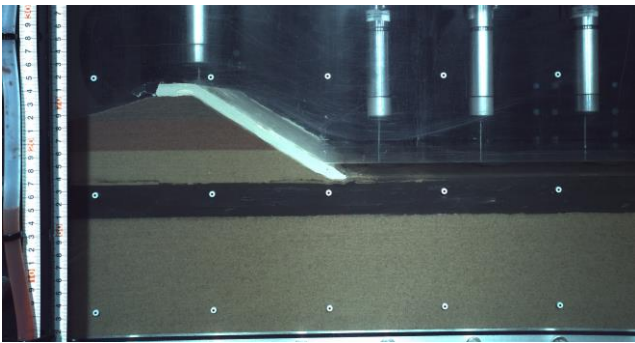
Figure 3. A photograph of the dike before failure occurs (note that a thin layer of Vingerling K147 clay (white) is used as an armor layer to retain water within the dike body).

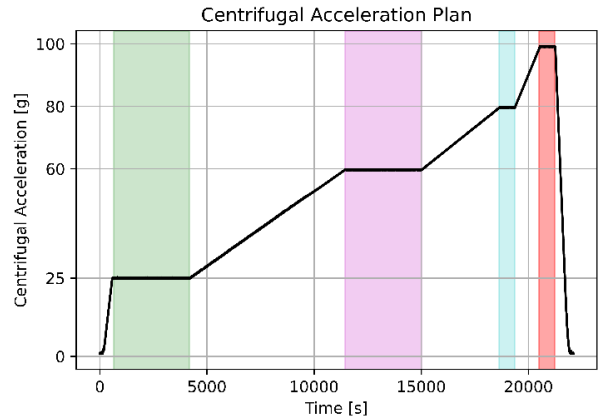
Figure 4. Centrifugal acceleration during the experiment.

The centrifugal acceleration regime applied to the model is illustrated in Figure 4. The hydraulic loading regime necessary to induce uplift is estimated on equivalent finite element calculations, assuming a stress field equivalent to an effective centrifugal acceleration of 80g. The hydraulic loading regime is illustrated in Figure 5, where the difference in influent (P5) and effluent (P6) pressure heads can be seen.

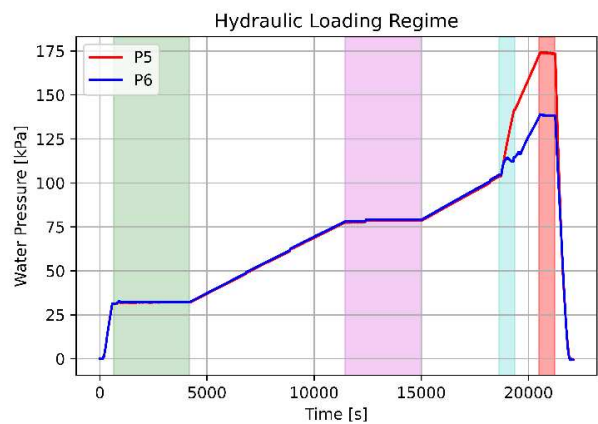
Figure 5. Hydraulic loading regime during the test.

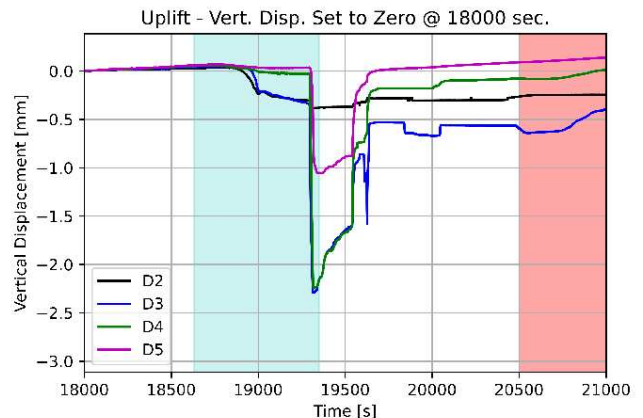
As a result of increasing the hydraulic head difference across the model, uplift of the cover layer is triggered. Vertical displacements measured by the DCDTs are illustrated in Figure 6 (notice that the background coloring in the graph coincides with different phases of the experiment as illustrated in Figure 4 and Figure 5). A photograph capturing the moment of uplift is also shown in Figure 7.

Figure 6. Vertical displacements measured by the DCDTs at the initiation of uplift.

- Although the presently described test only constitutes a singular test within the experimental program, uplift of the cover layer was observed in all tests.
- Uplift phenomena occurs when the limit equilibrium state is satisfied, i.e., the ratio of the vertical pressure exerted by the cover layer is equal to the water pressure below the cover layer, or when $\sigma_v / \sigma_w = 1$.
- The cover layer cracks due to uplift. This crack is seen as a diagonal crack occurring at the toe of the dike, see Figure 7 (to the right of the first white dot in the figure).
- Uplift at a centrifugal acceleration of 80 g causes the cover layer to rise approximately 2.5 mm, see D4 measurements in Figure 6. There

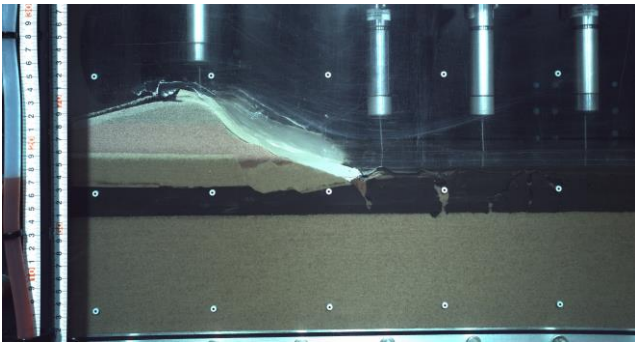
Figure 8 illustrates the overall deformation observed at the end of the test where multiple failure planes within the dike body are visible which also bring about settlements (reduced free-board). In addition to the dike body failure, the cover layer exhibits severe cracks, most notably at the toe. The cracks extend diagonally, and its slope is steeper than that of the dike slope. Multiple wells have also formed as a result of the increased hydraulic heads which reduce the integrity of the cover layer.

Figure 8. Overall deformation pattern of the model.

- Failure was found by a combination of a steep sliding plane at the active side that connects the opening at the cover layer with the sand layer.
- In the test series, no passive failure plane is visible, instead the cover layer seems to be horizontally compressed in combination with a further increase in curvature of the uplifted zone. The later could mean that the lateral stiffness of the cover layer might play a role in the observed deformation patterns.
