# The erosion resistance of different dried fine-grained dredged materials for application in dike construction

Stefan Cantré, Fokke Saathoff, Anne-Katrin Große, Tim Jurisch  
*Universität Rostock, Geotechnics and Coastal Engineering, Rostock, Germany*

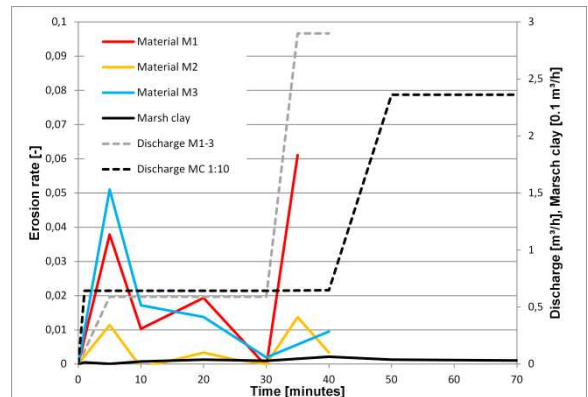
The DMs were compared to the marsh clay regarding their erosion rate (Figure 3). In the flume tests, the erosion rate was defined as the quotient of eroded soil volume  $V_s$  and overflowing water volume  $V_w$  during a defined time step. Material M2 shows the best results among the three tested DMs, with an average of only 1.1 mm of erosion depth after 30 minutes. The critical shear stress for surface erosion of the bare DM is probably below  $5 \text{ N}/\text{m}^2$  on a 1:3 slope.

Figure 3. Erosion rates ( $V_w/V_s$ ) from laboratory flume tests

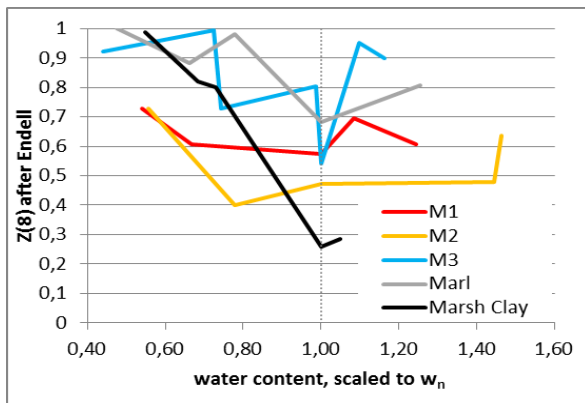
The disintegration numbers  $Z(8)$  are shown in Figure 4, scaled to the respective natural water content. This shows that (apart from M2 where the aggregates inside the basket gained weight due to water absorption) all materials show the lowest  $Z$  for  $w_n$ .

Figure 4. Disintegration numbers vs. normalised water content – justification for the use of  $w_n$

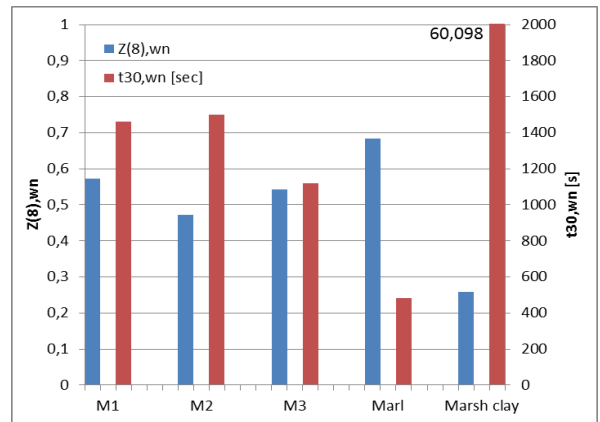
Figure 5. Disintegration numbers  $z(8)$  and times  $t_{30}$  for initial / natural water content

Only little disintegration was observed. The pre-saturated samples showed constant weight for a long time, before only a little amount of crumbling started at the end of the test procedure. Only the samples at natural water content showed a similar trend to the Endell test, where samples started to disintegrate after about 1,000 s, finally losing 60 % of their initial weight. Based on these test results, the disintegration time  $t_{30,v}$  for  $CI = 0.8$  could not be computed, and thus the disintegration time for natural water content  $t_{30,w_n}$  was used for comparison. Investigation of different water contents showed an increasing disintegration time (and erosion resistance) with increasing water content. Among the tested DMs, M2 performed best (Figure 5). M1 and M3 show comparable results. The comparably sandy marl material showed the fastest disintegration and the marsh clay performed best among all materials.

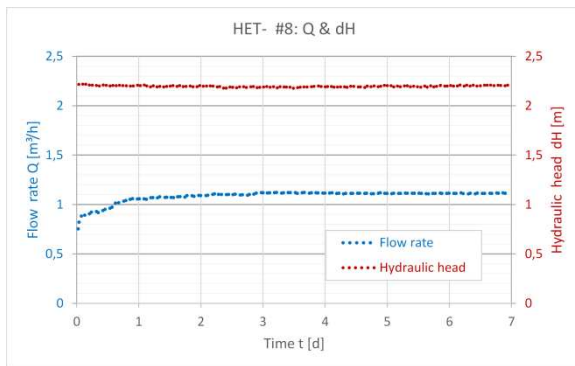
For head differences  $\Delta H < 2\text{m}$  no erosion was observed in the R3 series (Figure 6). Thus, the standard HET setup was changed to account for higher loads.

Figure 6. HET results R3 #8; 7 days of continuous high load and stagnating flow rate

For the DMs the evaluation of the hole erosion test is problematic. The theory to determine the characteristic curves and parameters is based on the assumption that erosion occurs rather continuously (particle by particle). After an initial widening of the hole, where loose material from the hole drilling is removed, erosion should start slowly (when exceeding  $\tau_c$ ) and then accelerate with increasing hydraulic gradient and flow rate. However, the DMs mostly erode in larger agglomerates rather discontinuously, sometimes even blocking parts of the hole before finally being washed out. It is therefore difficult to determine a reliable critical shear stress which is needed to compute the other parameters with eq. (1), (2). An example is provided in Figure 7, showing a discrete increase in hydraulic head difference resulting in very small amounts of erosion only at the beginning of the load increase and stagnating afterwards, comparable to Figure 6.

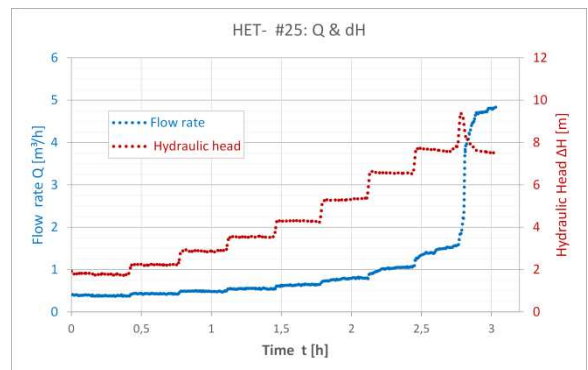
Figure 7. HET results -#25 with 9 different pressure steps, collapse at  $\Delta H \approx 9\text{ m}$

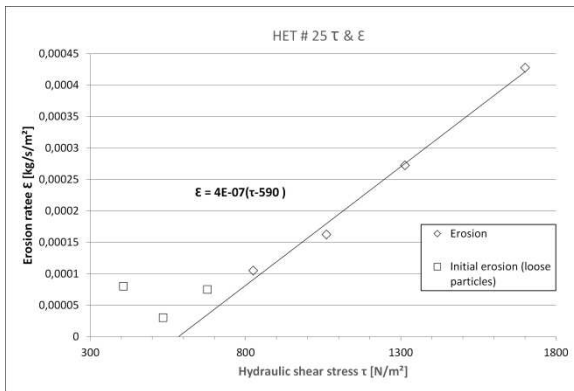
Figure 8 shows the interpretation problem where to define the linear part of the curve which is important to determine  $\tau_c$ . Here, a critical shear stress of 600 N/m<sup>2</sup> is determined, a very high value compared to those presented in Wan & Fell (2004). In this particular test erosion started with a head difference of 7.56 m and a real failure (considerable hole widening) was observed for 9.48 m.

Figure 8. HET results -#25, erosion rate, initiation of erosion
