Budarahals HEP – Headrace tunnel excavation – a project review

Jon Smari Ulfarsson-Project Manager/Geological Engineer
Landsvirkjun, National Power Company of Iceland

ABSTRACT: The Budarahals HEP 95 MW, in the lower highlands of southern Iceland, is harnessing about 40 m head in a 4 km long 140 m² in cross section elliptical shaped headrace tunnel. The rock mass on the tunnel route consists of 1 to 2-million-year-old igneous and sedimentary rock formations underlying hiatus and much younger and highly permeable moberg formation. Interpretation of extensive geological exploration revealed several different geological formations on the tunnel route of different geotechnical properties. The actual geological profile did only to a minor extent vary from the geological tender profile. However, unexpected difficulties were encountered. Statistical analyses and comparison to older comparable projects were performed on the quantity of installed rock support, and evaluation made on the excavation progress advance through different geological formations. This paper summarizes the result of rock mechanical testing, interpretation on deformation measurement and the as-built outcome as compar

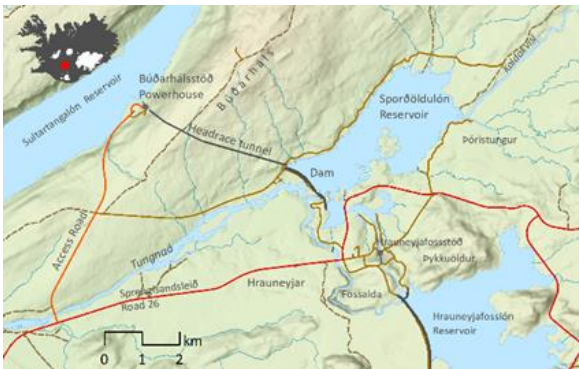
Figure 1. Location map, headrace tunnel alignment

Sporðöldulón, and the Sultartangi HEP reservoir, Sultartangalón, see figure 1.

Deep under the highest part of the mountain is a highly altered rock mass containing swelling clay minerals such as smectite. This rock mass has in places disintegrated into almost soil like material and would require full concrete lining in a large tunnel. Therefore, to avoid the worst part of this area, the tunnel alignment was bended away from straight line, see figure 1.

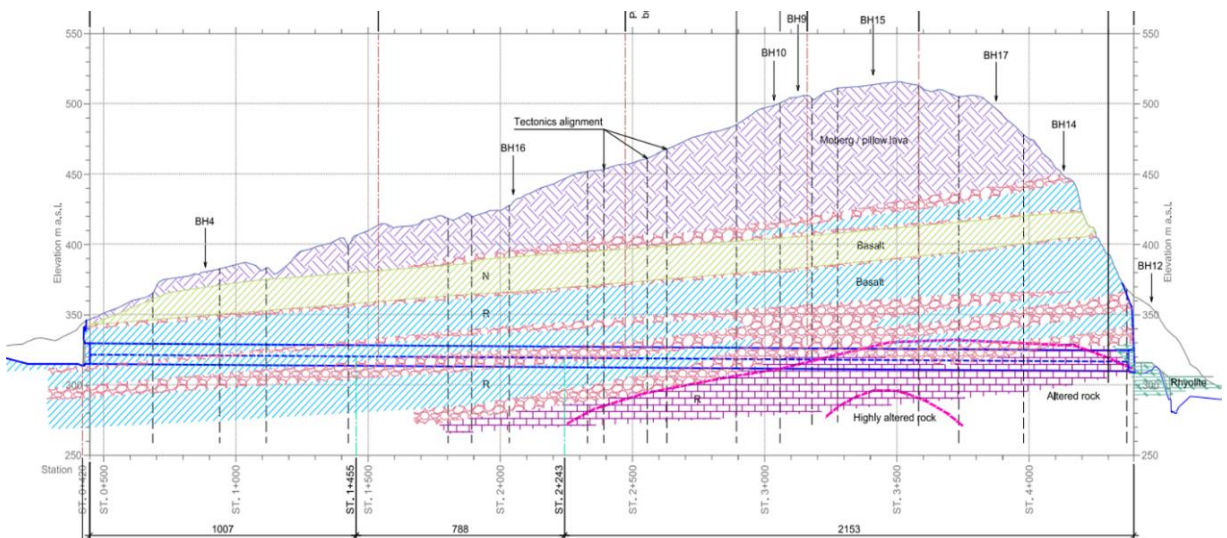
Figure 2. Geological section through the Budarhals as interpreted from exploration core holes.

Extensive geological exploration revealed several different geological formations, of different geotechnical properties, to be encountered on the tunnel route, see figure 2. This included among other three different types of basalt; fractured tholeiite basalt, large columnar porphyritic basalt and geothermally altered olivine basalt, rhyolite and sedimentary rock, mainly sandstone and conglomerate.

At exploration stage, the strike and frequency of tectonic lineaments was mapped from aerial photos, plotted on the geological section model as single broken vertical line, see fig.2

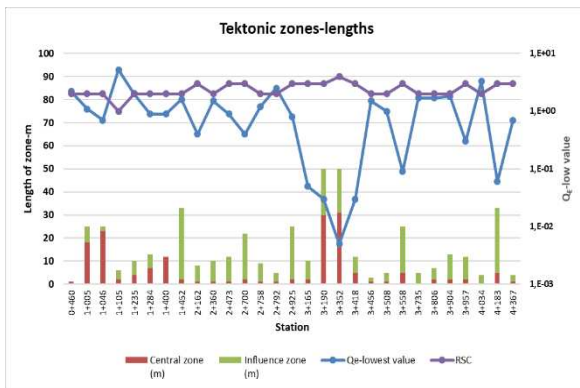
Figure 3. Analyses of the tectonic zones crossing the tunnel route (red is central zone, green influence zone).

In all, 29 fault zones were mapped with average length of the influence zone of 15 m, thus about 11 % (450m) of the total tunnel length, see figure 3.

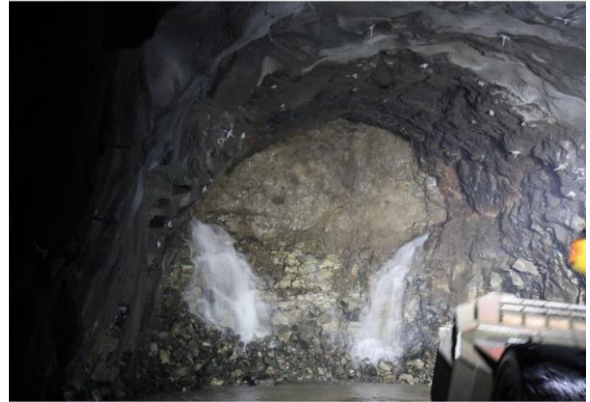
Figure 4. Inflow of water from fault plane 5m ahead.

Based on permeability tests in boreholes and field mapping of tectonic lineaments it was evaluated that water ingress would in general be relative limited mainly associated with tectonic fractures and dikes, see figure 4.

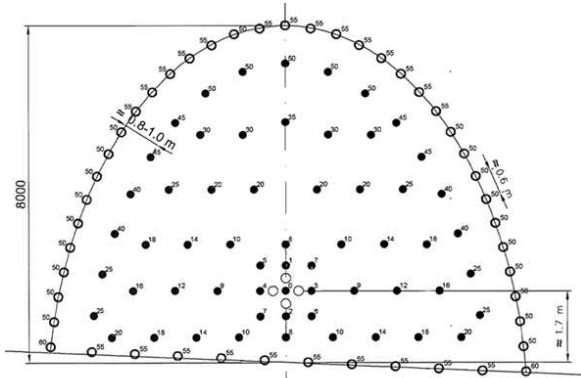
Figure 5. Typical blasting pattern for the top-heading.

The tunnel excavation was divided into two sections, top heading and bench, each cross-section of 70 m², figures 5 and 6.

The contractor's method statement revealed number of drill holes in the top heading of 110-125, 51mm wide blast holes and four 105mm cut holes. Drilled depth was assigned 5.3 m and the charging (Q-value) was around 2.3 kg explosive/m³ rock. (Landsvirkjun, 2016).

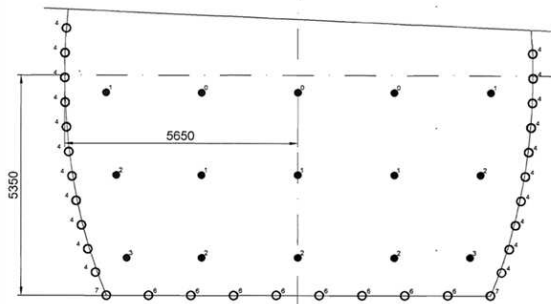
Figure 6. Typical blasting pattern for the bench.

For the bench excavation, number of blast holes of 46 eu., 4.8m long and of 57 mm diameter. Charging (Q-value) was about 1.08 kg/m³. (Landsvirkjun, 2016).

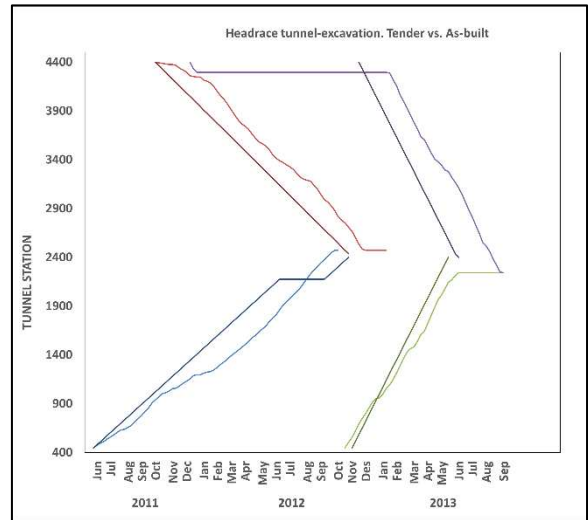
Figure 7. Contractor's scheduled versus as-built progress of excavation.

The effective as-built progress of the excavation for the whole tunnel, taken into account all variables, was 34.2 m/week for the top heading and 58.1m/week for the bench. The contractor's effective estimation in tender was 41,9 m/week for top-heading and 59,5 m/week for the bench, see figure 7, thus 82% and 98% respectively of his estimate.

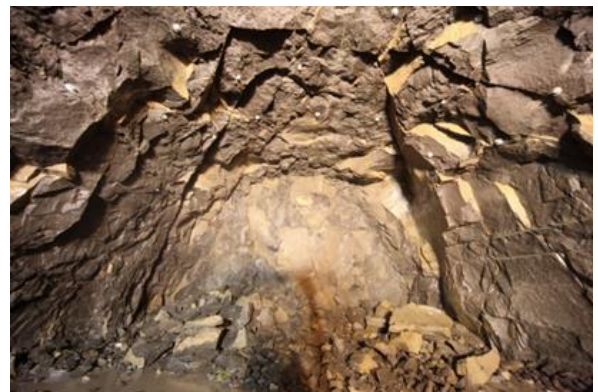
Figure 8. Large columnar basalt, diameter of 2-3m.

From the upstream portal and about 1100 m ahead the tunnel is excavated through a 10 to 15 m thick porphyritic basalt formation, with up to 3 m in diameter columns, irregular spaced, undulating joints sometimes filled with up to few centimetres of silt/clay, figure 8.

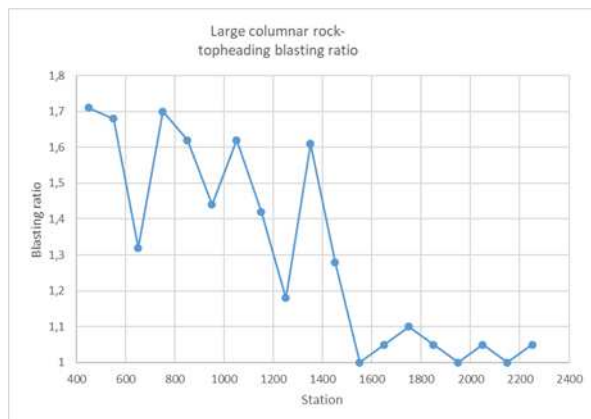
Figure 9. Re-blasting ratio in the first 2 km long large columnar top-heading section. Up to 70% re-blasting occurred in the large columnar basalt, st. 450 to 1550.

From the start of the tunnel excavation, progress was delayed considerably due to frequent underbreak and re-blasting, see figure 9, and the average progress of excavation was only about 26 m/week.

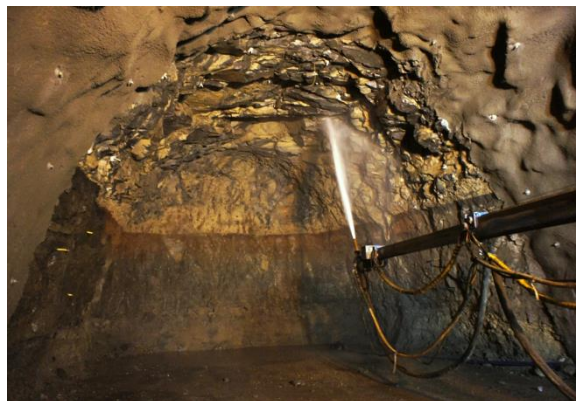
Figure 10. Mixed face, columnar basalt overlaying, sedimentary rock, st~2.200

Underlying the large columnar basalt is a sedimentary rock containing cobbles and boulders of over 1 m in diameter in sand/gravelly matrix, figure 10, and mixed face condition existed for next about 1,5 km. Excavation through those conditions, underbreak diminished considerably and progress of tunnel excavation was ascending, becoming between 35 to 45 m/week.

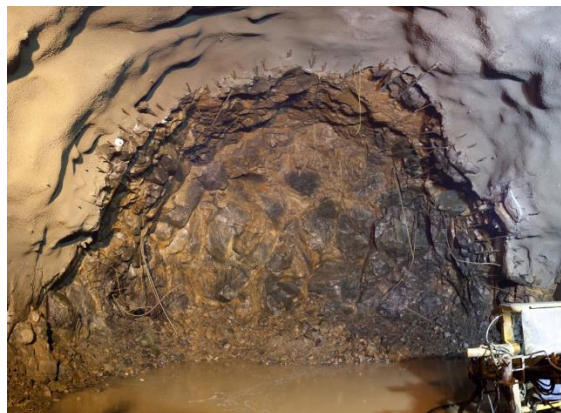
Figure 11. Mixed face, highly altered and unstable intensively weathered rock (rounded boulders) overlaying coarse gravel and boulders. Profile preserved by 6-8m long spiling bolts.

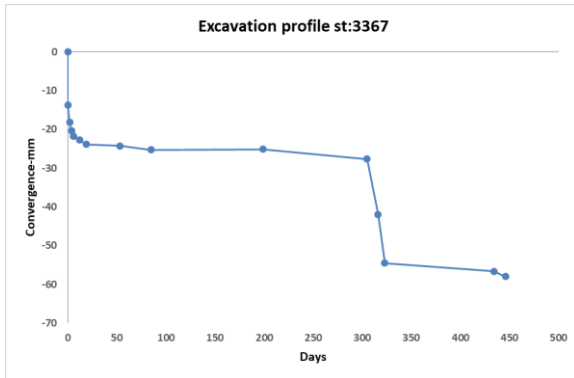
Figure 12. Convergence measurements in the alteration zone, top heading and benching 300 days later.

To evaluate stability (deformation) of the tunnel cross section, eye-bolts were installed at several tunnel lengths for convergence measurements, and further rod extensometers in two sections in the alteration zone. Horizontal deformation (convergence) was from few millimetres in solid basaltic rock to up to 60 mm in the alteration zone, benching with gallery 90% fully supported.

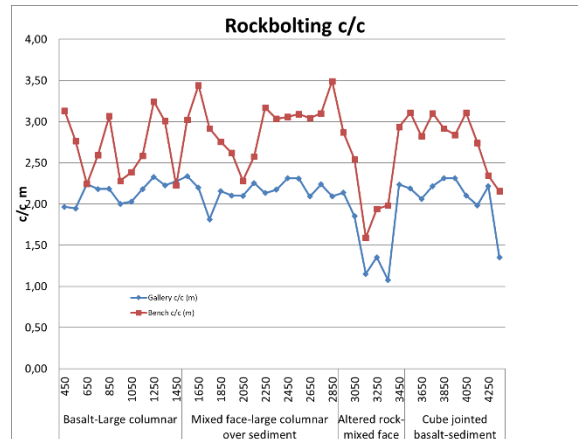
Figure 14. Average spacing of installed rockbolts in top-heading and bench - 100m sections (Landsvirkjun 2016).

In the alteration zone, installed rockbolts are longer and spacing of 1 to 1,5 m in the top heading and 2 m in bench walls, see figure 14. In addition, 8 m long spiling bolts with 0,4 m spacing were installed in the top-heading perimeter in the weakest sections.

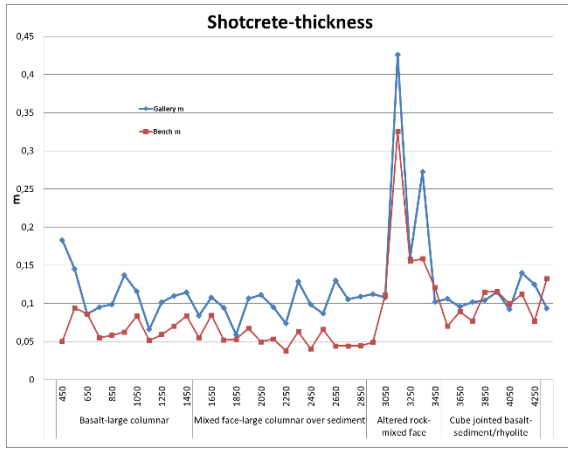
Figure 15. Averaged shotcrete thicknesses in top heading and bench-100m sections.

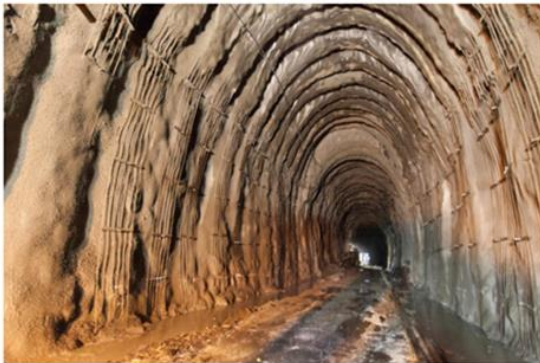
Figure 16. Sprayed concrete reinforced ribs under construction. Bending of the tunnel alignment ahead.

To be on the save side rock support was though assigned much greater for the top-heading than estimated at tender stage, deemed necessary from Q-value and geotechnical testing. Spiling bolts were installed over about 340 m section and over a 65 m long weakest part reinforced sprayed concrete ribs were installed with about 1 m spacing between 1 m wide ribs, see figure 16.

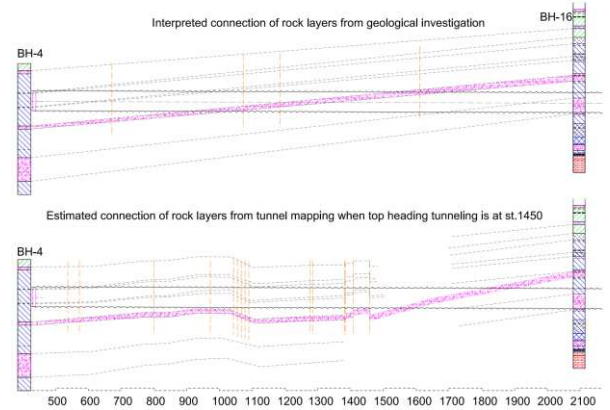
Figure 17. Tender vs. as-built geological model over 1000 m tunnel length in the large columnar section.

model, typically due to fluctuation of layers caused by tectonic faulting and layer's surface irregularity, see figure 17,

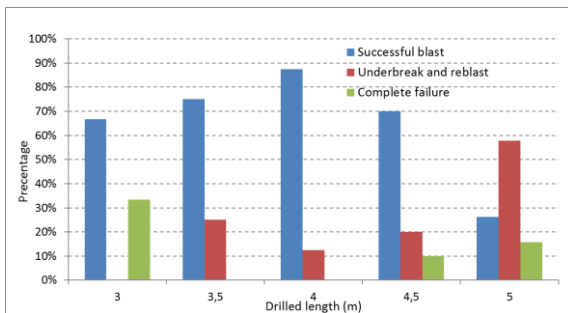
Figure 18 Successful blast (blue), complete failure (green) and underbreak (red).

By statistically comparing results from different approaches in order to minimize the problem, results showed that better results were obtained by reducing the pull length from 5.2 m to 4 m, see figure 18, increase the number of blast holes with less diameter (48 mm) instead of fewer wider holes (64 mm) for the same weight of explosive and use more energy releasing explosives with higher shock wave velocity, such as primer and dynamite along with the slurry.

The most likely reason for the blow-out and underbreak was reflection of the explosive energy wave away from the undulating columnar joint surfaces and energy loss in the joint fill material. Shorter rounds thus reduced this effect and the shock wave from high energy explosives gave better breakage of the columns.
