Geotechnical Challenges in Iceland

S. Erlingsson

Faculty of Civil and Environmental Engineering, University of Iceland, Reykjavik, Iceland

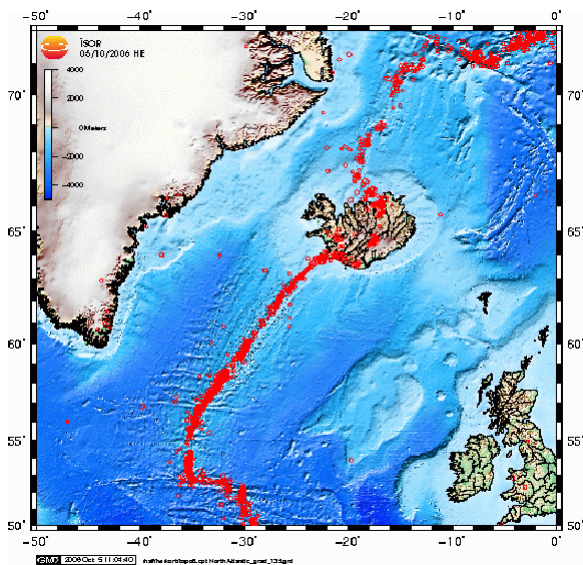
Figure 1. Epicentres of earthquakes in the Atlantic Ocean 1964–2006. Data are from the epicentre list of the NEIC, US Geological Survey. Figure courtesy of P. Einarsson.

Figure 1 shows the epicentres of earthquakes on the Mid-Atlantic Ridge during the period 1964–2006. It shows that the epicentres form a narrow deformation zone south and north of the country, but as it crosses the Iceland plateau the zone becomes wider. This can also be seen in Figure 2.

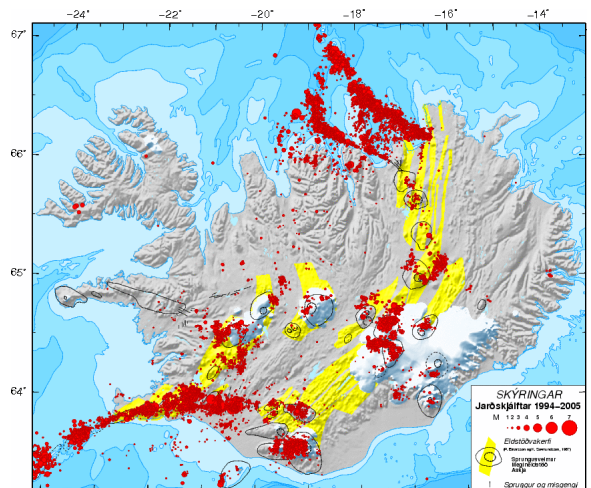
Figure 2. Earthquake epicentres, 1994–2007 and volcanic systems of Iceland. Epicentres are from the data bank of the Icelandic Meteorological Office. Figure courtesy of P. Einarsson.

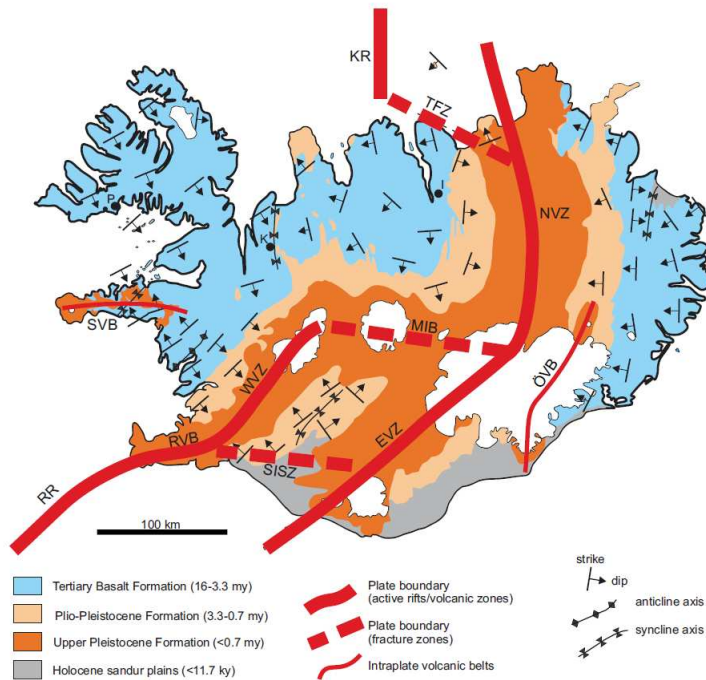
Figure 3. Simplified geological map of Iceland showing the main geological subdivisions as the fault structures, volcanic zones and belts. RR is the Reykjanes Ridge, RVB Reykjanes Volcanic Belt, WVZ West Volcanic Zone, MIB Mid-Iceland Belt, EVZ East Volcanic Zone, NVZ North Volcanic Zone, SISZ South Iceland Seismic zone, TFZ Tjörnes Fracture Zone, KR Kolbinsey Ridge, ÖVB Öræfi Volcanic Belt, SVB Snæfellsnes Volcanic Belt. Figure courtesy of Á. Höskuldsson.

A simplified geological map of Iceland is shown in Figure 3 where all the main geological subdivisions are indicated (Thordarson and Höskuldsson 2014).

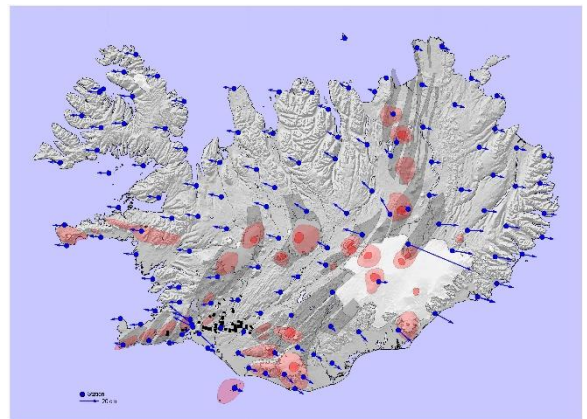
Figure 4. Observed lateral displacement measured with the GPS technique in Iceland during 2004 to 2016. Figure courtesy of G. Valsson.

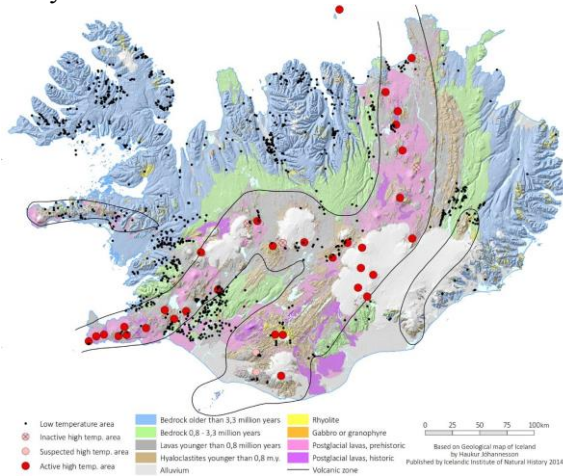
Figure 5. Geothermal fields in Iceland. Figure courtesy of H. Bjarnason.

Figure 5 shows a simplified overview of the geothermal fields of Iceland. The high temperature areas follow the AVZ. On both flanks of the AVZ, an irregular band of low temperature areas is formed. However, at a considerable number of locations low temperature fields have been observed further away from the AVZ.

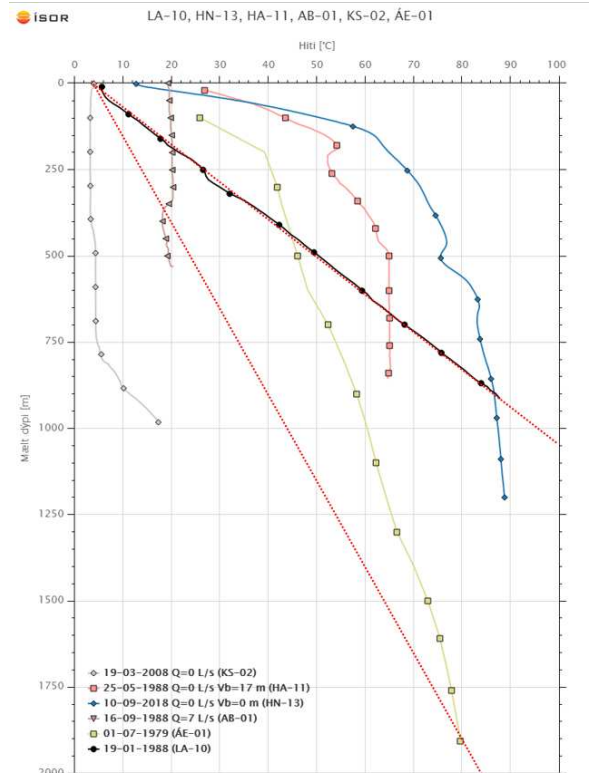
Figure 6. Temperature logs in a few boreholes in Iceland. Figure courtesy of Ó. Flóvenz.

Figure 6 shows typical temperature logs in boreholes in Iceland outside the AVZ (high temperature geothermal areas) (Flóvenz 2019). The figure shows that the temperature in the uppermost five hundred metres can vary from very low temperatures to almost 80°C. Thus, from a geotechnical point of view, at very many locations the risk of encountering high temperatures in the ground needs to be considered.

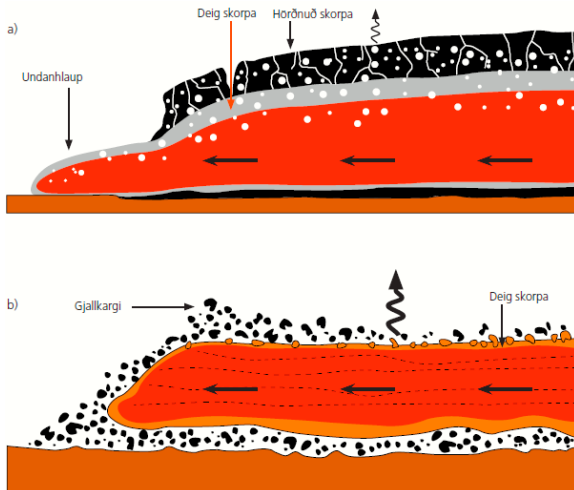
Figure 7. Melted lava flowing over existing land. The moving lava cools off from the surface and the bottom, creating highly fractured zones. Sólnes et al. 2013 (Þ. Þórðarson).

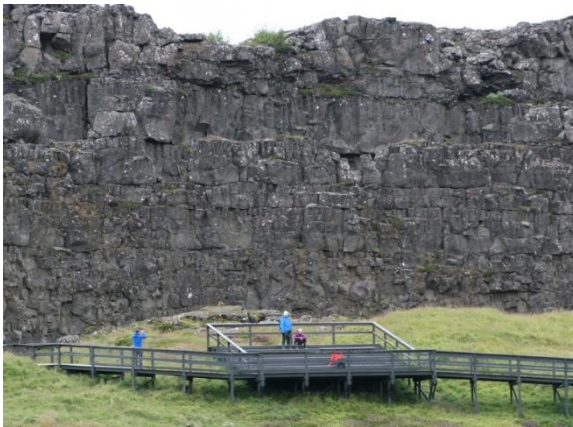
Figure 8. Cross section of typical Icelandic rock mass. Horizontal lines can be seen, forming boundaries between different lava layers. The layers are usually a few to tenths of metres in thickness.

Figure 8 shows a typical Icelandic lava stratum.

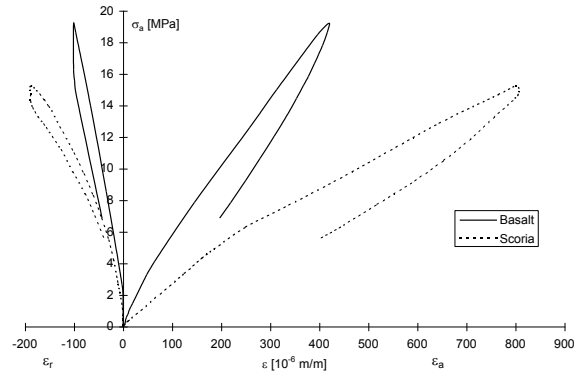
Figure 9. Stress-strain relationship of basalt and scoria in one-dimensional compression test. The indices *a* and *r* refer to the axial and radial directions, respectively.

Poisson's ratio from a uniaxial compression test of basalt and scoria is given in Figure 9 (Jóhannsson 1997). The samples were from the Hvalfjörður tunnel that was completed in 1998.

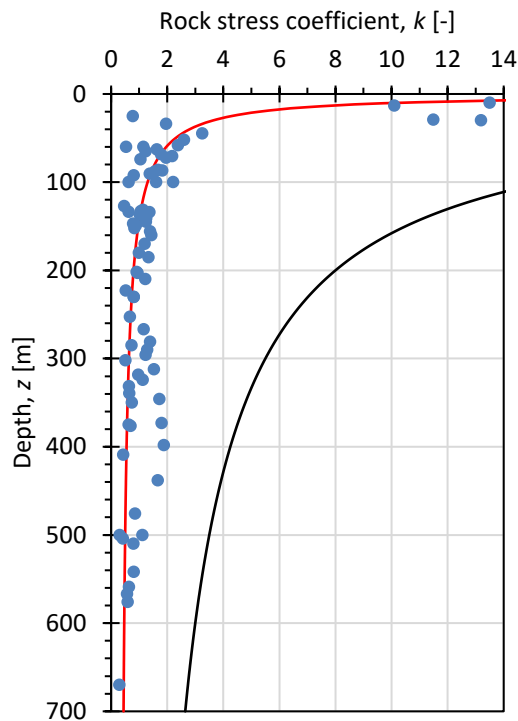
Figure 10. Rock stress coefficient as a function of depth from 17 stress measurement locations in Iceland. The black and red lines represent the upper and lower boundaries based on worldwide trends.

where σ_h , σ_H and σ_v are the minor and major horizontal and vertical stress components, respectively. The results of the rock stress coefficient measurements as a function of depth are shown in Figure 10.

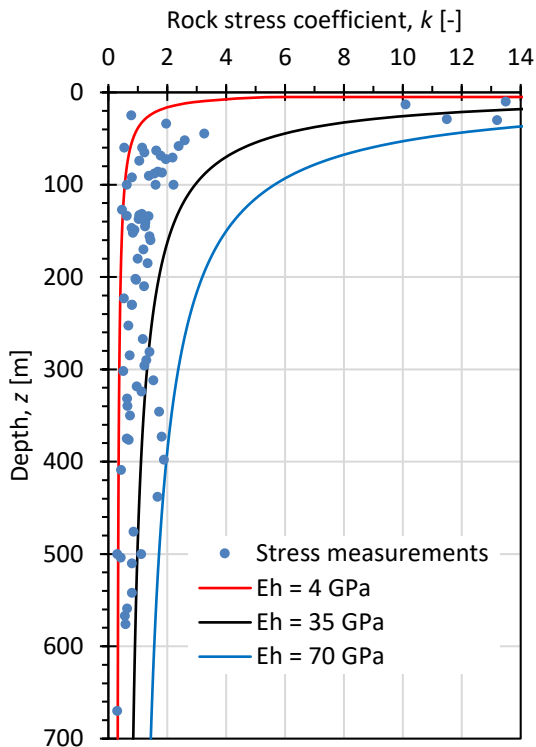
Figure 11. Rock stress coefficient as a function of depth. The lines represent three values of the horizontal deformation modulus.

Based on Figure 11 it is clear that the deformation moduli in the country lie mainly between 4 and 35 GPa, particularly at depths shallower than 300 m. At one location in the oldest bedrock (furthest away from the rift zone) a deformation modulus as high as 70 GPa was observed at depths greater than 300 meters.

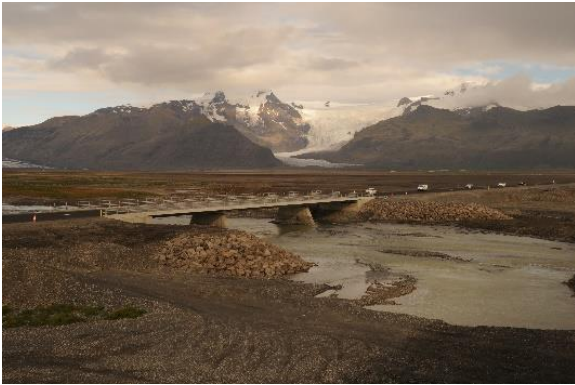
Figure 12. Thick sediments of loosely compacted sandy and gravelly soils in the forefront that have been piled up mainly in catastrophic events such as volcanic eruptions or glacial flow. Figure courtesy of by V. A. Ingólfsson.

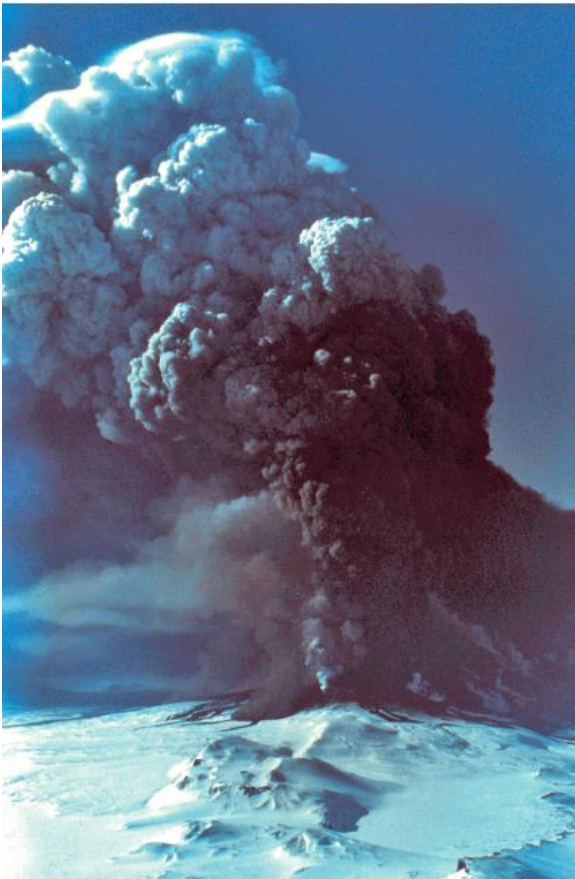
Figure 13. Mt. Hekla has created thick sediments of pumice in prehistoric eruptions. Sólmes et al. 2013 (Pálmi Hannesson/Sólarfilma).

Additionally there are soils that have been created in volcanic eruptions. Ash and pumice from Holocene volcanic eruptions can be found in some areas such as near some of the active volcanoes. Pumice is a lightweight and highly porous material of low strength. However, it also has good thermal properties and has been used in mortar or as thermal isolation layers in construction (see Figure 13).

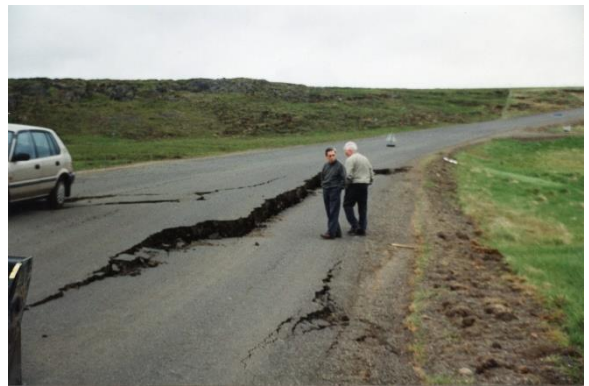
Figure 14. A pavement structure resting on a peaty subgrade in Holt, South Iceland that liquefied in the June 17, 2000 earthquake (M_w 6.5). Figure courtesy of V. A. Ingólfsson.

As in many northern European countries and in North America peat deposits can be found in some places in Iceland. The local climate, geography and environment favour bog and peat bog formations. The peat is usually lightly decomposed with a high void content and water content as high as a few hundred to one thousand per cent. Figure 14 shows a thin road structure resting on peaty land. The pavement structure was damaged in the June 17, 2000, earthquake (M_w 6.5) due to liquefaction of the underlying soft peat.

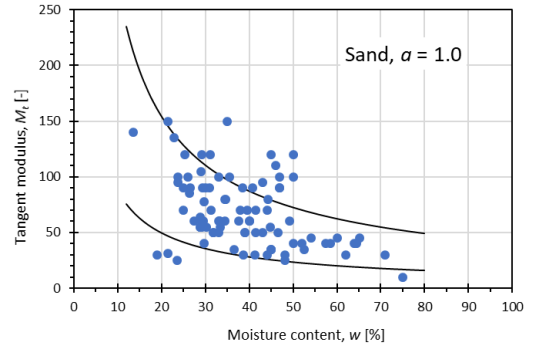
Figure 15. Tangent modulus M_t ($M_t = m\sigma_a$ as $a = 1.0$) of saturated sandy materials as a function of moisture content.

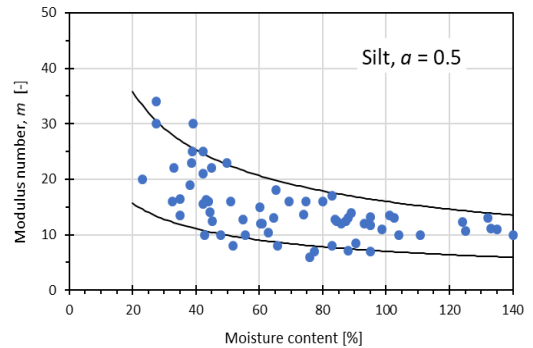
Figure 16. Modulus number m of saturated silty materials as a function of moisture content.

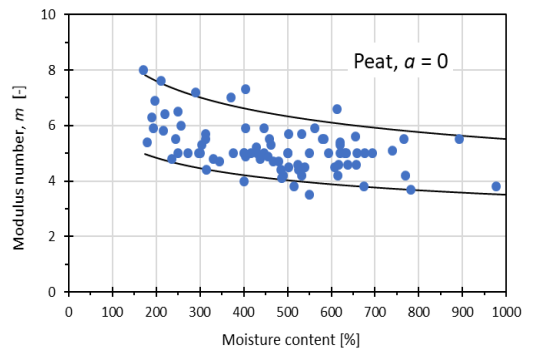
Figure 17. Modulus number m of saturated peat as a function of moisture content. Note that the moisture content is high, ranging from 150 – 1000%.

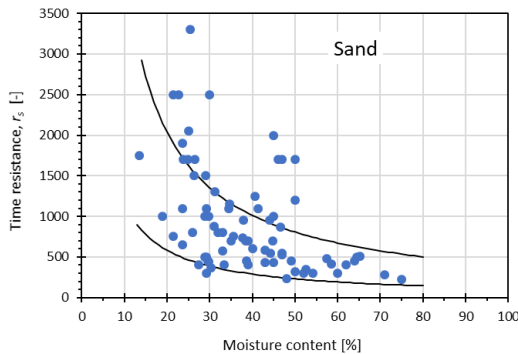
Figure 18. Time resistance coefficient r_s for sand as a function of moisture content.

The time resistance coefficient r_s for the three soil groups of sand, silt and peat are shown in Figures 18 – 20.

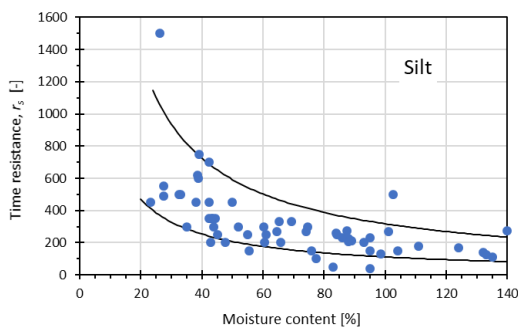
Figure 19. Time resistance coefficient r_s for silt as a function of moisture content.

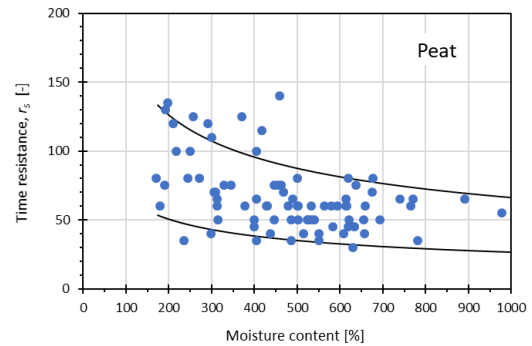
Figure 20. Time resistance coefficient r_s for peat as a function of moisture content. Note the high in-situ moisture content.

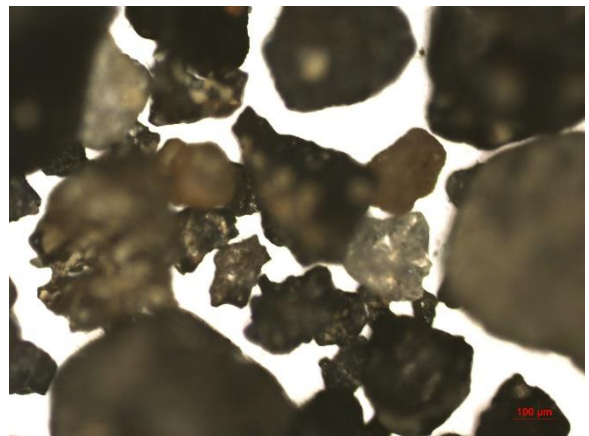
Figure 21. Magnified image of sand particles from a sample from test pit at the proposed Urridafoss HE project site (Wells 2009).

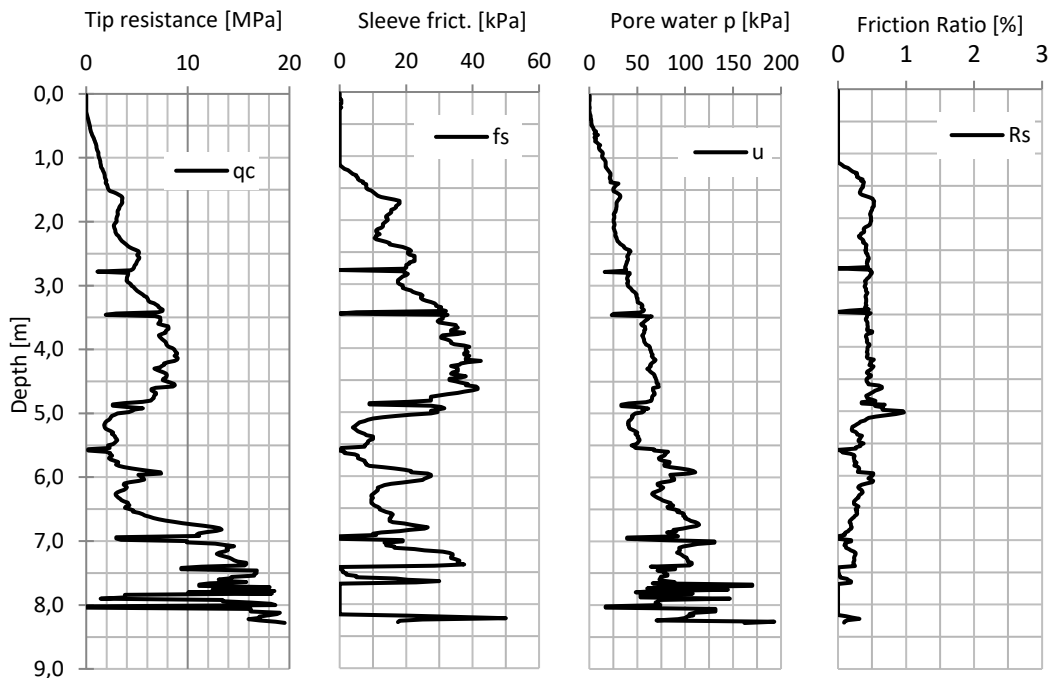
Figure 22. CPT results from a sandy site on the south coast close to Þorlákshöfn.

A Standard Penetration test (SPT) or Cone Penetration test (CPT) is further used. An example of CPT test results on the south coast at a location close to Þorlákshöfn is given in Figure 22. This is a site consisting of typical non-cohesive material with particle sizes ranging from silty particles and larger. Although the site deposit is very thick, the test was terminated at 8.3 m depth due to high resistance and consequently risk of damage to the CPT cone. This was probably due to the fact that the cone hit larger boulders that frequently occur in the local soils.

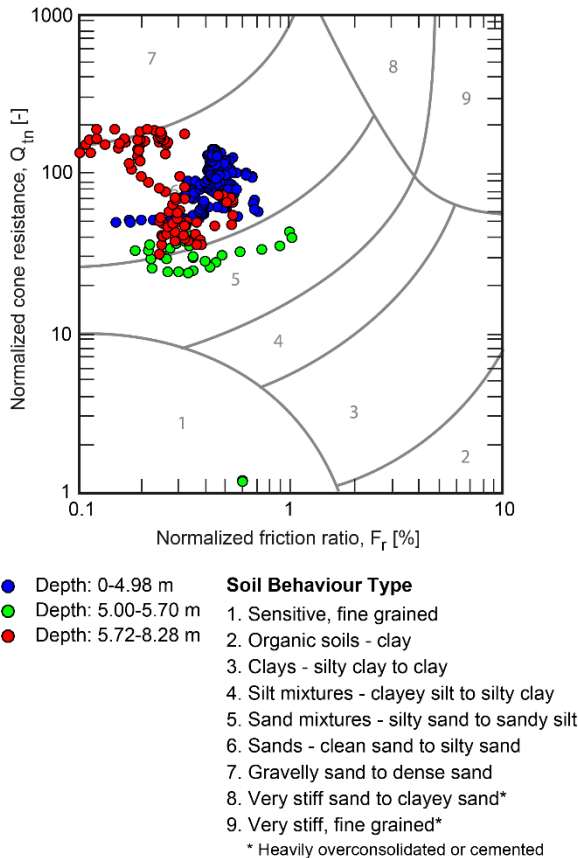
Figure 23. Normalized soil behaviour type (SBTn) chart with results of CPT measurements at the Þorlákshöfn site.

The results of the CPT measurements were then used to classify the deposit using the normalized soil behaviour type (SBTn) chart (Robertson 1990 and 2009) (see Figure 23). Most of the data points are classified as soil behaviour type 6 “sands – clean sand to silty sand”. However, some data points, mainly in the depth range of 5.0-5.7 m, are classified as type 5 “sand mixtures – silty sand to sandy silt”.

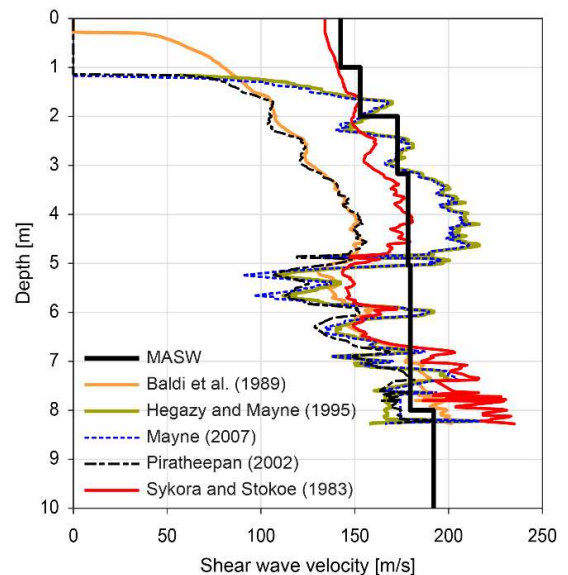
Figure 24. V_s -profiles for the Þorlákshöfn site predicted based on selected CPT- V_s correlations and obtained by MASW.

The CPT- V_s correlations in Table 3 were applied to the acquired CPT data. Figure 24 compares the V_s -profiles predicted based on the CPT- V_s correlation equations and the profile that was obtained by the MASW method.

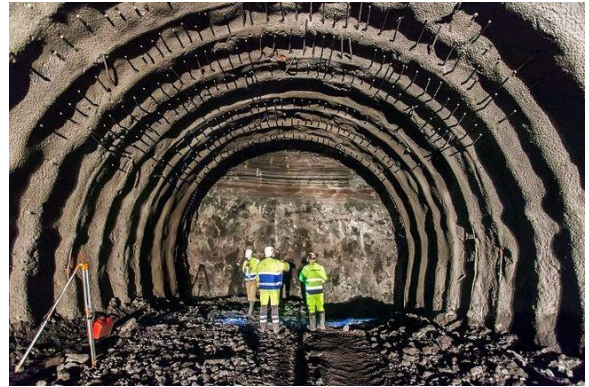
Figure 25. Lattice girders as a support in the 2-lane Vaðlaheiði road tunnel. Figure courtesy of B. A. Harðarson.

As of today, 14 road tunnels are part of the road network for a total of over 65 km of tunnels. Most tunnels include two lanes, giving a cross-sectional area of around 55 m². In addition, the total length of tunnels associated with hydropower utility is around 85 km with a cross-section area that varies from 6 to over 150 m² (Loftsson et al. 2005). Reinforcement is mainly designed according to the Q-system and on average around 3 rockbolts (3 m long) are used per metre for tunnels with ~8 m span (cross section around 54 m²) and 2.5 m³/m of fibre-reinforced shotcrete. If conditions are very poor shotcrete ribs or lattice girders provide additional support that has been proven to be both economic and durable. An example of using lattice girders is shown in Figure 25.

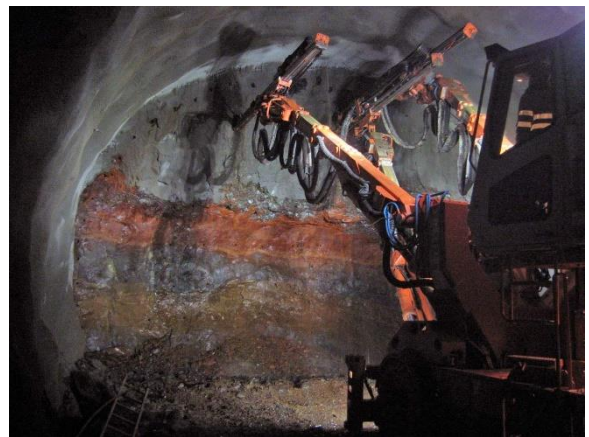
Figure 26. Drilling into a layered face at the Óshlíð road tunnel. Figure courtesy of B. A. Harðarson.

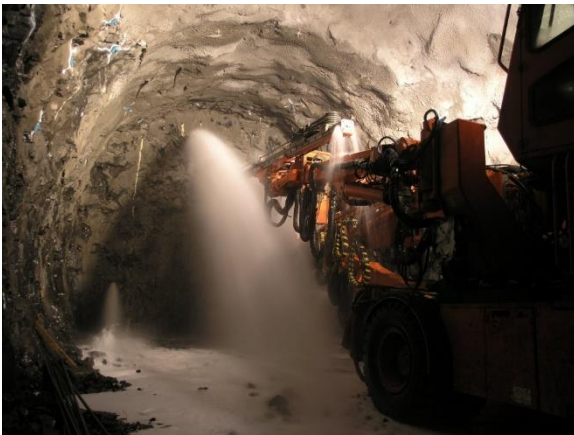
Figure 27. Water inflow into the Héðinfjörður tunnel. Figure courtesy of B. A. Harðarson.

The general low horizontal stresses and frequently fractured rock mass with irregular interbeds can lead to major water inflow into tunnels if excavation takes place under the groundwater table in the rock mass. This has happened in some tunnel excavations such as the Vestfjörður tunnel, Héðinsfjarðar tunnel and Vaðlaheiði tunnel, leading to delays and increased cost. An example of a water inflow into the Héðinsfjörður tunnel is shown in Figure 27.

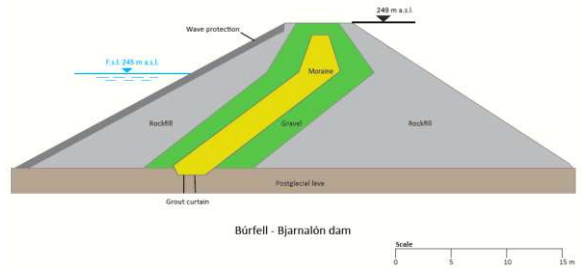
Figure 28. Cross section of the 5.9 km long and 33 m high Búrfell dam. The core consists of local loessic soil with alluvial gravel filter material and rock-fill shells. Figure courtesy of H. Bjarnason.

Iceland's numerous rivers are relatively short but with a large head and high run-off. This makes them very suitable for generating electricity. As of today hydropower accounts for almost 73% of all electricity production in Iceland (Bjarnason et al. 2019). Harvested electricity comes mainly from glacial rivers that have a seasonally varied flow rate. Water reservoirs with associated dams are therefore necessary. Today 29 dams in Iceland meet the criteria set by ICOLD (International Commission on Large Dams) for large dams. The oldest one is the Skeiðfoss dam, a concrete buttress structure constructed in 1945, and the most recent one is the Sporðalda dam commissioned in 2013 (Bjarnason et al. 2019). Most dams are earth-rockfill dams with a central impervious moraine core (23 dams), abutted by gravel filters, supporting fills and riprap for erosion and wave protection. Other types of large dams in Iceland are two concrete-faced rock fill dams (CFRD), one asphalt concrete-faced dam, one gravity dam and two buttress dams. A cross section of Búrfell dam is given in Figure 28.

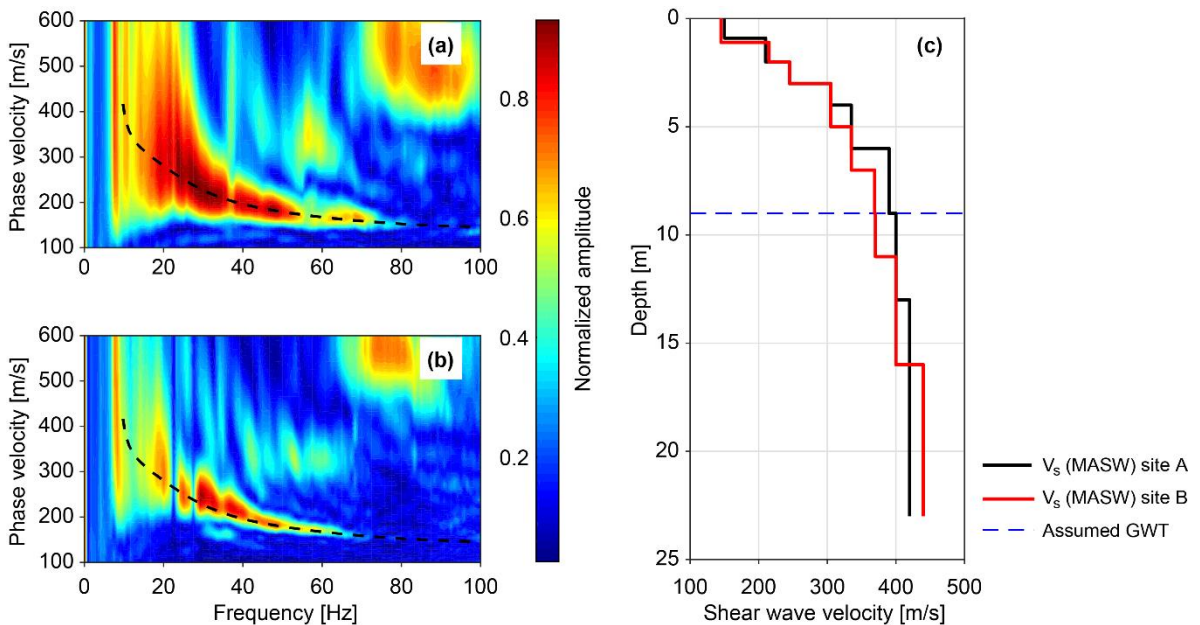
Figure 30. Results of MASW measurements at two locations on the crest of the Sultartangi dam (site A and B). Dispersion images obtained at Sultartangi site A by using survey profiles of length (a) 11.5 m and (b) 23 m. Estimated (c) shear wave velocity (V_s). The theoretical dispersion curve corresponding to the V_s -profile for site A is shown using a black dashed line in (a) and (b). The assumed location of the groundwater table (GWT) within the central core of the dam is shown using a blue dashed line in (c).

Results from the two MASW measurements at the Sultartangi dam are shown in Figure 30.

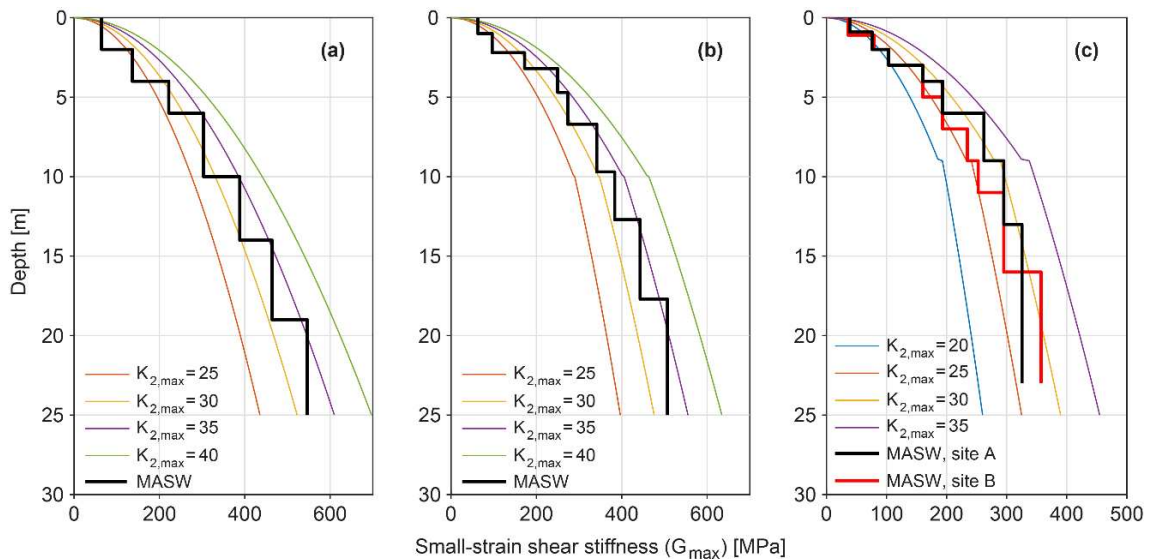
Figure 31. Comparison of empirical and experimental stiffness profiles for the (a) Sigalda dam site, (b) Sporðalda dam site and (c) Sultartangi dam sites. The empirical profiles were obtained by the model of Seed and Idriss using four different $K_{2,max}$ values.

empirical stiffness profiles for the Sigalda and Sporðalda dams. However, for the two test sites on the crest of the Sultartangi dam (where the central core was primarily made of loess), a slightly lower value of $K_{2,\max}$, or between 25-30, appears to provide the closest match. It can be further noted that a $K_{2,\max}$ in the range 25 – 40 is classified as very dense sand and gravel (Gazetas 1991).

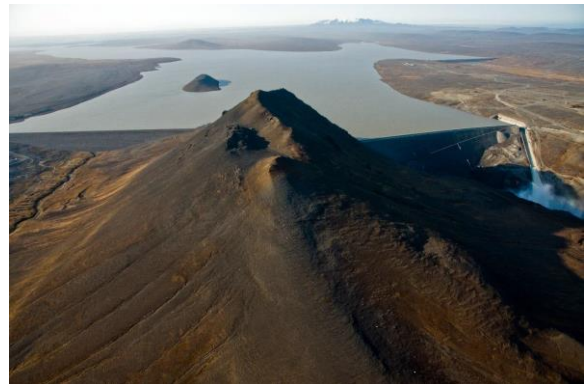
Figure 32. Hálslón Reservoir area; the Desjará Dam to the left, the Kárahnjúkar Dam and spillway in the middle, the Sauðárdalsstífla Dam to the right. The Brúarjökull Glacier (part of the Vatnajökull Glacier) in the background. Figure courtesy of H. Bjarnason.

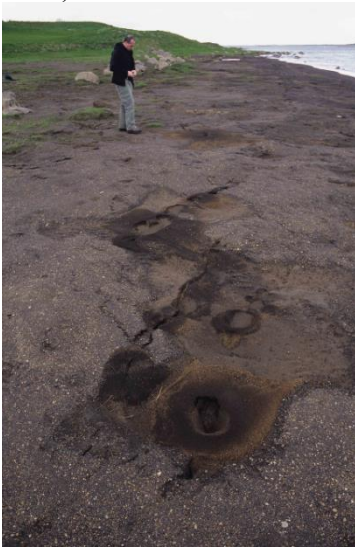
Figure 33. Sand boils (liquefaction) on the bank of the River Ölfus close to the epicentre of the 29 May 2008 $M_w 6.3$ earthquake. Figure courtesy of O. Sigurðsson.

In 2000 two earthquakes occurred within the SISZ with only a 4 day interval, on the 17th and 21st of June. Their magnitudes were both $M_w 6.5$. Eight years later on May 29, 2008, the third earthquake hit the area ($M_w 6.3$). Considerable damage was observed but no casualties (Einarsson 2008, Sigbjörnsson et al. 2009). Liquefaction was observed at Arnarbæli in the western part of the SISZ where sand boils were found on the bank of the River Ölfusá (Fig. 33).

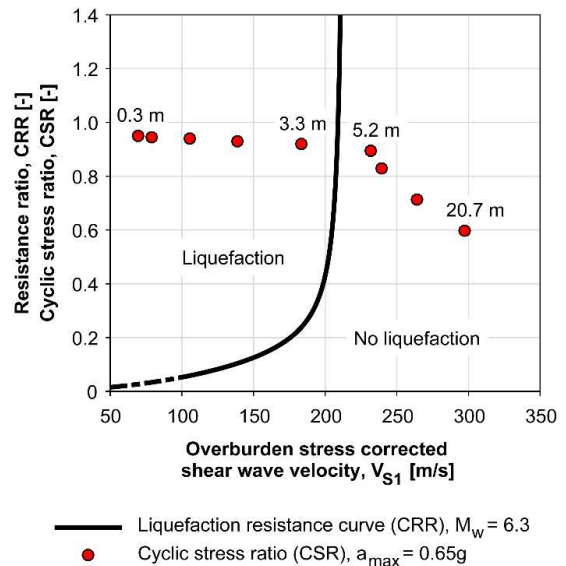
Figure 34. Liquefaction evaluation chart for the Arnarbæli site.

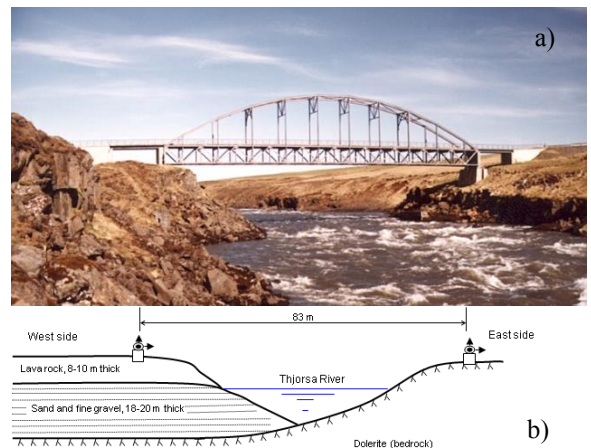
Figure 35. a) The Thjórská bridge. The left pier is resting on lava rock but the right pier is resting on bedrock. b) schematic cross section of the Thjórská bridge. Figure courtesy of B. Bessason.

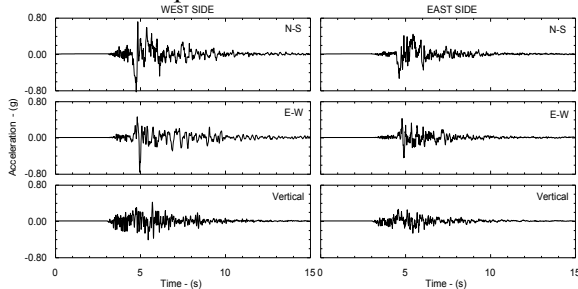
Figure 36. Recorded acceleration time histories at the Thjorsá bridge abutments. Figure courtesy of B. Bessason.

The observed peak ground acceleration (PGA) was 53% and 120% higher respectively in the N_S versus E_W components on the western abutment compared to the eastern abutment.

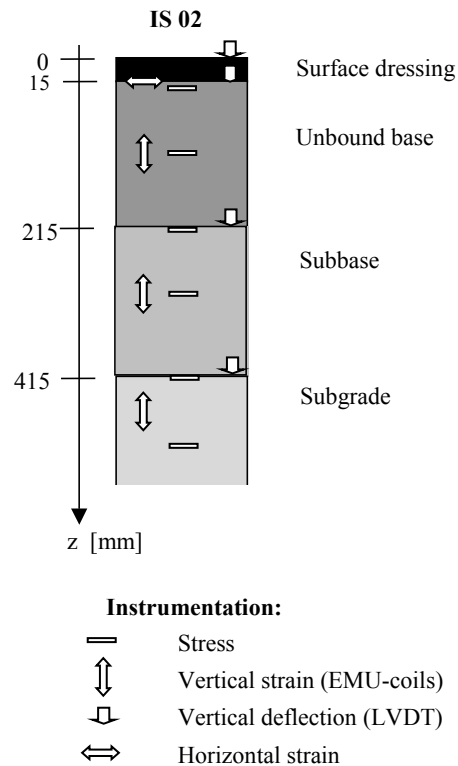
Figure 38. A thin pavement structure tested in an HVS testing facility.

Large parts of the Icelandic road network consist of thin flexible pavements with either a Hot Mix Asphalt layer or Bituminous Surface Treatments as the surface course over unbound base course and subbase layers. These structures are highly dependent on the performance of the unbound layers. Two typical structures were tested in a full scale Accelerated Pavement Testing (APT) using a Heavy Vehicle Simulator (HVS) testing facility for improving our understanding of the behaviour and the degradation of the structures under heavy loading. In the test over 500,000 rolling wheel load repetitions were applied (Erlingsson & Ingason 2004; Erlingsson 2005 and 2007). The structures were instrumented with deformation sensors, strain gauges and soil pressure cells. A cross section of one of the tested structures is shown in Figure 38.

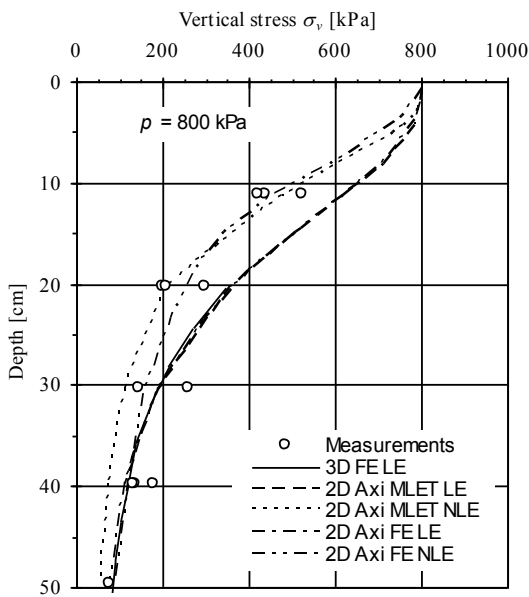
Figure 39. Induced vertical stress under the centre of a single tyre as a function of depth. The axle load was 120 kN and the tyre pressure 800 kPa. 3D = three dimensional analysis, 2D Axi = two dimensional axisymmetric analysis, MLT = Multilayer theory, FE = finite element, LE = linear elastic, NLE non-linear stress dependent elastic.

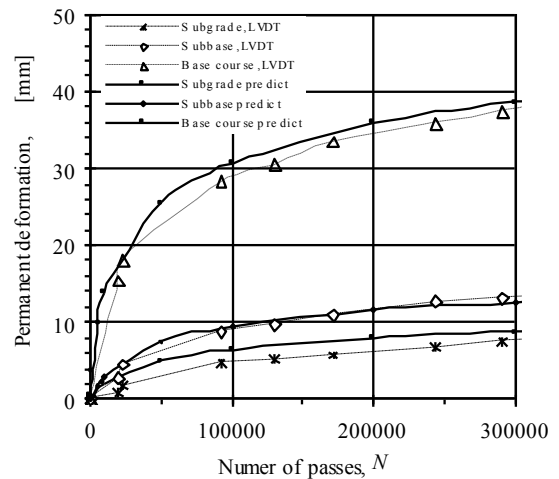
Figure 40. Rutting prediction versus measurements of permanent deformation development as a function of load repetition. The permanent deformation development of each layer is shown (subgrade, subbase, base course) as well as their sum (top line) which is manifested on the surface as rutting. LVDT = Linear Variable Deflectometer Transducers at the top of each layer, predict = prediction based on the numerical analyses.

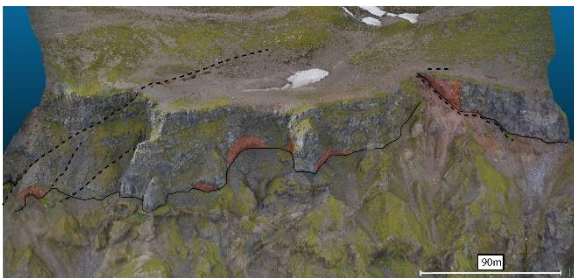
Figure 41. The Svínafellsheiði mountain slope. The solid black line marks the boundary between the topmost basalt layer and underlying móberg/hyaloclastite, the dotted black line shows the observed fracture, and the transparent red polygons shows the overhangs in the basaltic area. Figure courtesy of P. Sæmundsson.

One example of such mass movements has taken place at Svínafellsheiði due to the retreat of the Svínafellsjökull (part of the Vatnajökull Glacier). In 2014, over a 100 m long and up to 30 cm wide fracture in bedrock was discovered in the Svínafellsheiði mountain slope. The fracture is located at 850 m a.s.l. in the uppermost part of a 500 m high, almost vertical mountainside (Sæmundsson et al. 2019).

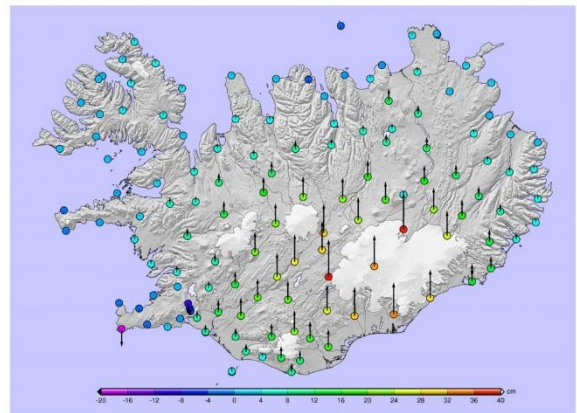
Figure 42. Vertical movements during the period 2004 – 2016 observed by GPS measurements. Figure courtesy of G. Valsson.

displacement continues to take place on the Iceland plateau. Figure 42 shows the uplift measurements in Iceland during the period 2004 – 2016. On average the land rise is about 1 cm per year, but with high spatial variations (Valsson 2019). These vertical movements affect the design of sea portals and other near-coast structures. In the south-east the uplift is about 3.5 cm/year and probably to a large extent due to the large mass reduction of the Vatnajökull icecap. In other areas hardly any uplift has been measured or even sinking movements observed. For the capital area an average sinking movement of 0.6 mm/y has been observed during these 12 years. For the period 1993 – 2004 the sinking movements were about 2 mm per year.

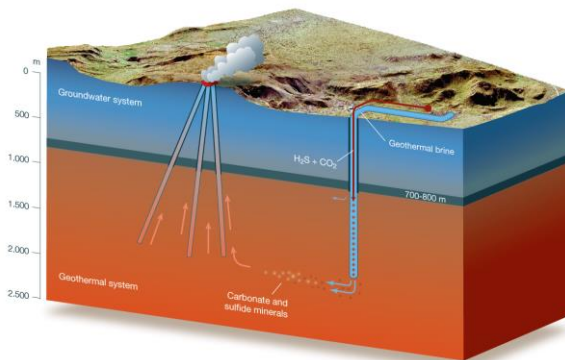
Figure 43. Schematic cross section of the CarbFix2 injection site. Gas-charged and effluent water are injected separately to a depth of 750 m and then allowed to mix until they enter the aquifer at a depth of 1900–2200 m. This combined fluid flows down a hydraulic pressure gradient to monitoring wells. Figure courtesy of S. R. Gislason.
