The paper was published in the proceedings of the 17th African Regional Conference on Soil Mechanics and Geotechnical Engineering and was edited by Prof. Sw Jacobsz. The conference was held in Cape Town, South Africa, on October 07-09 2019.

Preparations for field testing for the performance validation of piled wind turbine foundations in expansive clays

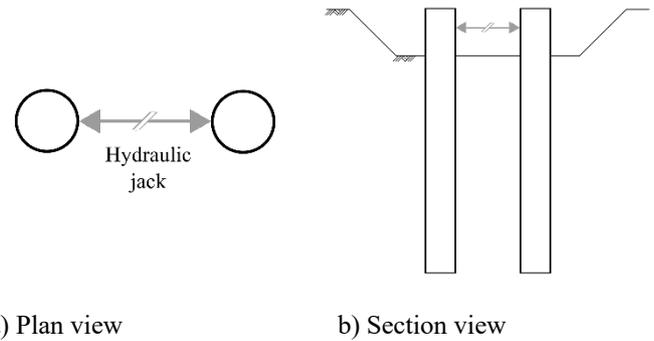
The pile load testing will be carried out by using a hydraulic jack and jacking two test piles against each other as shown in Figure 1. Each pile is monitored individually; in this way, two results are obtained from each test.

Figure 1. Layout of lateral pile load tests (not to scale)

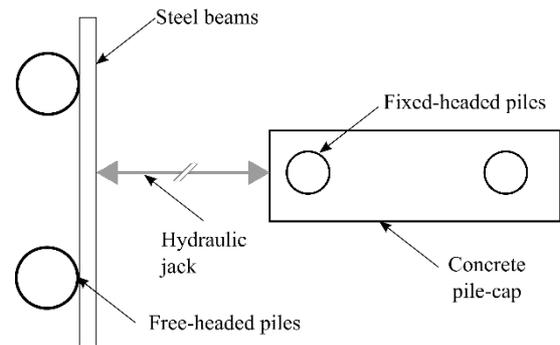
An additional test configuration is planned as shown in Figure 2 to test the pile and soil response for a fixed-headed pile as would be expected in the base of a wind turbine with a pile cap connecting all the piles. This will allow the comparison of the behaviour of the free head and fixed head piles.

Figure 2. Layout of grouped lateral pile load tests (not to scale)

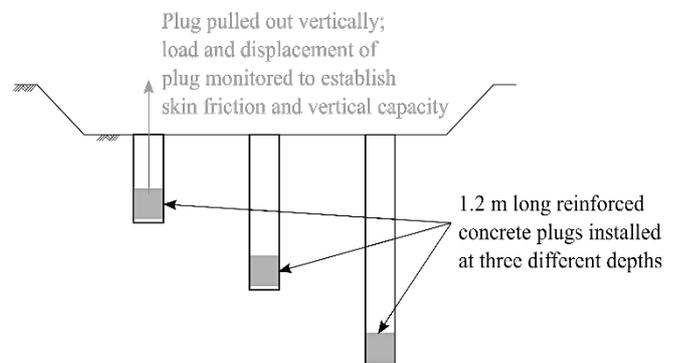
The vertical plug pull-out tests are planned to ascertain the maximum transfer of load from the heaving soil to the pile shaft at different depths in the profile at both NMC ('dry') and under soaked ('wet') conditions. The intention of these tests is to determine whether the shaft resistance will increase due to the increased lateral stress or will reduce due to softening of the clay on wetting. The proposed test set-up is shown in Figure 3. Three plugs at different depths will be tested to get an indication of the variance in the shaft resistance with depth. These results will enable the determination of the maximum pull-out forced exerted on the pile.

Figure 3. Schematic configuration of vertical plug-pull tests (not to scale)

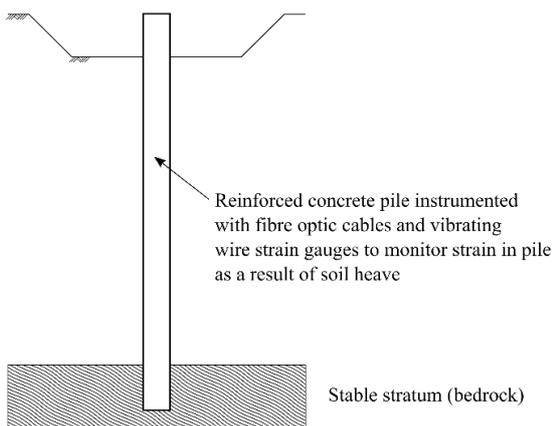
Two instrumented piles will be installed; a schematic example of one is shown in Figure 4. One pile will be subjected to accelerated heave by wetting the surrounding soil, and the second left to swell naturally and in response to seasonal moisture content changes. The strains in the pile will be measured using fibre optic cables and vibrating wire strain gauges cast in the pile.

Figure 4. Layout of grouped lateral pile load tests (not to scale)

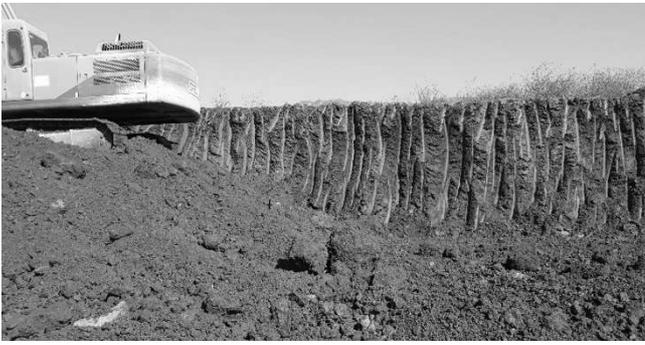
A visit was conducted to a potential site at the AttaClay mine which extracts attapulgite and bentonite clays by shallow surface mining. These minerals are processed and sold for use in applications such as binders, cat litter and dam sealing. A photograph of the clay quarry wall is shown in Figure 5; the excavator teeth mark on the sidewall give an indication of the stiffness of the clay profile. Evidence of cracking in buildings on site, an example of which is shown in Figure 6, indicates the expansive nature of the soil and thus the suitability for our project. Boreholes that had been drilled by the mine to 9 m depth indicated a clay profile to at least this depth.

Figure 5. Attapulgite and bentonite quarry wall at the AttaClay mine.

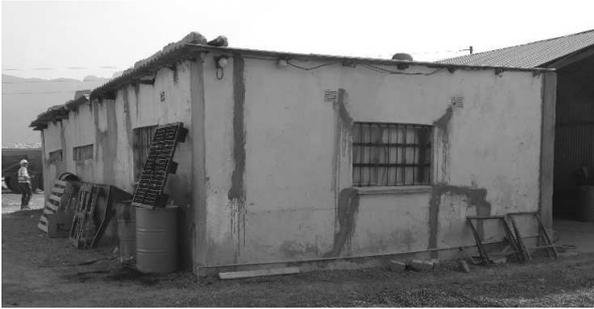
Figure 6. Cracked buildings on site showing evidence of expansive clays

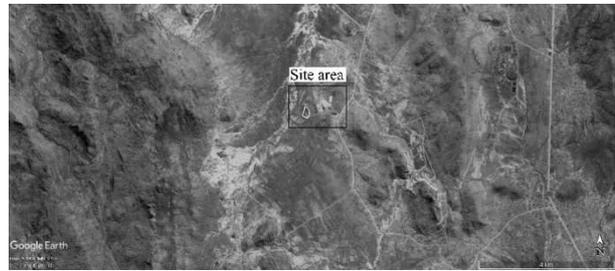
Figure 7. Google Earth image of field-testing site location

A map of the site location is shown in Figure 7 with the corresponding lithology from the Council for Geoscience (2019) geological map shown in Figure 8. A close-up of the proposed field-testing area is shown in Figure 9.

These figures show that the site is located in an alluvial plain between two formations of the Rustenburg Layered Suite of the Bushveld Complex: the mountains of the Dsjate Subsuite to the west and outcrops of the Dwars River Subsuite to the east.

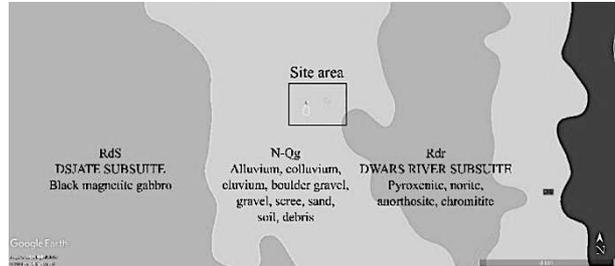
Figure 8. Overlay of geological zones (Council for Geoscience 2019) over site location

As described by Williams et al. (1985), the expansive clay identified on site is likely to be a combination of residual soils formed from the weathering of the Rustenburg Layers Suite and active material transported from the weathering of the adjacent basic igneous rocks.

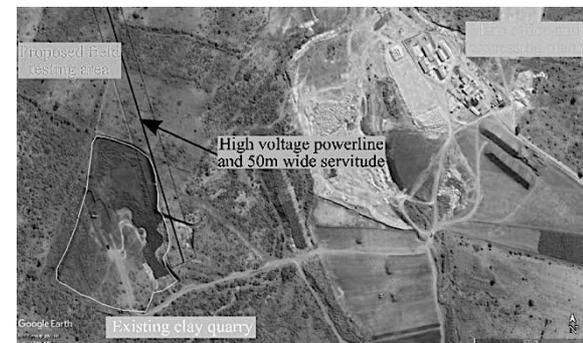
Figure 9. Existing clay quarry and mine area showing proposed field-testing area

Two tests pits were excavated at the end of the dry season to describe the soil profile in the proposed testing area north of the existing quarry (see Figure 9).

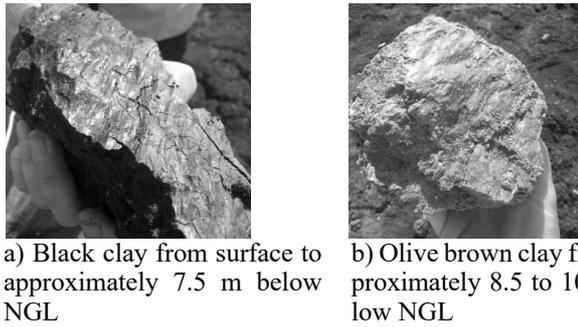
Significant fissuring and slickensiding was noted in all the clay material encountered in both test pits. Figure 10 shows photographs of blocks of clay removed from the spoils of the excavations; the smooth, shiny surfaces (slickensides) in the clay are evidence of movement along these planes due to cycles of wetting and drying confirming the expansiveness of the material.

Figure 10. Example of slickensided blocks of clay removed from the spoils of the test pit excavation

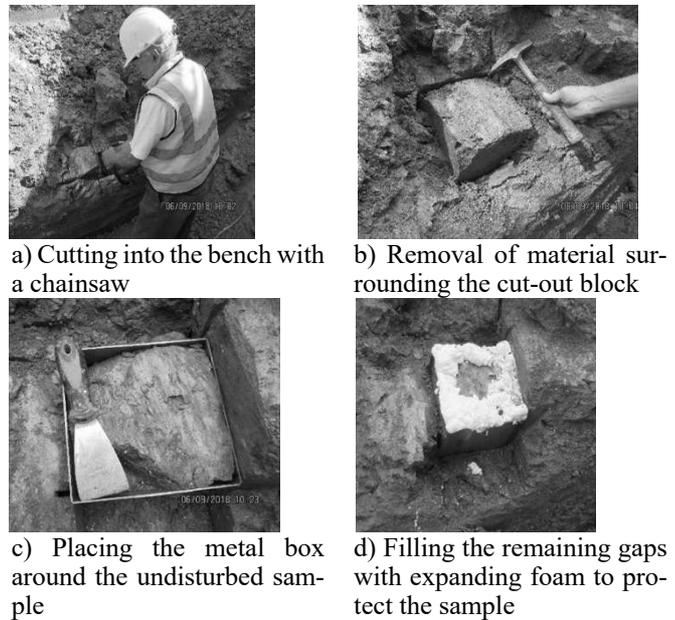
In TP1, the test pit was widened to create a bench about 1 m off the intermediate base of the pit. The chainsaw was used to cut into the soil from the top, loose material was removed, and the metal box was placed over the sample. Expanding foam was used to fill the gaps and secure the sample in place; the base of the sample was broken off to remove the block from the test pit. Whilst this method worked relatively well, the stress relief from the removal of the overburden material above the blocks caused the fissures to open, and several attempts were required to get a reasonably full sample box.

Figure 11. Removal of a block sample from the olive brown clay in TP1

Block samples were retrieved from the test pits to be used for further laboratory tests to investigate the strength and stiffness of the material. Due to the fissured nature of the material, these block samples could not be taken in the conventional manner where the material around the desired block is removed using a geological pick. A chainsaw was used to cut into the stiff clay, and the aim was to place a 200 x 200 x 200 mm metal box into the created cuts and remove the now structurally protected block sample. The process of cutting and removing the block samples is shown in Figures 11 and 12 for the samples of the olive brown and black clay taken from TP1 and TP2 respectively.

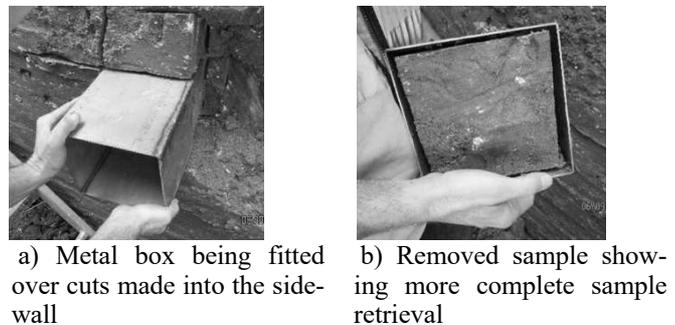
In an attempt to obtain better block samples in the second test pit, the chainsaw was used to cut directly into the pit sidewall as shown in the image sequence in Figure 12. This proved more successful, and once the metal box was in place, wedges of soil surrounding the sample could be removed allowing the sample to finally be removed.

Figure 12. Removal of a block sample of the black clay from the test pit side wall in TP2

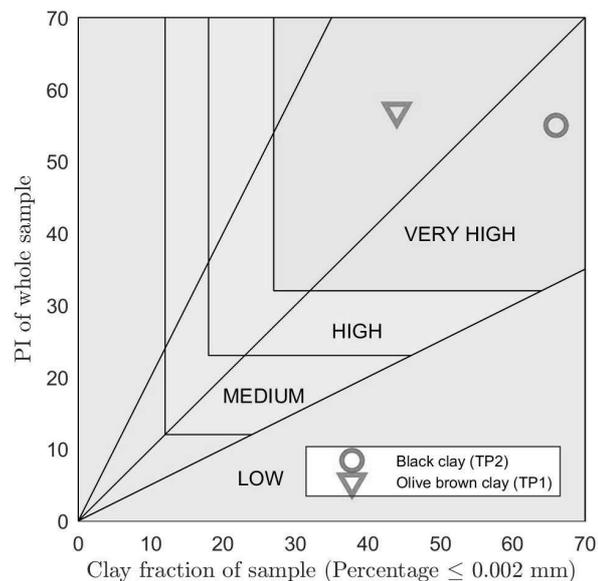
Figure 13 presents the activity chart as per Van der Merwe (1964) indicating potential expansiveness, based on the plasticity index (PI) of the whole sample and clay fraction. Both samples fall well within the very high expansive region, primarily due to the high PIs. The black clay has a significantly higher clay fraction than the olive brown clay, although the PIs are similar. This confirms the suitability of the material on site for the proposed field-testing.

Figure 13. Expansive potential of the clays on site plotted according to the activity chart of Van der Merwe (1964)

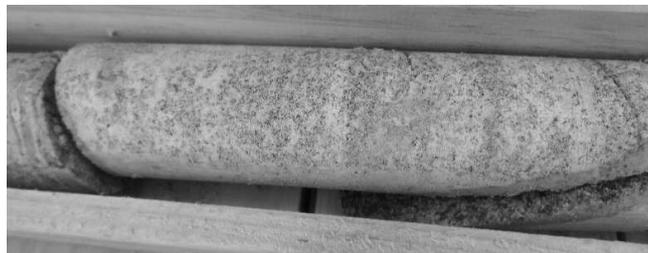
A thin transition was observed from the residual soil into the bedrock. The bedrock was described as hard to very hard rock, either norite or anorthosite; a photograph of a portion of the core is shown in Figure 14.

Figure 14. Portion of the residual norite core from 13.33 -14.02 m (BH1)
