# Earthquake Vulnerability and the State-of-the-Art of Hybrid Structural Reinforcement and Soil Improvement Methods for Non-Engineered Structures

S. Ortiz-Palacio<sup>1</sup>, S.J. Ibáñez<sup>2</sup>, V. López-Ausín<sup>3</sup>, J.A. Porres<sup>4</sup>

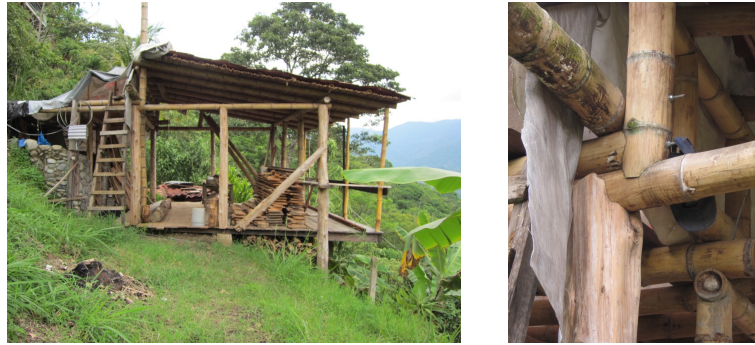
Figure 1. Bamboo-framed house under construction in Cañas (Guanacaste region), in Costa Rica, precariously adapted to a steep topography (Photos by V. López-Ausín)

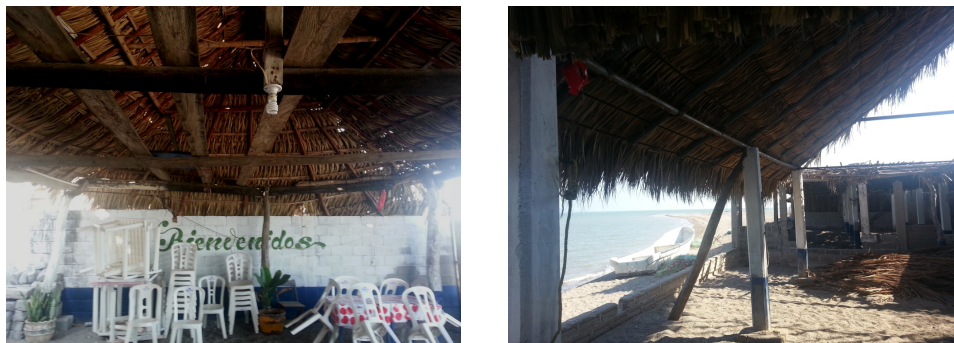
Figure 2. Left: Interior of a timber-roofed building with randomly mixed RC and timber columns and a single unreinforced masonry wall. Right: improvised wooden posts against poorly connected RC columns of the same building (Photos by S. Ortiz-Palacio)

As another example, we may mention the coastal city of Juchitán de Zaragoza, in the State of Oaxaca (Mexico). Although the region is influenced by the subduction boundary of the Cocos and North American plates and its seismic activity is considered to be among the strongest in the country, with frequent earthquakes (BC Consultores, 2012), in Juchitán de Zaragoza these events have more spaced in time. Although historically the city has been struck by some notable seismic events (as the recent 1999 Oaxaca earthquake, Mw 7.5 (Bravo et al., 2004) or the 2008 Unión Hidalgo earthquake, Mw 6.6 (Alvarez-Ramirez et al., 2012), which epicentre was just 50 km far from Juchitán de Zaragoza), many residents confessed little or no concern at all for earthquake hazards when questioned by the authors. As no casualties and seldom structural damage was reported, the seismic hazard is not among the priorities of the residents and, thus, almost none seismic resilient buildings can be found across the city, as the one shown in figure 2, supported by liquefactable sand deposits:
