## Model Tests on Sand Eruption from the Liquefied Ground through the Gap of Pavement

J. Kuwano<sup>1</sup>, R. Kuwano<sup>2</sup>

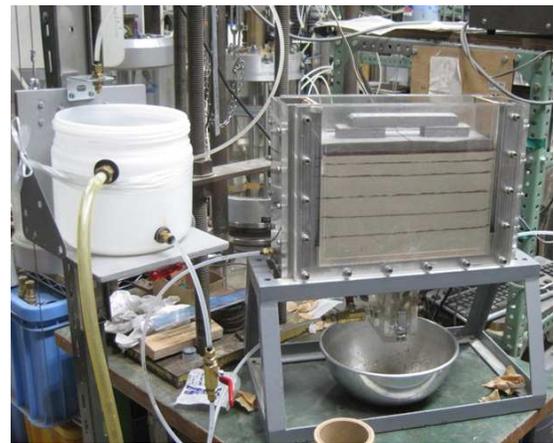
Figure 3. Schematic figure and photo of apparatus.

A 1g prototype scale model around the gap of pavement was prepared in a soil chamber of 30cm long, 8cm wide and 20cm high, as shown in Figure 3. Water was supplied from the bottom of the model ground simulating upward seepage flow caused by liquefaction. Hydraulic gradient of the water supply could be adjusted by the elevatable water tank connected to the bottom of the soil chamber. The model ground surface was covered by an acrylic lid having a 2mm wide opening, from which boiling sand could be erupted. Water table was adjusted by draining the water from the sidewall of the chamber. Water was slowly penetrated and the model ground was saturated in advance. Then the water tank was elevated at 5 cm intervals to apply additional hydraulic gradient to generate liquefaction in the ground. Sand grains lost effective stresses and upward seepage flow caused sand eruption through the opening in the lid. After the test, water in the model ground was drained for more than 24 hours and penetration resistance was measured at five locations using a 3mm diameter needle.
