# The effects of compensation grouting on segmental tunnel linings

S.W.Lee, G.R.Dasari, R.J.Mair, M.D.Bolton & K.Soga  
*University of Cambridge, UK*

**ABSTRACT:** The effectiveness of compensation grouting in mitigating surface settlements due to tunnelling subsidence has been widely proven. However, excessive grout pressures may cause deformations of tunnel linings and heaving of the ground surface. At the London Docklands Light Railway Lewisham Extension tunnelling site, the contractor has carried out an extensive monitoring programme to measure ground and building movements due to tunnelling works incorporating compensation grouting. The movements of a building and the tunnel lining due to tunnelling and compensation grouting are presented. Preliminary results from finite element analyses simulating the influence of compensation grouting are also presented.

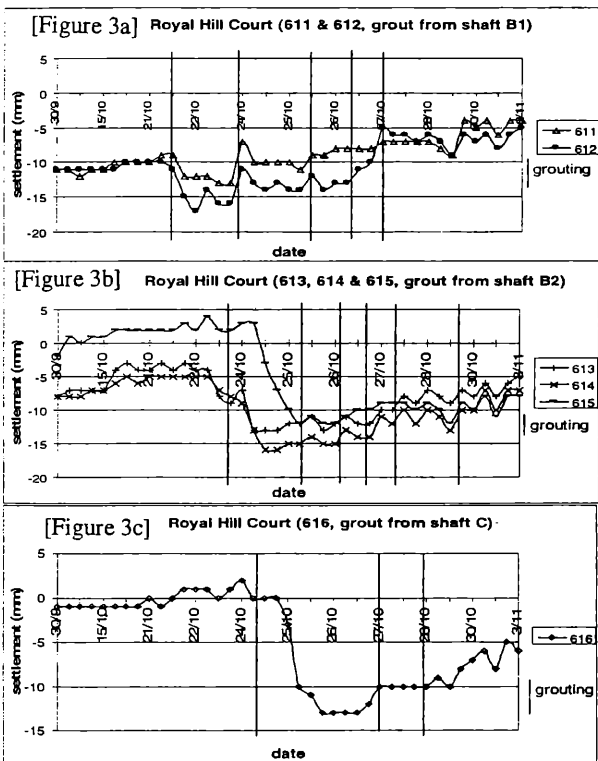
Figure 3. Settlement at Royal Hill Court before and after compensation grouting.

The settlements of six points (611- 616) located on the edge of the building are shown in Figure 3. The solid vertical lines in the Figure indicate the onset of grouting, each episode taking approximately half a day. The effectiveness of compensation grouting in reducing settlements can be seen. The grouting from shaft B1 lifted the building by about 11mm. Similarly, grouting from shafts B2 and C caused an average lift of 7mm.

In general compensation grouting has limited the final settlement to less than 8mm for all points concerned. Hence, the compensation grouting has resulted in the construction of the tunnels with building settlements less than 15mm, and the angular distortions less than 1:1000, thereby satisfying the specified design criteria.

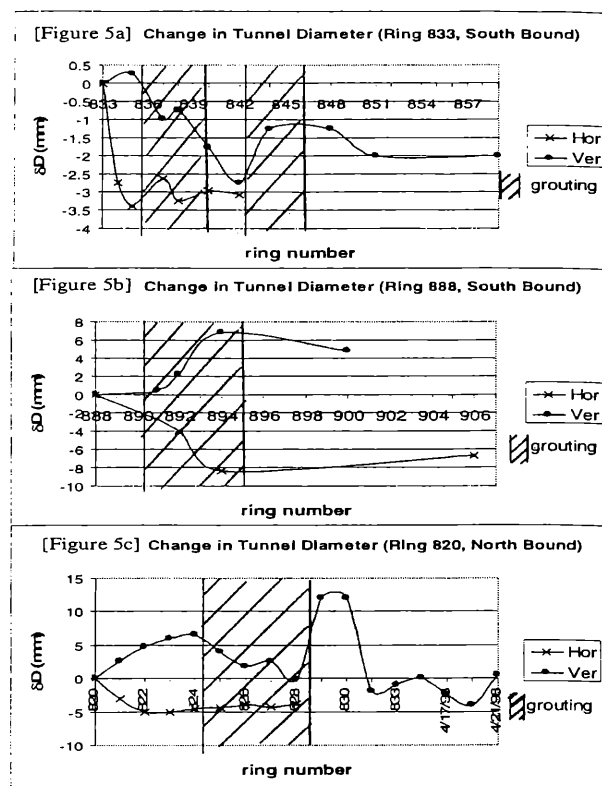
Figure 5. The effect of compensation grouting on tunnel lining.

Examples of the effect of compensation grouting on the tunnel lining are shown in Figure 5. The hatched zones indicate the grouting periods. The Figure shows the changes of vertical and horizontal diameter of selected tunnel rings as the tunnel face

advances away from the ring and new rings are erected. The numbers of the new rings erected are shown on the x-axis. The tunnel rings selected are Ring 833 (southbound), Ring 888 (southbound) and Ring 820 (northbound), in all the Royal Hill Court area.

Following the first grouting episode, the vertical diameter of ring 833 shortened by 1.75mm and the horizontal diameter elongated by 0.5mm, approximately. However, after the second grout injection the vertical diameter increased. No information on the horizontal diameter change is available following the second grout injection.

For Ring 888, compensation grouting resulted in an increase of the vertical diameter and shortening of the horizontal diameter. In other words, the lining deformed in a vertical elongation mode. This is contrary to what is expected.

Similar to Ring 833, Ring 820 of the northbound tunnel depicted the expected type of lining deformation, i.e. vertical squatting, when grouting was applied. The decrease in vertical diameter was 4.8 mm and increase in horizontal diameter was 1.1 mm.

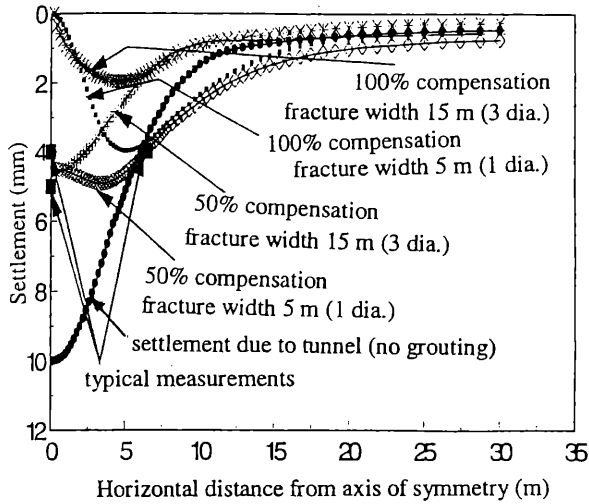
Figure 8. Predicted compensated settlement with grouting.

Two analyses were carried out, with two fracture widths 5m and 15m corresponding to one and three tunnel diameters, respectively. In each case grouting pressure was increased until the maximum surface settlement had been fully compensated. The pressure required to fully compensate the settlement in each case was very close to the initial total vertical pressure at the grout level. The surface settlement profiles, for the 5m and 15m fracture width, due to tunnelling and compensation grouting, are shown in Figure 8. Two profiles correspond to 50% of compensation and two more correspond to full compensation. The measurements from the RHC are also included in this Figure. There is a reasonable agreement between measured settlements and FE results with 15m fracture width assuming 50% compensation. It can be seen that 5m fracture width predicted a concentrated settlement profile. This is unfavourable as it will result in more angular distortion. The angular distortion due to 15m fracture width is smaller. Therefore, it is better to grout over a wider area.

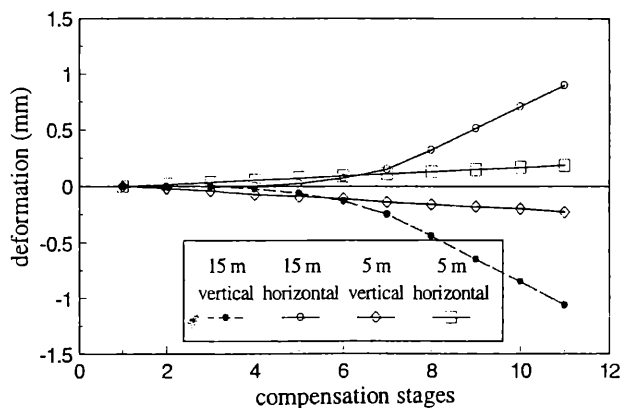
Figure 9. Predicted vertical and horizontal deformation due to compensation grouting.

The lining was modelled as an elastic material with reduced integration elements. The predicted horizontal and vertical movements of the tunnel lining due to compensation grouting are shown in Figure 9. The vertical diameter of the tunnel reduced and the horizontal diameter increased. In other words, the lining deformed in a vertical squatting and a horizontal elongation mode. The magnitude of movements is quite small compared to field measurements. It may be that field measurements included effects of the tunnel build which were not modelled in the FE analyses.
