# Tunnelling underneath a large diameter water main in Shanghai

Jinyuan Liu<sup>1</sup> and Yujun Wen<sup>2</sup>

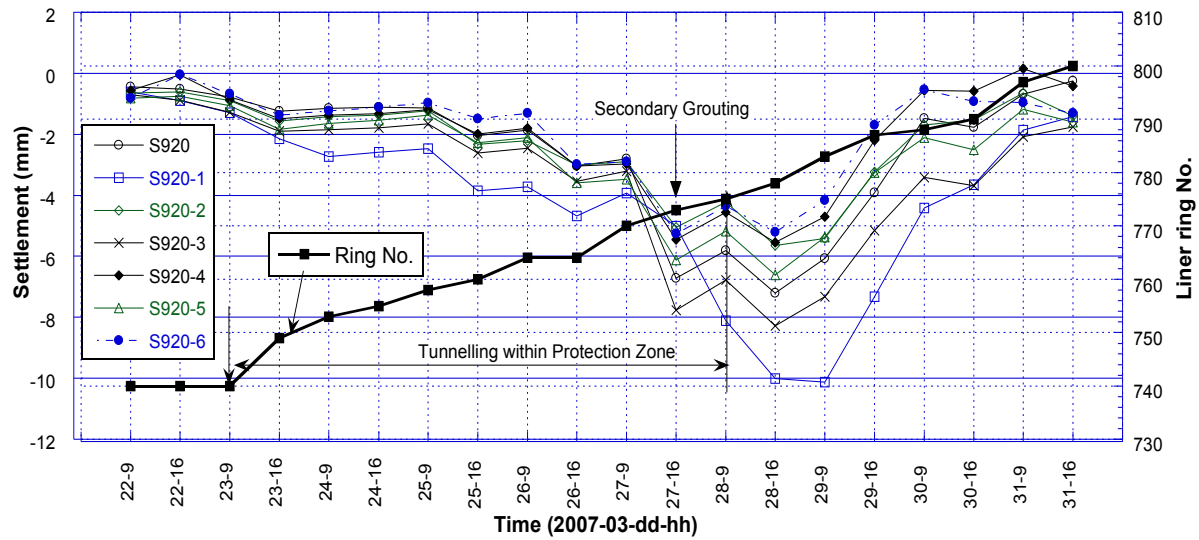
Figure 2. Surface settlement during western-bound tunnelling

There were seven surface settlement targets at the water main location, as shown in Fig. 1. The settlements of these targets are shown in Fig. 2 along with the construction activities. It can be found that the surface settlement accelerated significantly after the TBM pass-by. These settlements were reduced by the injection of secondary grouting.

The time and amount of annular grouting were adjusted based on the settlement measurement. The grouting pressure was controlled at approximately 0.3 MPa with an amount of 3.3~3.6 m<sup>3</sup> per ring, which was about 200~220% the annulus void between the mined diameter and the external diameter for each ring. After the shield tail pass-by, the secondary grouting was conducted inside the tunnel at every three to five rings to seal water and reduce ground settlement. The chemical grout ingredients were cement: water: sodium silicate mixed at a 1.0: 0.5: 0.03 ratio by weight to provide a quick hardening and a low shrinkage.

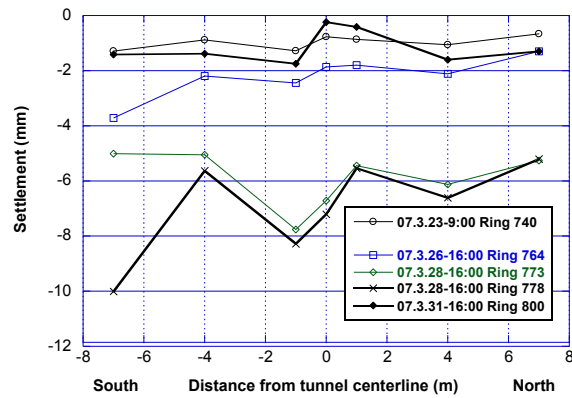
Figure 3. Surface settlement at the water main location

The surface settlement curve on the cross section perpendicular to the tunnel alignment is shown in Fig. 3. An asymmetrical settlement trough was developed at the ground surface with higher settlements were measured on the south side closer the eastern-bound (EB) tunnel. It is believed that the soil disturbance due to the earlier drive of EB tunnel contributed to this asymmetrical settlement trough. The maximum ground surface was measured before the start of secondary grouting. The secondary grouting significantly reduced the ground surface settlement, as shown by two heavy lines before and after secondary grouting. An upward ground movement of 8 mm was measured due to this secondary grouting.

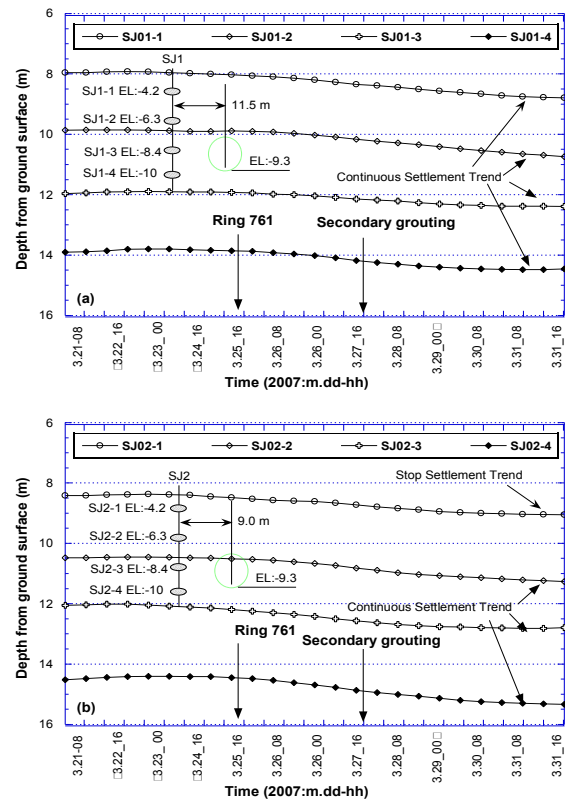
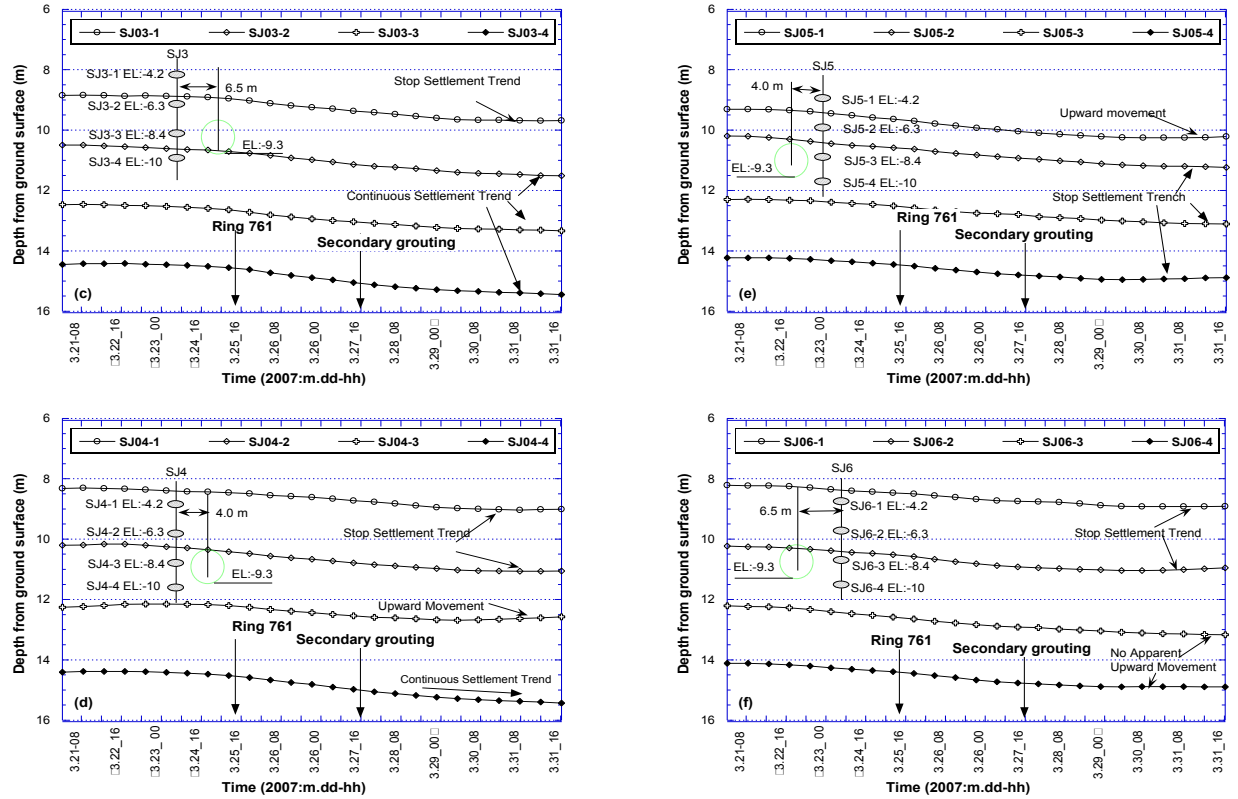
Figure 4. Subsurface soil settlement around the water main during tunnelling (Note: The magnitudes of settlement are multiplied by 10 in the figure)

The deep soil movement are shown in Fig. 4, where the magnitudes of ground movements are multiplied by 10 to show clearly their trends. It can be found that the rates of settlement in two boreholes immediately adjacent to the water main, SJ04 and SJ05, were reduced after secondary grouting, especially the two depths above the water main elevation. i.e., the readings at two depths of approximately 8 m and 10 m showed that the settlements were stopped due to secondary grouting, while other locations did not show this upward movement trend, but most cases the settlement rates were reduced after introduction of secondary grouting. The reasons for these different responses are believed to be the poor soil compaction during trench backfilling for water main installation. In addition, the secondary grouting has more effect on soil with lower overburden pressures.

There were eight borehole extensometers, named from SJ01 to SJ08, installed along the WB tunnel alignment near the water main. The plan and sectional views of these boreholes are schematically shown in Fig. 1, where the extensometer rings were embedded at depths of approximately 8, 10, 12, and 14 m from the ground surface. Two boreholes, SJ07 and SJ08, were damaged during construction and only the rest six boreholes provided readings during tunnelling.

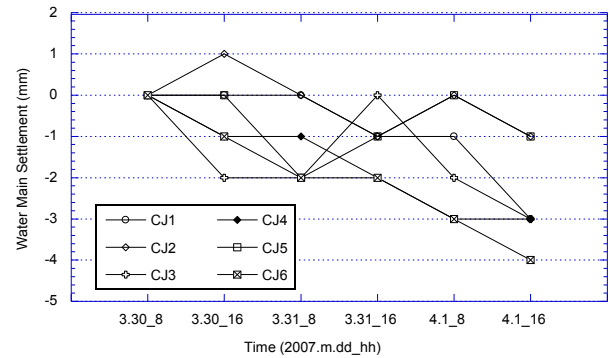
Figure 5. Soil movement in the vicinity of the water main

There were only limited readings available on soil movement immediately above the water main due to the private ownership of these readings. These soil settlements reflect approximately the settlement of water main itself. These settlements are shown in Fig. 5 after pass-by of TBM (Lu at el. 2007). It can be found that the settlement of the water main was approximately within 4 mm based on these measurements. The water main settled gradually after TBM pass-by due to dissipation of excess pore pressure generated mainly due to grouting.
