# Red Deer Pipeline River Crossing- Geotechnical & Geophysical Assessments

Amer Awad, PhD, P.Eng., Dan Parker, P.Geol.  
WorleyParsons, Calgary, Alberta CANADA

## ABSTRACT

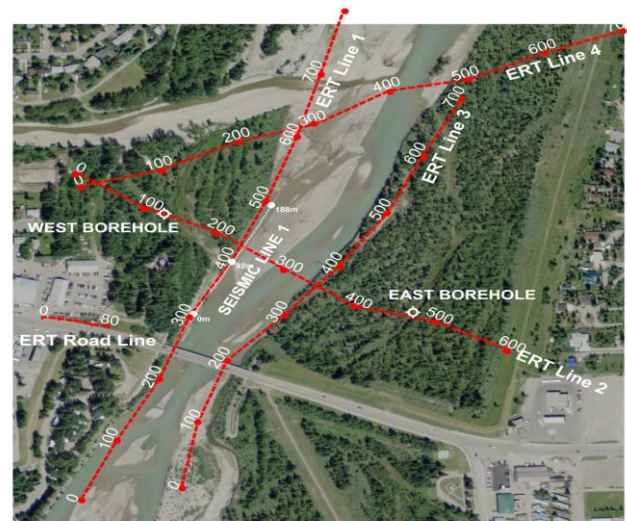
Figure 2 Locations of the geophysical survey lines

A georeferenced base map showing the positions of the ERT and seismic refraction surveys is presented in Figure 2. Positions of the ERT and seismic lines were surveyed using a Real Time Kinematic Epoch 25 GPS System, providing for sub-meter (i.e. 3 cm) accuracy in eastings, northings, and elevation. Coordinates in this report are referenced to UTM NAD83 Zone 11 North. Topographic information is referenced to mean average sea level, and provided as metres above sea level (masl).

Two lines, ERT Line 2 and ERT Line 4, were collected across the river, and along two of the suggested pipeline crossing options, Option 2 and Option 3, refer to Figure 1. ERT Line 2 and ERT Line 4 are 600 m and 700 m in length, respectively. The positions of the geophysical survey have been indicated on Figure 2, which contains a georeferenced satellite image. ERT Line 2 and ERT Line 4 positioned such that they have a common approximate starting line position on the west side of the River and each line crosses near at least one possible horizontal drilling entry point, see Figure 2.

One seismic refraction line was also collected along the west bank of the river (Figure 2). Seismic Line 1 was collected parallel to the river, along ERT Line 1, and is placed safe distance from the traffic bridge to minimize the vibration caused by the moving traffic along the highway. A sledge hammer was used as a source of energy. The 48 geophones were spaced 4 m apart.

The geotechnical field program to evaluate subsurface conditions at the site of the proposed pipeline crossing was undertaken and included drilling two (2) boreholes, one each on the east and west sides of the Red Deer River, Figure 2, to a depth of approximately 31.5 mbgs.
