# Foundations and basements construction of a shopping mall on the soft soils of Bogotá – PAPER #849 PanAm-CGS 2011

Luis F. Orozco, MSc &, Marcela Salcedo, MSc  
*LFO Ingenieros de Suelos, Bogotá, DC, Colombia*

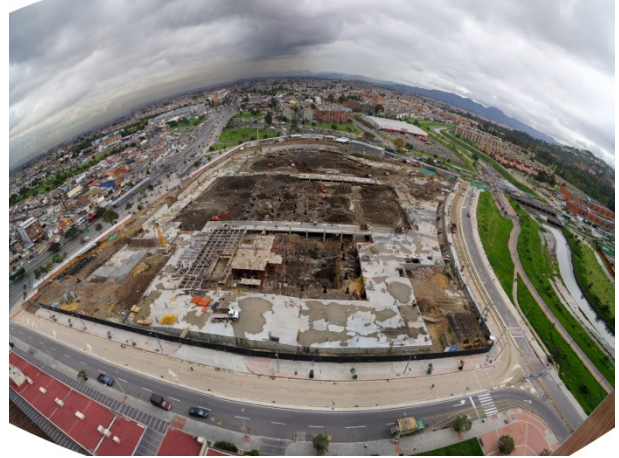
Figure 4.1 Aerial view from the east showing belt and strut slabs at first floor level.

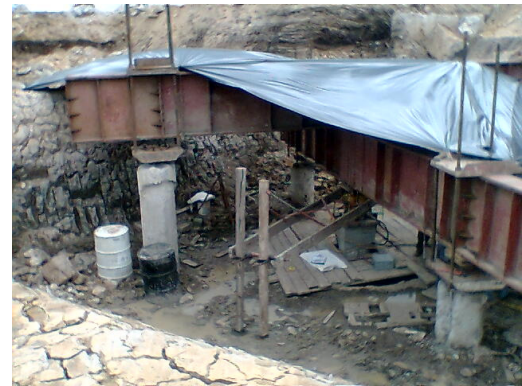
Figure 5.2 Load Test (8)

Piles were designed to support a theoretical value equal to 50% of the load of the column, with a bearing capacity factor of safety of two and reinforced according to the building code so they were also able to support substantial tension loads. Friction pile capacities were designed according to the beta method (7) (figure 5.2) and checked with values obtained from the Dutch cone penetrometer, but were later adjusted upwards, a small percentage, based on a load test of a pile  $\phi$  60 cm with its tip at a depth of 45 m which had been isolated in the upper 7.5 m to simulate the future excavation for the underground floors. It resulted in failure at 305 tons.

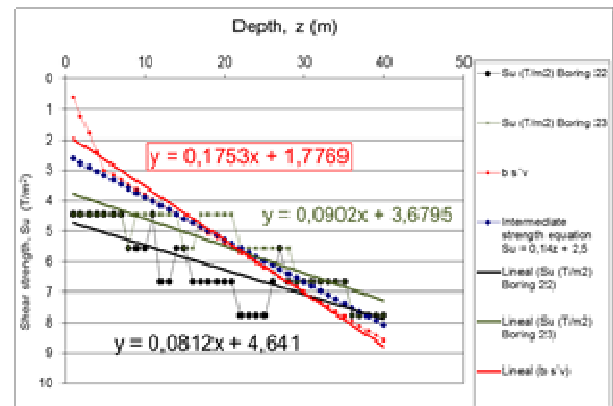
Figure 5.3 shear resistance (Friction pile capacities were designed according to the beta method). (3)

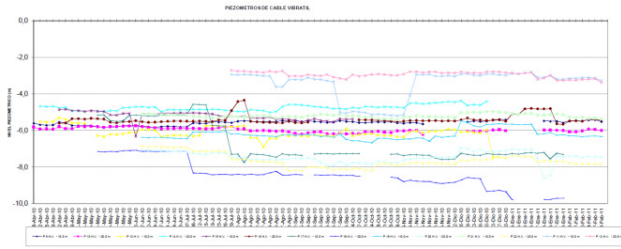
Figure 5.4 Pore pressures around the site according to vibrating wire piezometers (10)

The complementary mat foundation was designed to support  $6.0 \text{ T/m}^2$  (59KPa) of the weight of the building, which is almost its total weight in the commercial area, and it was designed also to support  $7.6 \text{ t/m}^2$  (74KPa) of the total weight in the footprint area of the office building. The mat works to distribute the load evenly, for each of the six separate structures. It is needed to avoid bottom failure due to the weight of the soil around the building as well as to support a pore pressure of  $6.0 \text{ T/m}^2$  (59KPa) which will develop at foundation level with time after construction is finished. This also means that the water table will be lowered at the site from a depth of 5.0 m or somewhat lower, according to vibrating wire piezometer levels at the beginning of construction, to a depth around 6.0 m. (Fig 5.4)

The geotechnical instrumentation includes: nine inclinometers at chosen locations around the site and close to the walls, to a depth of 30 m; eighteen Casagrande and eleven vibrating wire piezometer batteries (at -10 and -20 m)(figure 5.4); three spider type extensometers located at the center of the main areas of excavation; very detailed topographic monitoring, controlling movements of the walls, surrounding sidewalks and buildings, and a water main on Avenida Boyacá to the west; strain gages placed on reinforcing bars at chosen locations to monitor strains and stresses on belt and strut slabs.

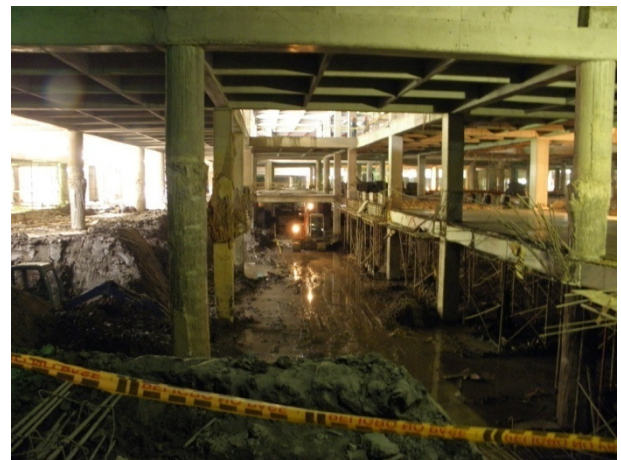
Figure 5.5 Construction of mat under first floor slab.

In the central areas excavation proceeded from -9.0 m to -11.5 m. and the mat foundation was built as excavation progressed (Fig 5.5). The surrounding berms were lowered, simultaneously with mat construction in central areas, to the level of first basement floor by the alternating trench method (10 m wide trenches), and the first basement wale slab was built within the trenches at levels -7.5 and -8.8 m. After construction of the first basement belt or wale slab, the lowest level of the shoulder was removed using the trench method, but very slowly and carefully, with widely spaced trenches 4.0 m wide at the most, all to avoid bottom failure due to the weight of the soil outside the retaining walls. Daily results of the precision instruments were crucial at this

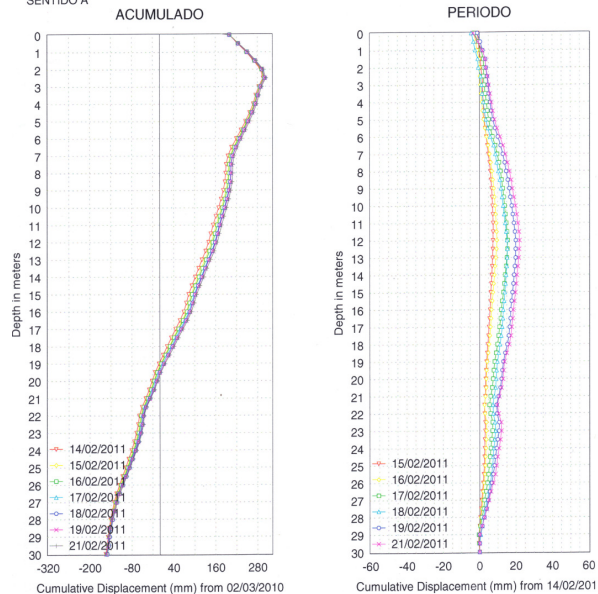
**CENTRO COMERCIAL TITAN PLAZA**  
 INCLINOMETRO No 6  
 E Y R ESPINOSA Y RESTREPO S.A.  
 SENTIDO A

Figure 7.2 Results of inclinometer number 6. (9)

On the other hand, when excavations reached the mat foundation level and they got to a distance of about 25m from the retaining walls the inclinometers showed movements of up to 30 to 40 cm, within depths of 5 and 20m below the sidewalk level. When this happened (twice during construction at two different sites) immediate action was taken constructing the mat as soon as possible and completing the wale slab and beams projected to the central columns at first basement level. These measures were needed to avoid a bottom failure which might have developed breaking the slurry walls and with very negative consequences to the structure adjacent to the excavation.

Figure 7.1 shows the location of geotechnical instruments. Figure 7.2 has the results of inclinometer 6 at the critical point in time when immediate action was taken.
