Vibration Induced Settlement of a 13.5 metre Railway Embankment (Paper ID 989)

Peter Barlow, M.Sc., P.Eng.
AMEC Earth & Environmental Ltd., Edmonton, Alberta, Canada
James P. Murphy, M.Eng., P.Eng.
Cimarron Engineering Ltd., Calgary, Alberta, Canada
Greg Bridgewater, P.Eng.
TransCanada Pipelines Ltd., Calgary, Alberta, Canada

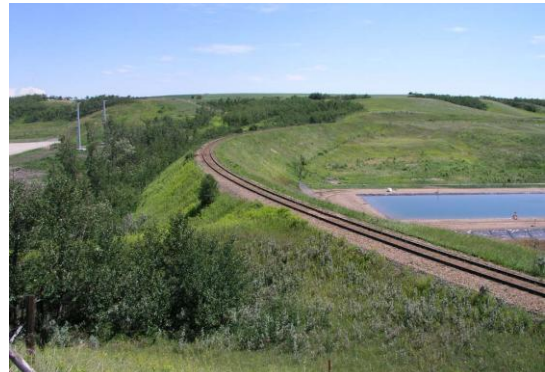
Figure 2. CPR embankment in area of crossing.

The embankment was built to accommodate railway grade requirements as the alignment crosses the Battle River valley. In order to climb out of the valley and keep within grade limits, the railway constructed a large sweeping curve as seen in Figure 2. The valley is approximately 110 m deep and the curved alignment required an extensive fill operation that resulted in the high embankment that supports the railway. This embankment was probably constructed in the mid 1900s and no information was available from construction of the railway. A number of geotechnical drilling investigations (see references) were conducted to characterize subsoil conditions along the approaches to the embankment, and directly through the embankment fill from track level. A geophysical survey was also conducted on the embankment fill using Ground Penetrating Radar (GPR)

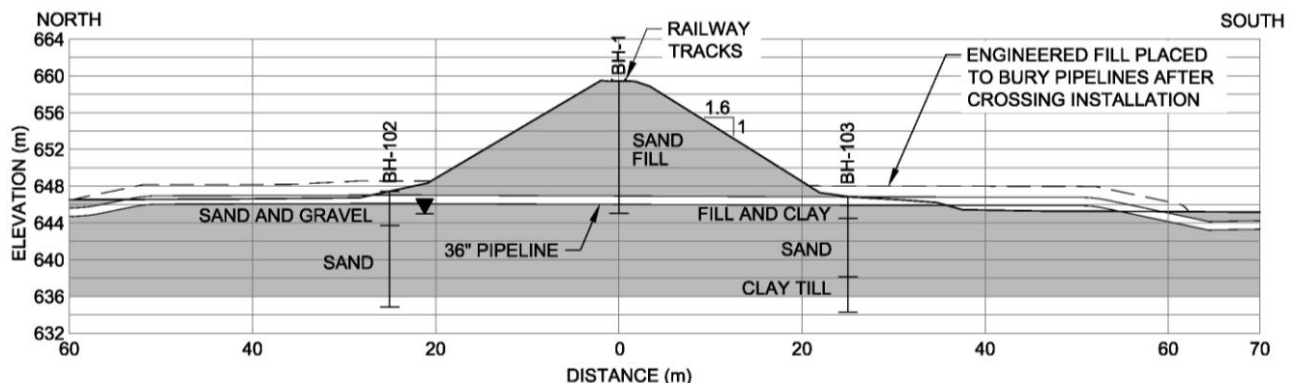
Figure 3. Cross section of railway embankment showing soil conditions and pipeline alignment

The various geotechnical investigations (Coffey 2009 and 2010) determined that the in situ soil conditions below the railway embankment comprised an average 10 m thick layer of loose to compact fine grained sand, with an average SPT N value of 14 (uncorrected). The sand was overlying low to medium plastic, firm to stiff silty clay till with a trace of sand and gravel. The water table was encountered approximately 1 m below grade in the fine uniform sand deposit underlying the embankment. A cross sectional view of the embankment is provided in Figure 3.

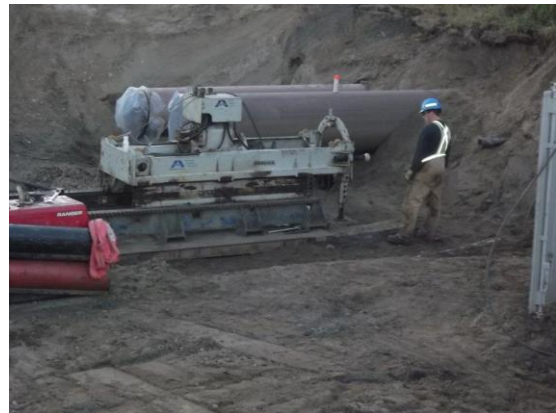
Figure 4. Bore rig preparing to install 6 inch pilot hole beside first two installed pipelines.

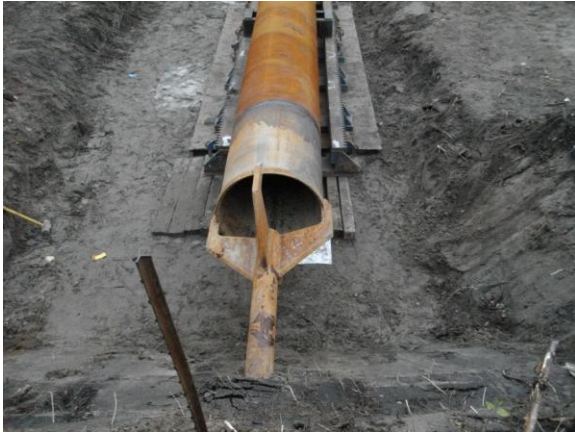
Figure 5. "Spider" attachment connecting 30 inch casing for first Installation to 6 inch pilot string, protruding from embankment.

Once the pilot hole was complete the driving shoe or "spider", was welded to a section of casing pipe and connected to the drill steel at the leading edge. Figure 5 shows a photograph of the spider attaching the 30 inch casing pipe with the pilot hole drill pipe for the first installation. A 24 inch pneumatic hammer proceeded to drive the casing in from rig side. The drill pipe was then removed piece by piece as the casing penetrated the soil. The spider allows the majority of the soil to enter into the casing during the initial portion of each advance. However, as soil accumulates during the advance, a plug is established within the casing, and a greater proportion of the soil is displaced around the casing. As this happens the hammering is harder, resulting in increased vibration levels. Typically, the casing is driven until the advance rate is slowed to a point where the soil inside the casing needs to be removed by augering. This was typically done every 15 m when an additional section of pipe was added to the casing. Once the soil is extracted

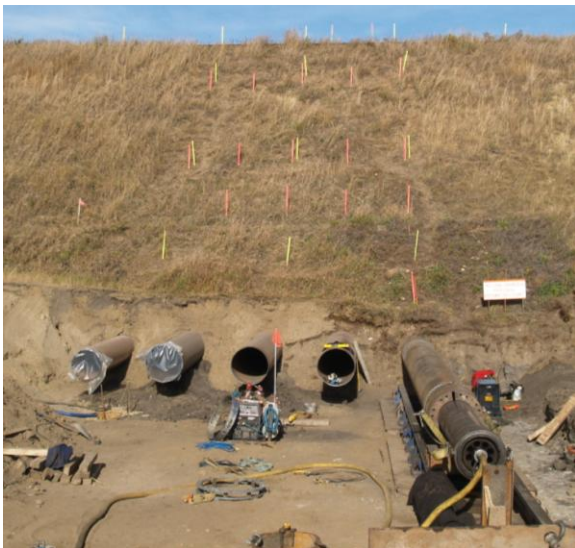
Figure 6 shows a view of the embankment looking north, as the pneumatic hammer is installing the casing for the

fifth and final pipeline.

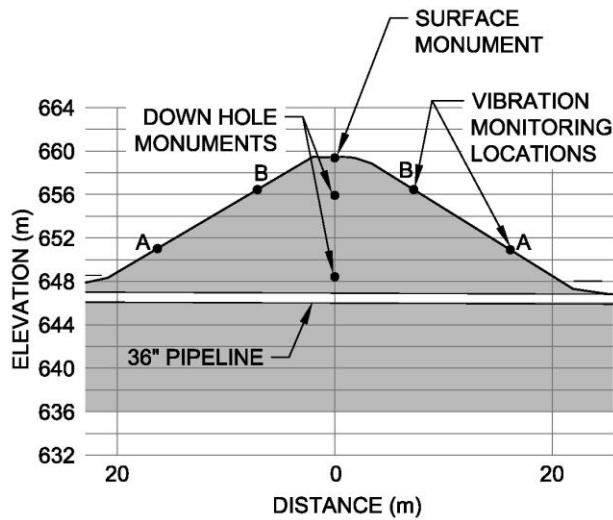
Figure 7. Embankment cross section showing position of monitoring system components.

The elements of the instrumentation program are illustrated schematically on the cross section on Figure 7.

After some initial experimentation, the unit was generally positioned within the middle third of the side slope, either in Position A or B, as indicated on Figure 7. Vibrations that occurred during the installation of the product pipeline behind the casing were generally below the detection limit of the monitoring equipment. It is of interest to note that vibrations induced by train traffic were in the order of 3 mm/sec when the unit was 3 m below track level. This is about 10 times smaller than the velocities quoted above when the unit was the same approximate distance from the front of the casing.

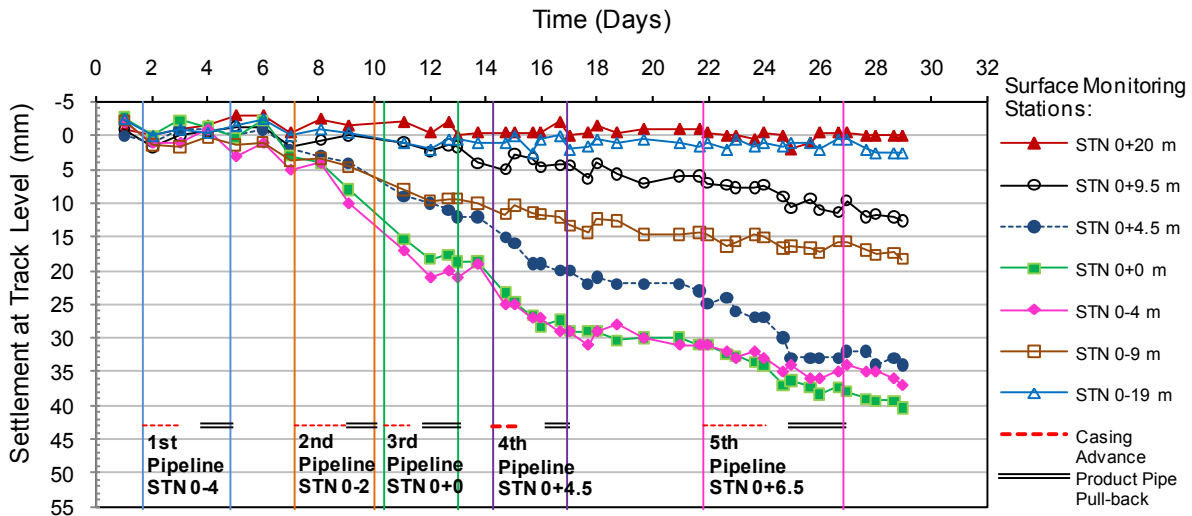
Figure 8. Ground settlement versus time for survey stations along top of railway embankment.

The progressive ground settlement measured at track level for each of the 7 monitoring stations throughout the duration of the 5 installations is plotted versus time on Figure 8. Also indicated on the figure are the time intervals for the initial casing advance and product pipeline installation for each crossing.

- The maximum settlement per individual pipeline installation ranged from 5 to 11 mm, with an average maximum of 9 mm per installation. The

maximum settlement was generally centered above the active installation.

- The total cumulative settlement at the end of the 5 installations was 40 mm at the maximum point.
- The settlement that occurred during the casing advance was on average 3.6 times larger than the settlement during advance of the product pipelines for the last two installations. The frequency of surveying of the monuments did not allow quantification of the difference between settlements during casing and pipeline advance for the first three pipelines.
- The magnitude of settlement for each successive pipeline installation did not decrease with time. The magnitude of settlement was directly related to pipeline diameter, where the maximum settlement for the 30 inch pipeline was 5 mm; and the settlement for the final 4 36 inch installations averaged 10 mm.

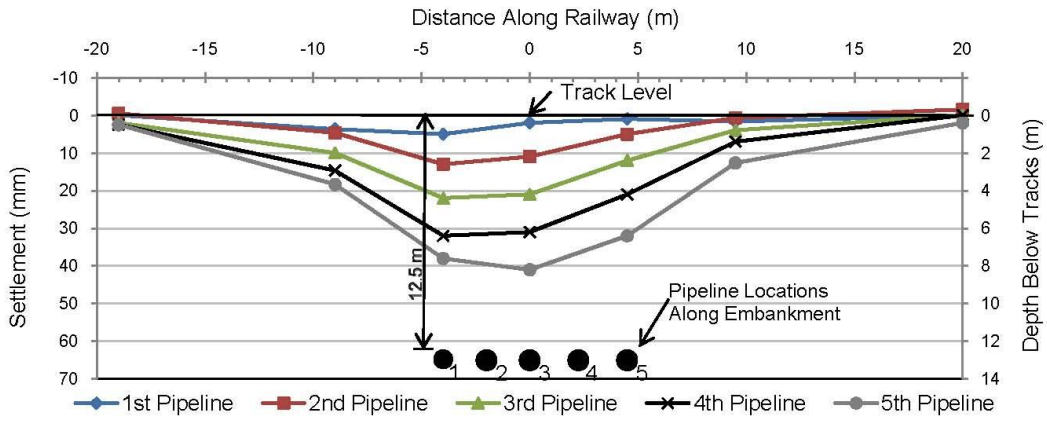
Figure 9. Ground settlement profile at track level along railway at the end of each pipeline installation.

The surface settlement trough measured along the track at the completion of each installation is shown on Figure 9. The maximum settlement is plotted for each of the pipeline installations on Figure 10.

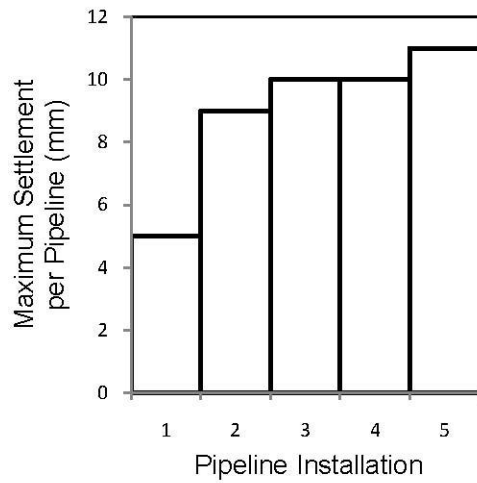
Figure 10. Maximum settlement at track level for each pipeline installation.

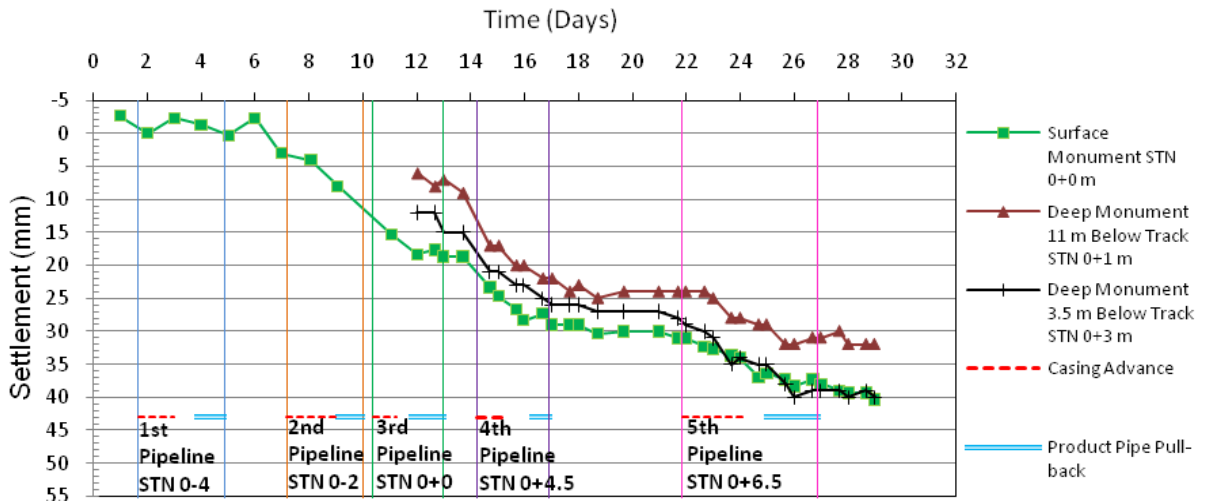
Figure 11: Ground settlement versus time for survey monuments at depth in embankment

Two survey monuments were installed to allow measurement of settlement at depth within the embankment fill. Figure 11 shows the settlement versus time profile for the two sub-surface installations compared to surface settlement measurements at track level at the two monuments that were in the area above the deep monuments. There was a general trend of settlement reducing with depth in the embankment. The deepest sub-surface monument that was 1.5 m above pipeline level and 11 m below track level showed the approximately 8 mm less settlement than the monument that was only 3.5 m below track level. The surface settlement at the closest monitoring station at track level had the same approximate settlement as the shallow, 3.5 m sub-surface monument.
