# Assessment of the Settlement and Horizontal Displacement of Test Embankments with Preloading, Drains, and Vacuum in the Former Texcoco Lake, Mexico

**Abstract.** In this paper, the settlement and horizontal displacement of four test embankments (TEs) built in the former Texcoco Lake are evaluated. The embankments are part of the New Mexico City International Airport (NAICM) project and were constructed to study the effects of different soil improvement techniques based on surcharge preloading with (a) sand drains and prefabricated vertical drains (PVDs), (b) PVDs and drain-to-drain vacuum pressure, and (c) PVDs, vacuum pressure, and an airtight membrane. Their behavior is compared with that of an unimproved reference embankment. The site conditions are described, and the geometric and construction characteristics of each embankment are presented. A monitoring period of 360 days after the start of construction is discussed. In addition, the degree of consolidation in each trial embankment is calculated based on *in situ* records from settlement plates. Finally, the effectiveness of each soil improvement technique is analyzed, and some concluding comments are provided.

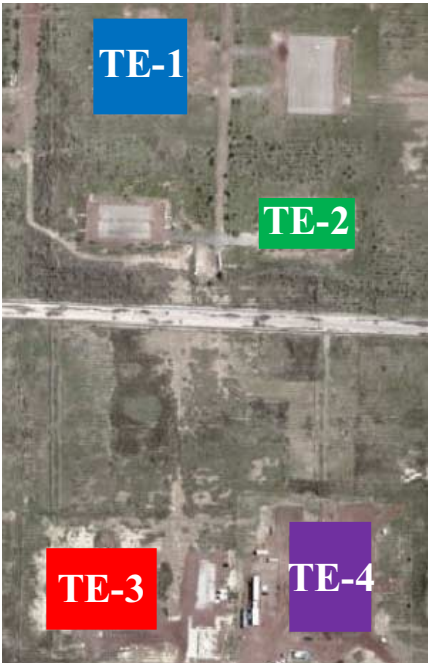
Figure 3. Locations of TE-1 to TE-4 within the polygon of TEs.

The four TEs described in this paper, TE-1 to TE-4, are located within a test polygon at the south side of runway 3 of the NAICM (Figure 2) whose exact location is illustrated in Figure 3. Their general characteristics are described below:

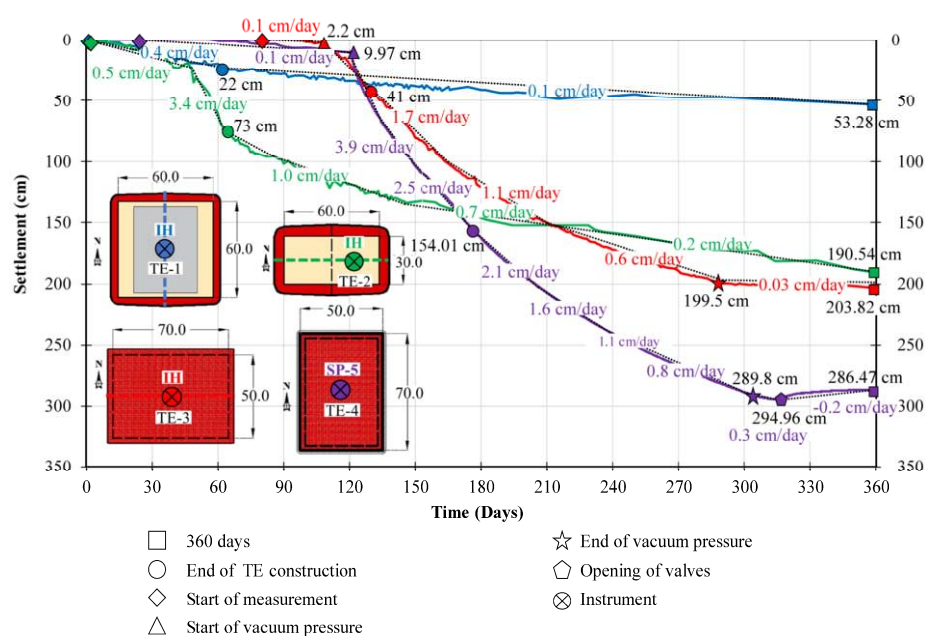
Figure 5. Settlement and settlement rate per day in TE-1 to TE-4.

Figure 5 shows the dimensions (plan view), the *in situ* measurement points, the settlement measurements, and the estimated settlement rate per day in TE-1 to TE-4 for 360 days (the square symbol) from the onset of construction. The settlement in the center of platforms TE-1 to TE-3 was measured using HIs, and for TE-4, the settlement was measured with an SP. Day zero (0) indicates the beginning of construction.

The construction times (the circular symbols) were 62, 63, 127, and 175 days for TE-1 to TE-4, respectively. For TE-3 and TE-4, the first settlement measurements (the diamond-shaped symbols) were made on days 80 and 23, respectively; similarly, the beginning and end of the application of vacuum pressure are indicated by triangular and star-shaped symbols, respectively. In addition, in TE-4, due to the pump shutdown protocol, vacuum pressure was retained inside the membrane keeping the valves closed for 15 days after the vacuum was turned off. With the above, it was possible to observe the effect of the remaining vacuum pressure in the event of an electric power failure. The pentagonal symbol indicates when the valves were opened.

Figure 5 shows that the settlement rate recorded during embankment construction is influenced mainly by the pressure exerted on the soil by its constituent materials. The settlement rates of the embankments with vacuum pressure, TE-3 and TE-4, are similar even before applying the vacuum pressure because both have 2 m height of *tezontle*. In contrast, TE-1 and TE-2 exhibit different settlement rates at the end of construction because they have different heights and materials, but mainly because TE-2 has vertical drains that facilitate the expulsion of groundwater and thereby accelerate consolidation settlement. In contrast, the maximum settlement rate for TE-3 and TE-4 is maintained for a short time and gradually tends to decrease as consolidation progresses. The average settlement rate ( $V_{avg}$ , Table 1) of TE-3 and TE-4 is up to 60% greater than that of TE-2 and up to 800% that of the TE-1. The average settlement rate of TE-4 is 14% greater than that of TE-3.

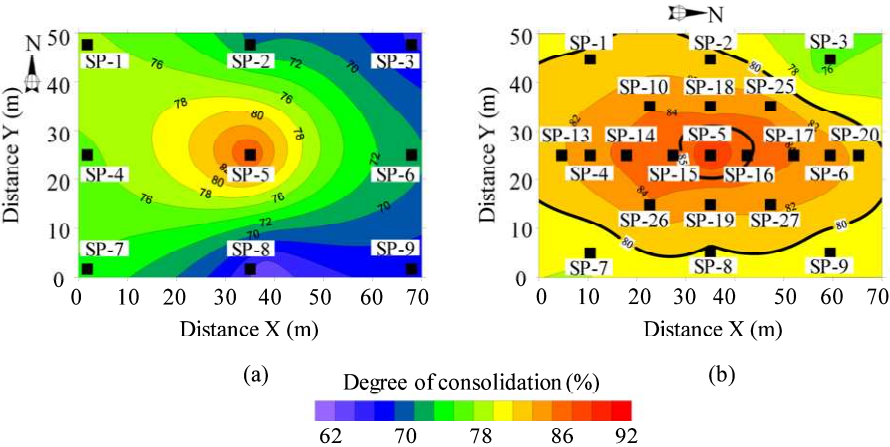
**Figure 8.** Plan view distribution of the DOC for (a) TE-3 and (b) TE-4 based on surface measurements in SPs.

Based on the settlements measured by the geotechnical instruments installed in the test sections, it is possible to estimate the ultimate primary settlement with the Asaoka's method [1] and consequently determine the degree of consolidation (DOC) [12] achieved with each technique used. Figures 8a and 8b show the plan distribution of the DOC in the embankments with vacuum pressure, TE-3 and TE-4, obtained from the SPs surface measurements at the end of vacuum pressure application. Because TE-1 and TE-2 did not have installed SPs, these embankments are not included in the

calculations. Figure 8 shows that the DOC is more uniform in the area of TE-4 than that of TE-3. For TE-3, the vulnerability was observed in the connections as the ground settled, which caused vacuum losses that affected the settlement [9,10]. In both TEs, the values are higher in the center than in the periphery and much smaller in the corners.
