The paper was published in the proceedings of XVI Pan-American Conference on Soil Mechanics and Geotechnical Engineering (XVI PCSMGE) and was edited by Dr. Norma Patricia López Acosta, Eduardo Martínez Hernández and Alejandra L. Espinosa Santiago. The conference was held in Cancun, Mexico, on November 17-20, 2019.

Underpinning and Releveling of a Building Using Control Piles and Sub-Excavation

Keywords. Control piles, settlement control, underpinning, releveling, sub-excavation.

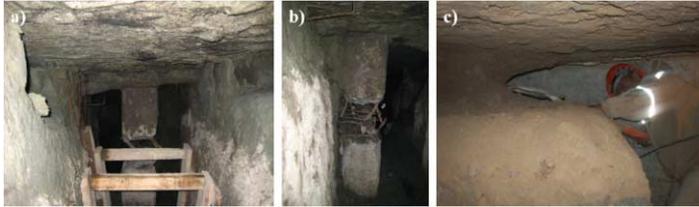
Figure 5. a) Access tunnels and sub-excavation zones, b) disconnection of a friction pile from the original foundation, and c) manual sub-excavation technique (Source: Author's own photograph).

The releveling works consisted of lowering the highest part of the building. For this, it was necessary to a) dig tunnels under the base slab of the box-type foundation (Figure 4 and Figure 5a) to reach the shaft of the original foundation friction piles and b) disconnect some of the original friction piles located in strategic zones (Figure 5b) to allow the vertical movement of the structure.

Subsequently, the technique of manual sub-excitation was applied in the higher areas or those with less settlement (Figure 4 and Figure 5c), and a volume of approximately 210.3 m³ of soil was removed under the base slab of the box-type foundation to induce the vertical movement of the structure. The sub-excitation was complemented by the release of the metallic nuts of the control system to favor the descent of the structure until reaching the desired level. Once this level was reached, the heads of the control piles were cut, with the purpose of having a separation of 10 millimeters between the head beam and the concrete stabilizers. Then, each pile was preloaded up to its nominal load of 980 kN (100 t).
