# Ground improvement at the Prestons Subdivision, Christchurch

J. S. Muirson and J. Kupec

*Keywords:* liquefaction, ground improvement, impact compactor, full scale site trials

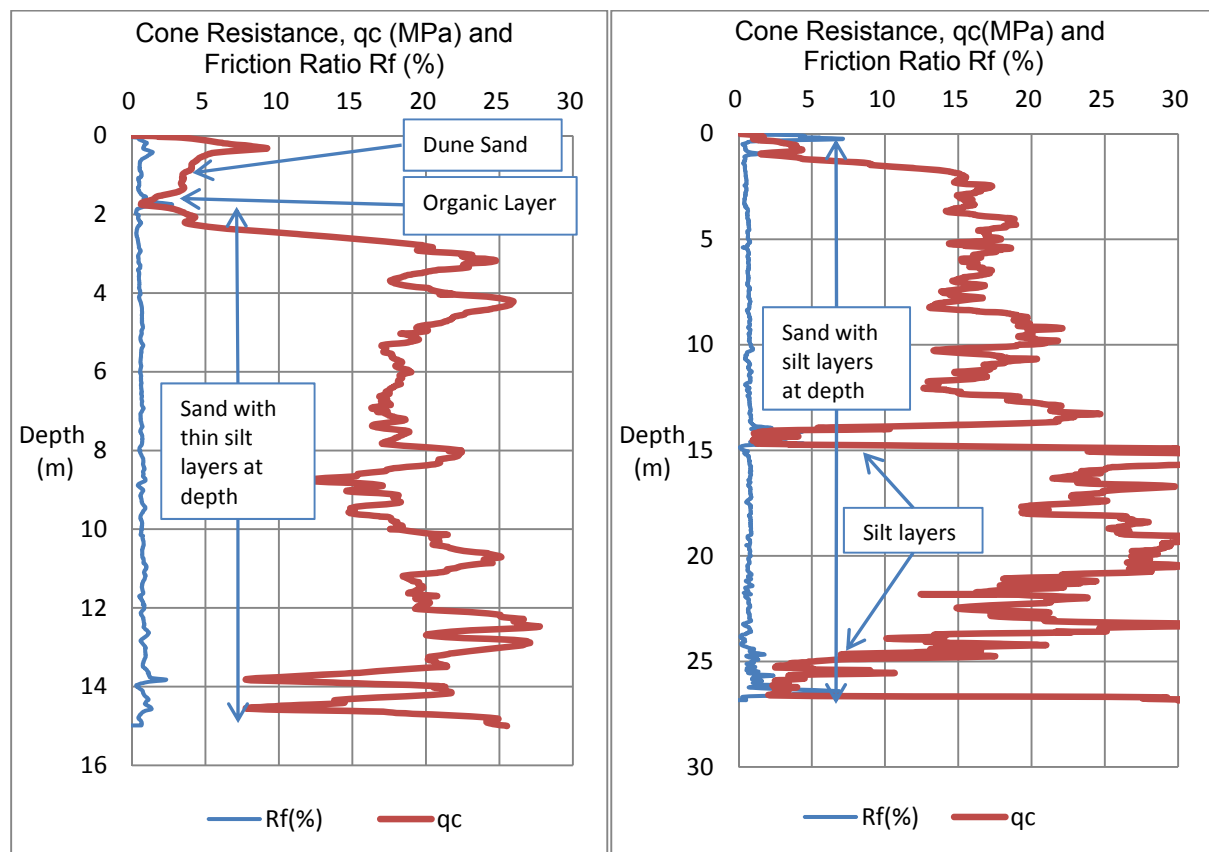
Typical CPT logs showing the soil profiles are presented in Figure 1. The CPT in Figure 1a is located in an area of dune sands, while Figure 1b is located in an area of predominately beach sands. It can be seen that the soil profile to depths in excess of 15m comprise predominantly of sand with a thin organic layer underlying the dune sands in Figure 1a.

Figure 1. a) Typical CPT profile in an area of dune sand and b) typical CPT profile in a beach sand area

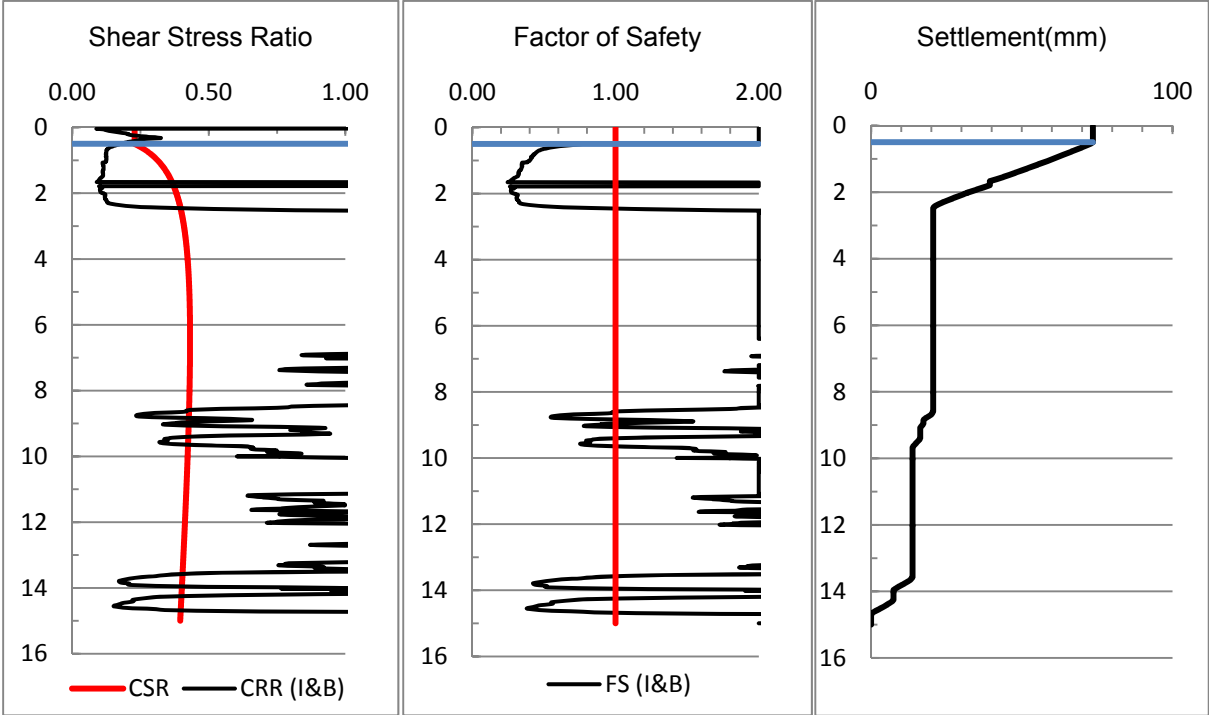
Figure 2a. Typical liquefaction profile within the **dune sand** for the ULS case, based on the Idriss and Boulanger method

The liquefaction analysis identified that liquefiable layers tended to be located within the upper 3m of the soil profile with further liquefiable layers at depths of greater than 7m. The typical liquefaction analysis profiles for the ULS case are provided in Figure 2. Free field liquefaction settlements were in

the range of Technical Categories TC1 and TC2 for the upper 10m, in accordance with MBIE Guidelines. The technical classification was generally governed by the liquefiable layers in the upper 2m to 3m of the soil profile, as shown in Figure 2.

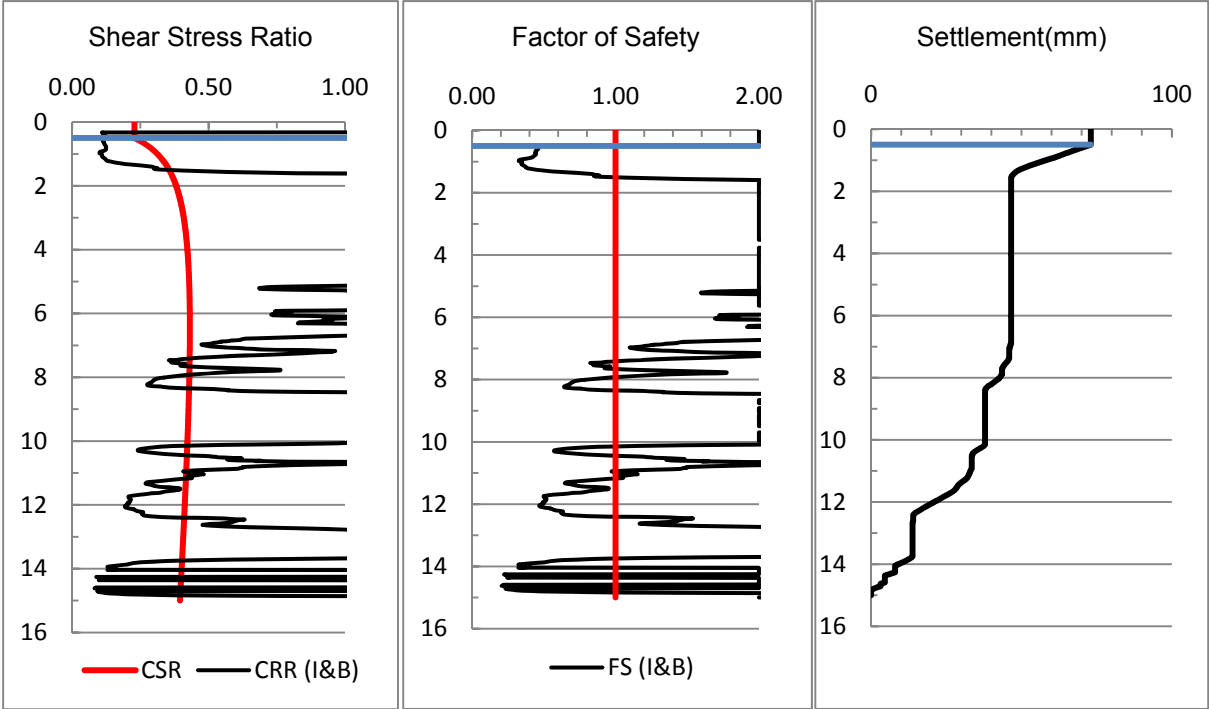
Figure 2b. Typical liquefaction profile within the **beach sand** for the ULS case, based on the Idriss and Boulanger method

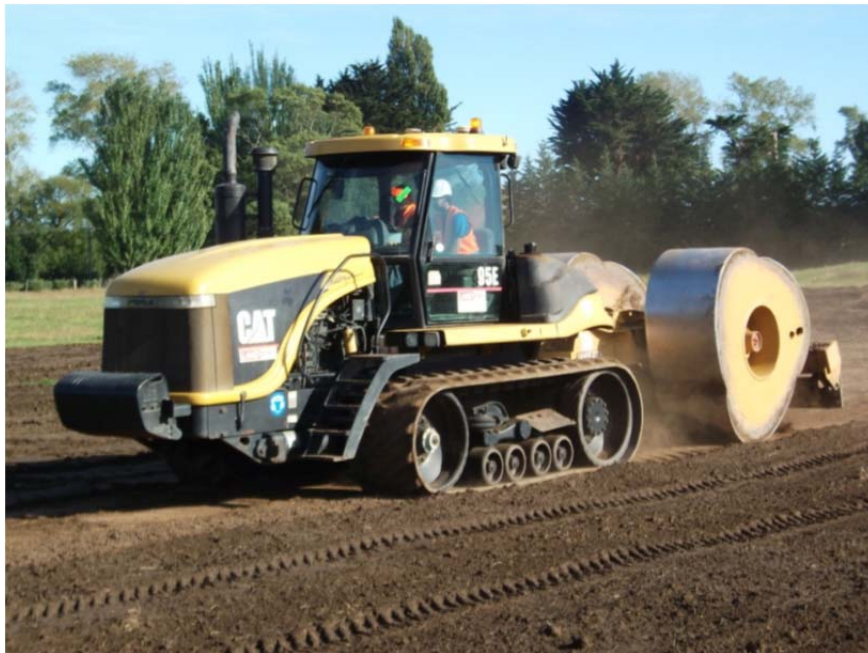
At the time of our assessment Landpac was introducing a high energy impact compaction (HEIC) technique into the Christchurch market. The HEIC machine used in this particular case comprised of a 3-sided dual drum impact compactor with a kinetic energy rating of 135kJ (Figure 3). The impact compactor densifies soils using a modular weight dropping from a height at a regular rate.

*Figure 3. Impact compactor working at the Prestons Subdivision*

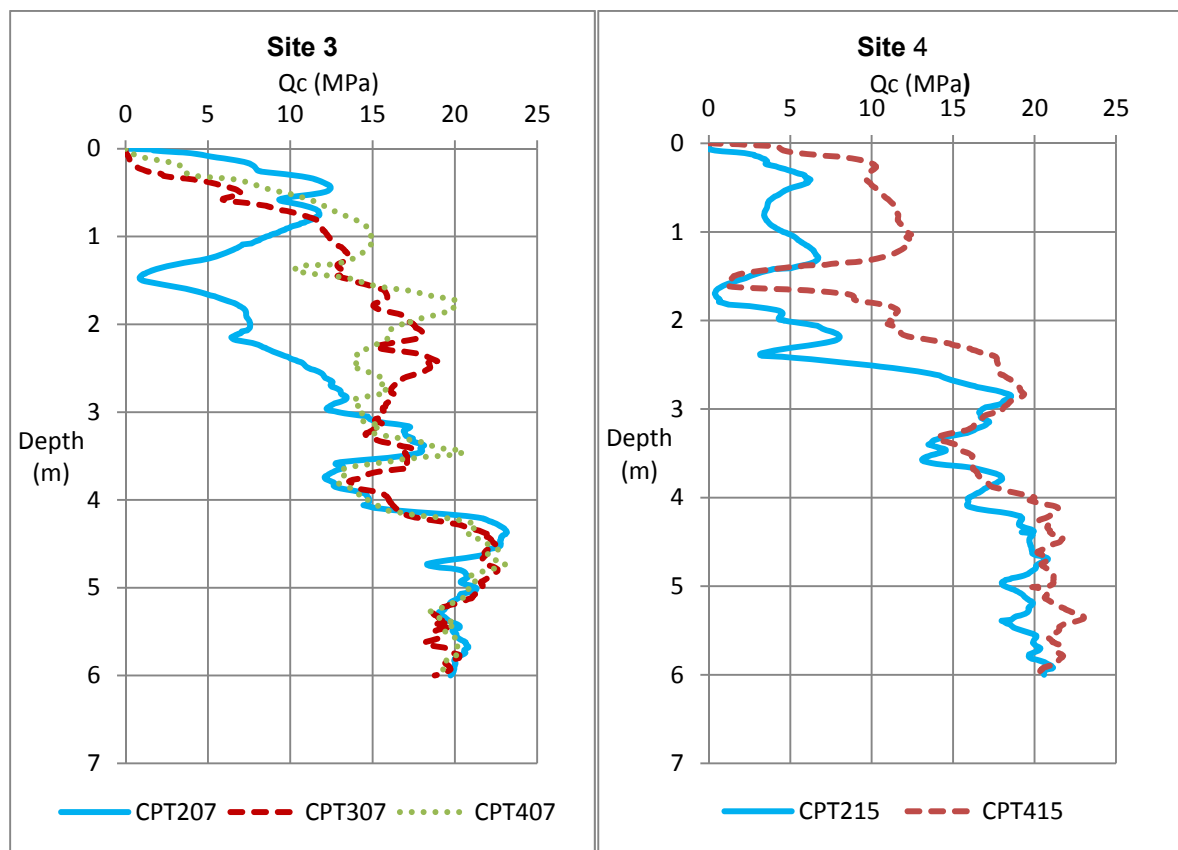
Profiles showing the CPT  $Q_c$  for two of the CPTs carried out as part of the trial are shown on Figures 4a and 4b. Figure 4a shows the CPT profile for a test location within Site 3, where CPT207 is the pre-compaction, CPT307 following 40 passes and CPT407 following an additional 10 passes. Figure 4b shows the CPT profile for a test location within Site 4, where CPT215 is the pre-compaction and CPT415 following 40 passes.

Figure 4. a) Site 3 CPT profile comparison for CPT207, CPT307 and CPT407 b) Site 4 CPT profile comparison for CPT215 and CPT415

It is evident that there is reasonable ground improvement in the upper 3m. The CPT profiles also show that 40 passes appear to be the maximum number of passes, after which there is no significant improvement. Detailed analysis also indicated that where organic layers were present, as seen at a depth of 1.7m at Site 4, there was little to no ground improvement of the organic layers.

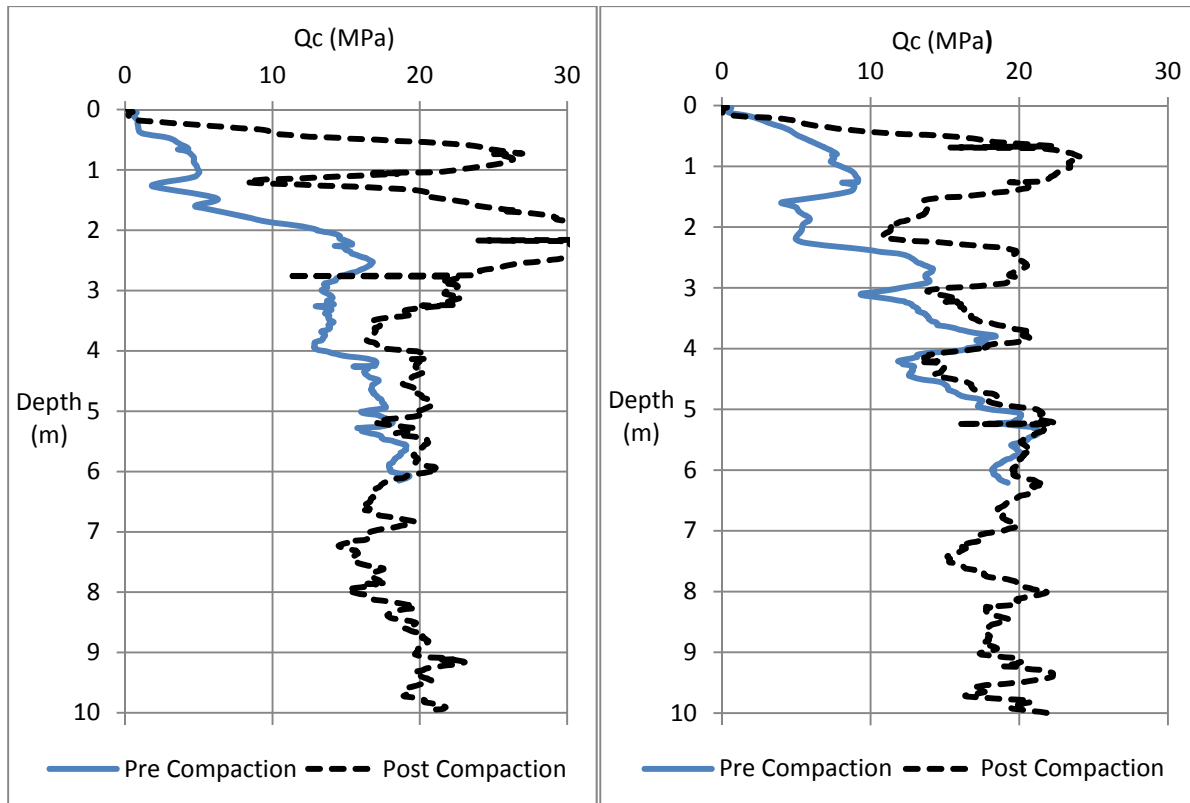
Figure 5. a) and b) Two CPT profile comparisons where impact compaction was undertaken

Assessment of the ground improvement was carried out using CPT tests. Prior to any impact compaction, pre-compaction CPTs were carried out to confirm the pre-existing soil densities. Once the required 40 passes were completed post compaction CPTs were carried out near the pre-compaction CPTs. A comparison of pre and post compaction CPTs was undertaken to confirm the increase in cone resistance. Liquefaction assessment was then undertaken on the post compaction CPTs to confirm the extent of the liquefaction potential after impact compaction. Two of the CPT comparisons are presented in Figure 5, show the indicative densification achieved in the upper soil profile.
