# Remediating contaminated marine sediments using a mudcrete reclamation

**ABSTRACT:** Remediation of the second-highest priority contaminated site in New Zealand was completed by dredging contaminated marine sediments from the Calwell Slipway Basin, Port Nelson, mixing them with Portland cement and powder activated carbon to form mudcrete, and constructing a mudcrete reclamation. Other drivers for the project included restoring navigability and extending an existing reclamation. The addition of cement and powder activated carbon to the sediments increases strength, and binds particles together to minimise leaching of contaminants. Environmental and engineering design components are discussed including results of the laboratory bench trial undertaken to determine appropriate dosage rates, full-scale production trials, and results achieved during construction. Geotechnical design of the reclamation was governed by seismic loading and the need to mitigate liquefaction of both the marine sediments beneath the mudcrete the existing reclamation.

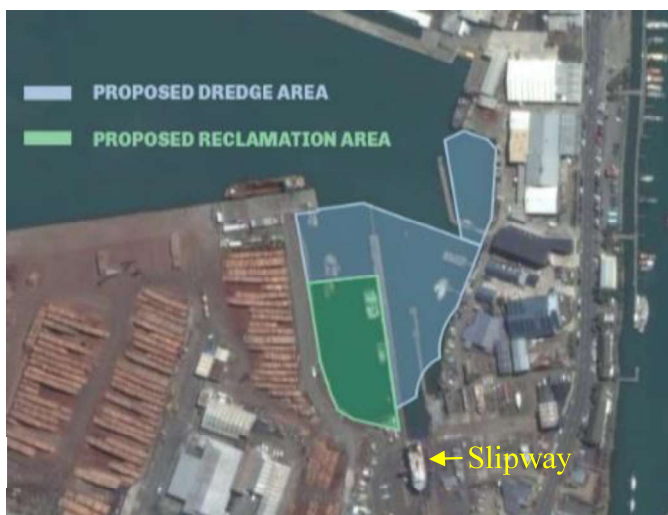
Figure 1: Port Nelson - Calwell Slipway

Remediation of the contaminated sediments comprised dredging the sea bed sediments, combining them with cement and powder activated carbon to create mudcrete. The mudcrete was used to extend existing reclaimed land along the slipway inlet, creating approximately 5000 m<sup>2</sup> of additional land storage and parking area for Port Nelson (refer Figure 1 for layout).

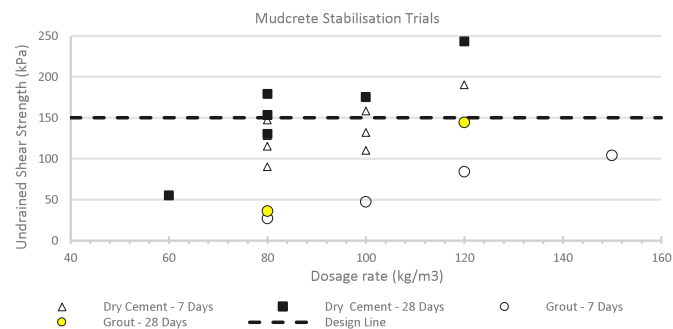
Figure 2 - UU Test Results (bench trials)

UU test results showed the dry cement additive produced higher strength than the grout mixture. The reasons for this are not completely understood and could be due to several factors, such as cement reducing the moisture content of the sample through hydration, water to cement ratio during blending, in-situ moisture content of the sample, or blending errors. The results from the dry cement samples indicated that a dosage of 80 kg/m<sup>3</sup> (4% to 5% depending on sample bulk density) would provide  $S_u$  values of 115 kPa after 7 days, increasing to 150 kPa after 28 days, with average strength gain of 39%. On this basis, the average design undrained shear strength chosen was 150 kPa, with a minimum of 100 kPa. Results of the UU stabilisation bench trials are shown in Figure 2.

UCS testing done on selected blends was undertaken in the first phase of bench trials. The results indicated a cement dosage of 60 kg/m<sup>3</sup> (approximately 4% of sampled bulk density) increased the undrained shear strength ( $S_u$ ) from 20 kPa to 110 kPa after 7 days. Higher dosage rates resulted in higher strength, with 100 kg/m<sup>3</sup> (6%) increasing  $S_u$  to 220 kPa.

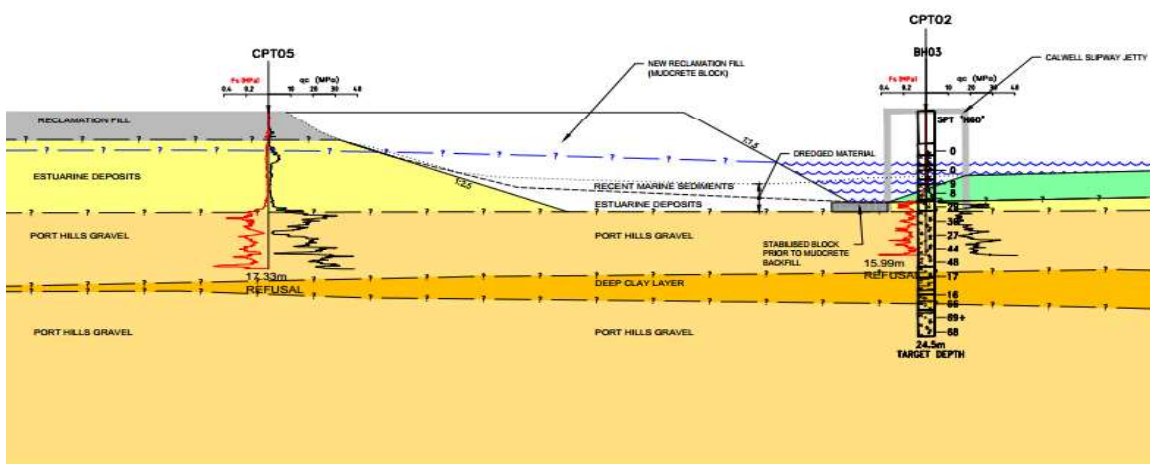
Figure 3 - Mudcrete reclamation

Further analysis was undertaken where the in-situ estuarine deposits and reclamation fill against the mudcrete block were assumed to liquefy during a seismic event, in order to determine the level of deformation that could be expected. Deformation analysis was undertaken using a sliding block method to determine the yield acceleration, i.e. acceleration required to reach a factor of safety equal to 1.0, with deformation estimated using methods by Ambraseys and Menu (1988), Jibson (2007), Bray and Travasarou (2007). With the mudcrete block extending down to the Port Hills gravel unit, the deformation across the reclamation zone was estimated to be in the order of 50 mm. The design profile is illustrated in Figure 3.

Stability analyses were undertaken for the pre-existing site conditions and the new reclamation. Bathymetry and topographical survey data indicated the pre-existing slopes were in the order of 7.5 m high. Removal of the contaminated marine sediments and underlying liquefiable estuarine deposits increased the slope height to approximately 11 m.

Stability assessment of the revetment slopes was undertaken for both static and seismic conditions. The purpose of the static stability analyses was to determine an appropriate slope angle for long-term performance, with a factor of safety of 1.5 required under a 10 kPa surcharge loading. To achieve an adequate factor of safety, a design slope of 1V:1.5H (34 degrees) was required around the edge of the new reclamation area. Graded rock armour placed in layers around the reclamation was specified for erosion protection.

Analyses showed that leaving the estuarine deposits in place beneath the new reclamation would result in flow type failures, i.e. a factor of safety of less than 1.0 achieved post seismic with liquefied soil conditions, which would result in excessive lateral and vertical deformation, with the potential to impact the Calwell slipway. To reduce this risk, the liquefiable sediments were dredged and mixed with the contaminated sediments, stabilised, then placed within the reclamation area, creating a block of mudcrete down to the Port Hills Gravel.

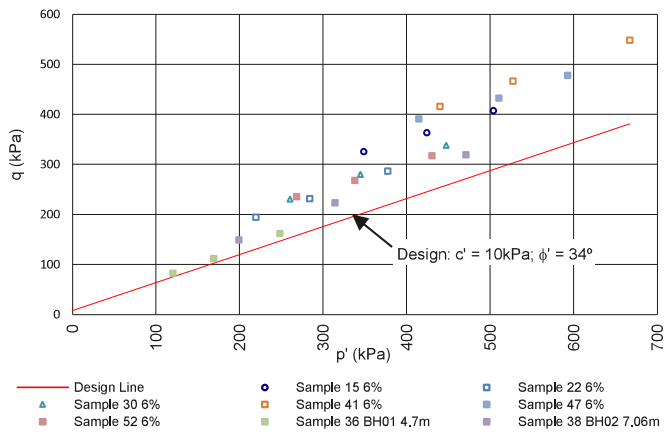
Figure 4 - CU Test Results

CU triaxial testing was also undertaken at specified intervals from samples collected off the pugmill conveyor. All samples tested met the design requirements, including the samples collected during the site trial phase. Figure 4 presents the p'-q plots of all the CU triaxial testing completed during the project.

CU test results were completed on dry cement blends only, with cement a dosage of 80 kg/m<sup>3</sup>. Based on the results, the design effective stress parameters were selected as  $c' = 10$  kPa,  $\phi' = 34^\circ$ .

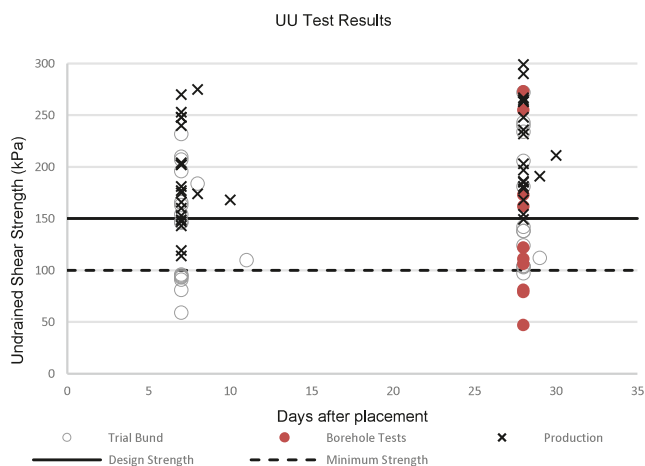
Figure 5 - UU Test results during construction

Following the trials, full-scale production and reclamation was commenced. Quality control testing was required for the duration of the project with treated marine sediments collected directly from the pugmill conveyor at specified production intervals. The material extracted from the processing plant showed a consistent mixture, with the laboratory test results consistently meeting the design requirements. Lower strengths were recorded in material with moisture content above 70%, which was more typical in the finer grained contaminated sediments near the surface. Figure 5 presents all the UU test results undertaken during trials and production of the mudcrete during the reclamation project.

undertaken on selected samples from the boreholes, refer Figure 5, confirming the poorly cemented core did not achieve the specified design strength of 150 kPa, however the strength was significantly greater than non-stabilised sediments.

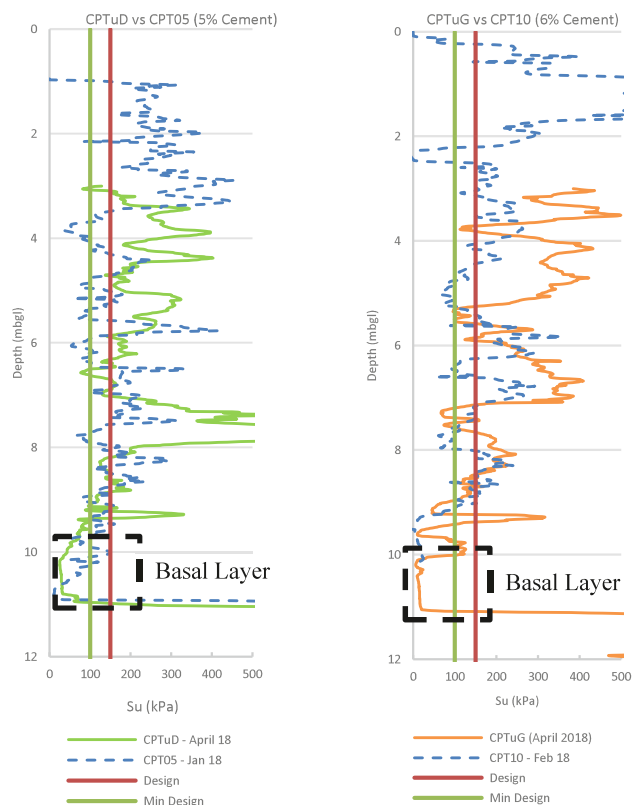
Figure 6 - Comparison between dosage rate and testing 3 months apart

Additional CPTs were undertaken based on results from the trial bund. The CPTs were undertaken to gain a strength profile below MSL and to assess the effects of increasing the cement dosage to 6% of the bulk density. The results indicated that strength gain was quicker with the increased dosage, however comparison between the trial bund area with 5% cement and the zones with higher 6% dosage indicated the final undrained shear strengths were similar at completion of the project. Results from the UU triaxial tests were used to calibrate the cone factor (Nkt) value used to estimate undrained shear strength from the CPTu's. An average value of 14 was calculated over seven individual samples, with Nkt values varying from 10 to 16. For illustrative purposes, an Nkt value of 14 has been adopted. Figure 6 presents the results of two CPTu's located near each other, tested approximately three months apart. The results show an increase in mudcrete strength with 5% cement and 6% cement dosage rates over the three month period.

Weaker zones with lenses of material below the design strength required (150 kPa) are also shown in Figure 6. The weaker zones were non-continuous and could be a result of several factors, such as water ingress, processing and placement. UU testing was also

Insitu testing results and core logs also show inconsistency in achieving the design depths. The results indicate that a basal layer of estuarine deposits was not completely treated, refer Figure 6. From the insitu test results, the layer is typically no more than 0.5 m thick and ranges from negligible thickness to approximately 2.0 m thick. The thickest zones were around the trial bund area, where a wide trench was excavated down to the design dredge level, potentially allowing disturbed material to flow into the excavation.

Additional stability modelling was undertaken to assess the overall impact this layer has on the reclamation during a ULS seismic event. The results indicated an increase in displacement from 50 mm to 250 mm. The modelling assumed a theoretical worst case of a 2.0 m thick continuous layer of un-cemented material. The effects of the mudcrete bund and the change in effective stress were not taken into account for estimating the liquefied shear strength ratio ( $\tau/\sigma_v'$ ) of the layer.
