The paper was published in the proceedings of the 11th Australia New Zealand Conference on Geomechanics and was edited by Prof. Guillermo Narsilio, Prof. Arul Arulrajah and Prof. Jayantha Kodikara. The conference was held in Melbourne, Australia, 15-18 July 2012.

Key strategies for managing acid sulphate soil (ASS) problems on the southeastern coast of New South Wales, Australia

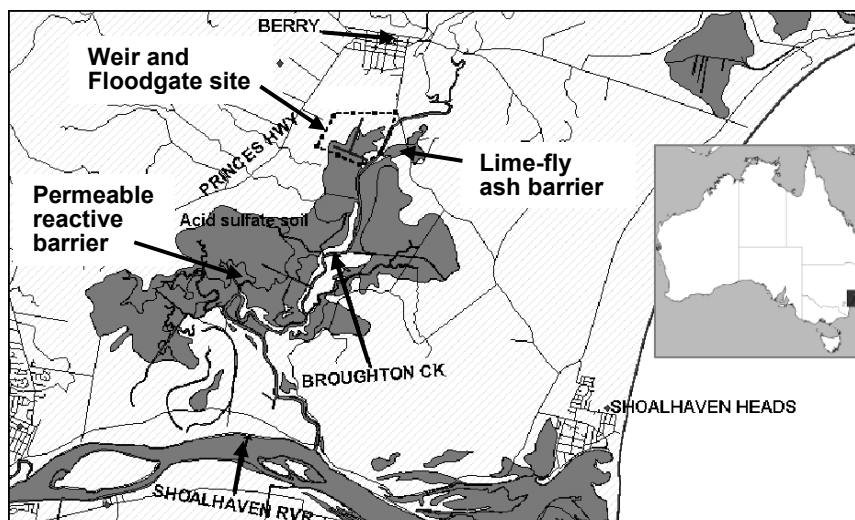
Figure 1. Map of study sites, Shoalhaven River floodplain, southeast NSW, Australia (shaded sections represent areas affected by acid sulphate soils) (Adapted from Indraratna et al. 2001)

The remediation study sites are located within a small sub-catchment of approximately 120 ha located in ASS terrain (~2500 ha total high risk ASS) between the townships of Berry (34.7°S, 150.7°E) and Bomaderry (34.8°S, 150.6°E) in the Shoalhaven Floodplain, southeast NSW, Australia (Figure 1). This region is very low-lying with pyritic soil within close proximity to the surface organic layer. A network of flood mitigation drains (3.5 m deep × 8 m wide) were constructed across the sub-catchment in the late 1960s to minimise the risk of flooding on agricultural land. These drains discharge into Broughton Creek, a left bank tributary of the Shoalhaven River. One-way, top-hinged floodgates located at the entrance of most drains inhibit tidal intrusion of estuarine water, maintain low drain water elevations and lead to the build-up of acid reservoirs behind the floodgates. High levels of acidity, as indicated by massive acid scalds on the Shoalhaven Floodplain, create unfavourable conditions for vegetation growth, which directly affects local dairy farming and other forms of agriculture.

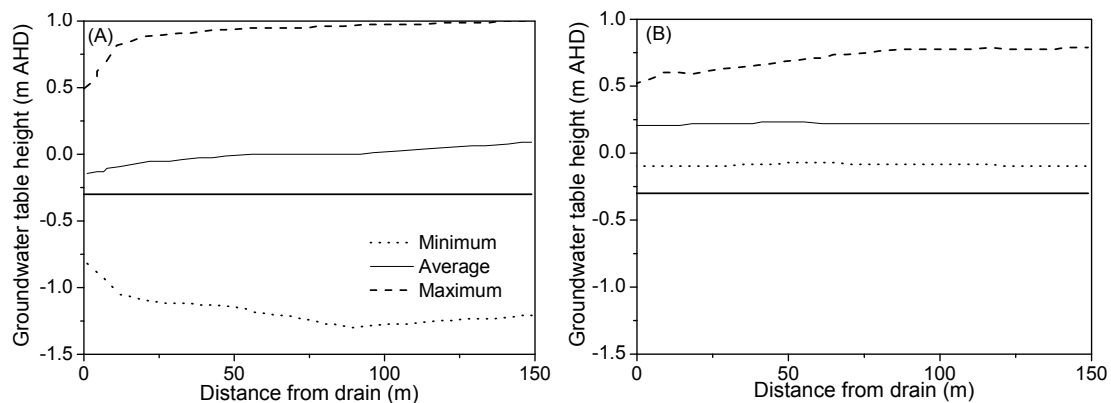
Figure 2. Average groundwater table height (A) before and (B) after weir installation (Adapted from Blunden (2000))

The first ASS remediation strategy adopted within the Shoalhaven Floodplain was the implementation of fixed-level weirs in 1998, after numerical modelling showed the maintenance of the groundwater surface above the pyritic layer (1.2 m below ground surface, -0.3 m Australian Height Datum (AHD)) and a reduction in the amount of acid generated (Blunden and Indraratna 2000). Comprehensive field trials were implemented to verify improvement of ground and drain water at the field site by three v-notch weirs installed in flood mitigation drains (Indraratna et al. 2001). During the pre-weir period, drought periods characterised by high rates of evapotranspiration and low rainfall led to very low groundwater tables that exposed pyritic soil to oxidising conditions (Figure 2A). The v-notch weirs were successful in maintaining the groundwater table at or above the pyritic layer at most locations for the monitoring period (Figure 2B). The lower hydraulic gradients established under the influence of the higher drain water level maintained by the weirs reduced the discharge of acidic oxidation products from the groundwater to the drain. However, elevated groundwater levels did not improve the long-term groundwater quality with pH maintained at 3.5-4.0 throughout the monitoring period following weir installation. The weirs were able to reduce 'new' acid formation but biological oxidation of pyrite can occur even under submerged conditions. The concentration of Al^{3+} in the groundwater remained high

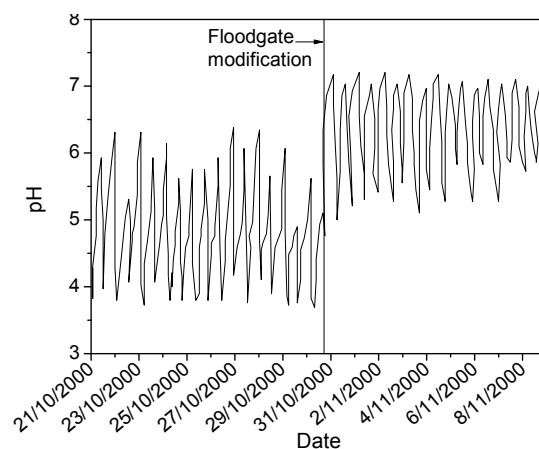
Figure 3. Drain water pH pre- and post-floodgate modifications (Adapted from Indraratna et al. (2005))

The second ASS remediation strategy adopted was the modification of floodgates to allow ingress of brackish creek water to improve drain water quality by the buffering action of carbonates (CO_3^{2-}), and bicarbonates (HCO_3^-) present in seawater. Since floodgates modifications would change the hydrodynamics of a drain, a number of concerns including the change in drain water quality due to tidal buffering and optimisation of the drain water level with tidal influx without overtopping the levee bank were addressed prior to installation of the floodgates. Tidal restoration in a flood mitigation drain and subsequent changes in drain water composition were simulated using a geographical information system (GIS) and ion-specific code written within PHREEQC and laboratory experiments, respectively. The simulations and laboratory results indicated that tidal buffering could improve drain water quality (Indraratna et al. 2005). Two styles of modified floodgates were installed in October 2000: (1) a winch-operated floodgate that lifts vertically, controlling the amount of water entering the drain, and (2) an automated *Smart Gate* system that permits tidal flushing based on real-time monitoring of water quality (e.g. pH, electrical conductivity (EC), dissolved oxygen (D) and temperature) up- and down-flow of the gate. Prior to floodgate modifications, the average pH of the drain water was 4.32, while the average pH post-modification was 6.04 (Figure 3). Al^{3+} decreased by > 50% from 11.3 mg/L to 4.38 mg/L. Similarly, total Fe decreased from an average of 23.1 mg/L to 10.3 mg/L. Tidal flushing (i) reduced the acid reservoir effect, (ii) increased drain water DO levels, (iii) enhanced fish passage, (iv) decreased exotic freshwater weeds and (v) recharged the phreatic zone during dry periods.

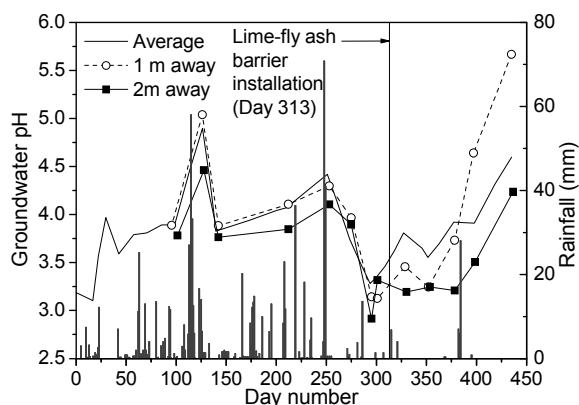
Figure 4. Groundwater pH pre- and post-installation of lime-fly ash barrier (Adapted from Indraratna et al. (2006))

The third ASS remediation strategy was the injection of a lime-fly ash slurry to form an impermeable barrier above the pyrite layer (1.2 m below ground surface, -0.24 m AHD) to halt infiltration of O₂ and neutralise groundwater acidity. Lime and fly ash were selected due to their ability to neutralise acidity and pozzolanic nature, respectively. Varying lime-fly ash ratios were tested to decide on the most appropriate viscosity and ratio of constituents to be used in preliminary injection trials (Indraratna et al. 2006), the results of which were used to alter the proposed barrier installation methods. Two weeks after the barrier was completed (June 2004), coring of the treated area confirmed the formation of a continuous layer (0.7 m below ground surface) that had sufficiently hardened to form the semi-impermeable barrier of thickness 100-130 mm. Changes in groundwater composition were monitored in a network of 31 observation wells at the study site to determine the barrier effectiveness. The barrier significantly improved groundwater quality. Groundwater pH increased from an average of 3.28 to between 4.5 and 5.5 (Figure 4) after installation of the barrier, with greater influence evident close to the barrier than further away. The concentration of pyritic oxidation products Al³⁺ (pre-barrier: 35.7 mg/L; post-barrier: 20.1 mg/L) and total Fe (pre-barrier: 67.6 mg/L; post-barrier: 37.0 mg/L) in the groundwater also, on average, decreased. The Cl⁻:SO₄²⁻ ratio in the groundwater increased after the barrier was installed from 0.38 to 0.80, which confirmed that the barrier had successfully controlled pyrite oxidation in the soil. A comparison between the average groundwater table elevations before (0.23 m AHD) and after (0.17 m AHD) installation also indicated a perched water table, which would reduce the exposure of pyritic soil to atmospheric O₂, reduce pyrite oxidation and the generation of acidic products. While the barrier is relatively inexpensive to install, it only has a localised impact on groundwater quality and, thus, limited applicability due to the large areas of land that contain ASS within the Shoalhaven Floodplain. The longevity of the barrier is also uncertain, as it will become ineffective due to armouring by Al or Fe precipitates or by the exhaustion of the neutralising capacity of the lime and fly ash.

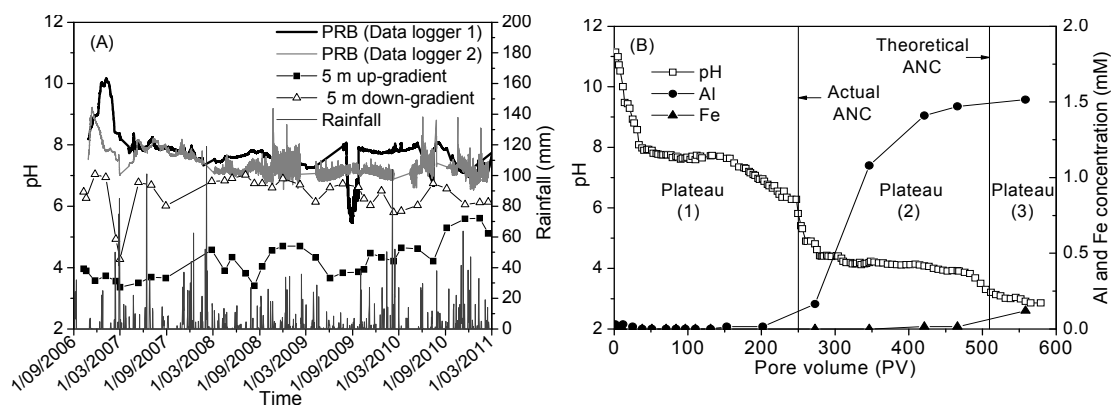
Figure 5. (A) Groundwater pH up-gradient, inside and down-gradient of the PRB. (B) Column effluent pH, Al^{3+} and total Fe as a function of pore volume (Adapted from Regmi et al. (2011))

The PRB has successfully neutralised the acidic groundwater to ~ pH 7.3 (Figure 5A) and removed ~ 95% of Al^{3+} and total Fe (Indraratna et al. 2010). Up-gradient of the PRB, the groundwater is acidic (~ pH 3.4-5.6). The average pH down-gradient of the PRB is > 6.0 due to dilution of acidic water by alkaline effluent from the PRB. Groundwater inside the PRB is alkaline to neutral (pH 10.2-7.3), confirming the effectiveness of recycled concrete for neutralising acidic groundwater in ASS terrain. However, a decrease in the neutralisation of acidity and removal efficiencies of Al^{3+} and total Fe over time indicates chemical armouring of the concrete and, thus, a decrease in PRB longevity. A long-term column experiment using recycled concrete was undertaken to determine the neutralisation reactions occurring within the PRB (Regmi et al. 2011). A synthetic acidic influent of constant flow rate 2.4 mL/min was used to simulate groundwater from the field site using the average value of contaminants measured over a 6-month monitoring period. The average porosity of the concrete was 0.52 (total pore volume (PV) was 534 mL). Three plateaus were observed (Figure 5B) and attributed to the: (1) dissolution of carbonate/bicarbonate alkalinity at pH 7.9-7.7 (40 < PVs < 155) followed by a gradual decrease to pH 6.5 (235 PVs); (2) re-dissolution of Al hydroxide precipitates at ~ pH 4 (300 < PVs < 500); and (3) re-dissolution of Fe oxyhydroxide precipitates at ~ pH 3 (> 500 PVs). Armouring of the recycled concrete aggregates, observed as white and orange precipitates within the column, resulted in a decrease in the actual acid neutralisation capacity (ANC) of the concrete (71 mg/g as CaCO_3 , 250 PVs) by ~50% compared to its theoretical ANC (145 mg/g as CaCO_3 , 510 PVs). Although a decrease in hydraulic conductivity within the column was observed due to chemical armouring, this would not be a major problem in the PRB due to the larger particle sizes used compared to the column experiment. Currently, steady piezometric head within the PRB indicates that chemical armouring has not yet affected groundwater flow within the PRB. Research is currently being undertaken to quantitatively assess changes in flow behaviour due to armouring/clogging in order to develop a time-dependent porous medium flow model combining particle retention and groundwater flow with chemical precipitation. This will be used to determine corresponding reductions in void space within the PRB, thereby analysing the interrelated effects of acidic flow induced clogging and PRB effectiveness.
