Laboratory and Field Strength of Mine Waste Rock

SUMMARY Laboratory testing of samples of waste rock fill at Bougainville, Papua New Guinea, has enabled the quality of the rock fill to be defined in terms of its particle size distribution. The strength of poor quality rock fill has been determined by triaxial testing and by back-analysis of observed waste dump slips, and slope stability charts have been prepared for waste dump design.

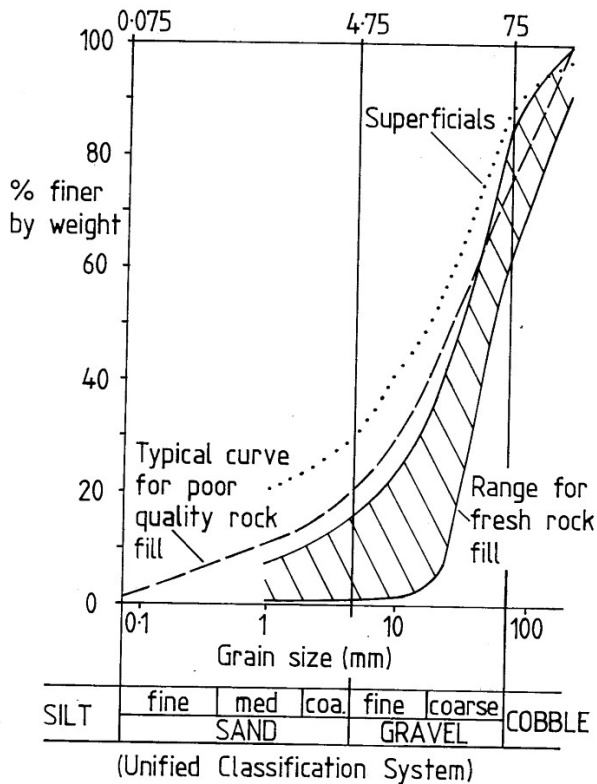
Figure 1 Particle size distribution curves

The range of particle size distributions obtained is shown on Figure 1. On the basis of the particle size distribution curves obtained, three categories of waste material were defined as follows.

- (i) Good quality rock fill - less than 15% sand size or finer and about 20 to 35% cobble size or coarser, comprising fresh rock.
- (ii) Poor quality rock fill - about 20% sand size or finer and about 25% cobble size or coarser, comprising moderately to slightly weathered rock.
- (iii) Super-ficials - about 30% sand size or finer and about 10% cobble size or coarser, representing the upper limit on the particle size distribution plot for dumped waste material.

- (i) The strength characteristics of waste rock fill can be related specifically to the particle size distribution of the waste rock, with the proportion of sand size or finer being less than 15% for good quality rock fill and at least 20% for poor quality rock fill.

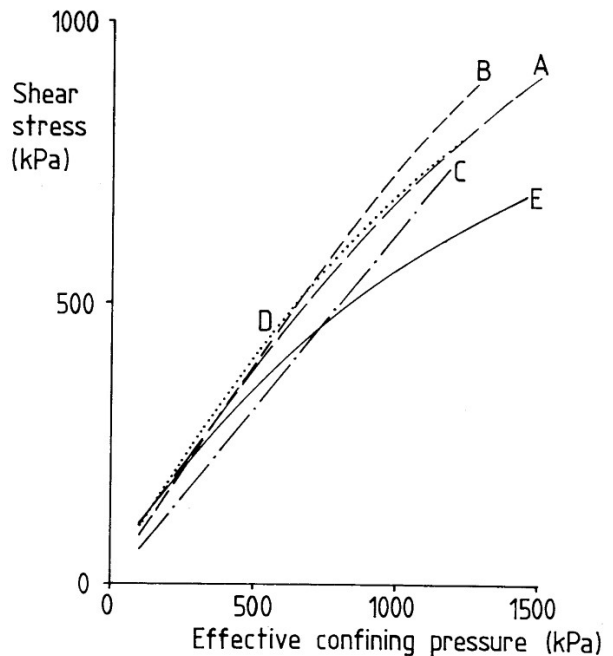
Figure 2 Comparison of failure envelopes

The failure envelopes obtained from the triaxial testing of poor quality rock fill samples 1 and 2, under various conditions, are presented on Figure 2. Comparisons of the five curves can be made to

- (i) Density has little effect on the shear strength of the material (curves A and B).
- (ii) A significant reduction in shear strength results from saturation of initially loose samples (curves A and C). This effect diminishes with increasing effective confining pressure.
- (iii) Saturation has a negligible effect on the shear strength of a compacted sample (curves B and D).
- (iv) Sample 2 had a similar shear strength to that of sample 1 up to an effective confining pressure of about 300 kPa, but had a significantly lower shear strength at higher confining pressures.

At an effective confining pressure of 400 kPa, which is appropriate to the field situation, samples 1 and 2 displayed similar shear strengths and the effect of initial density was negligible. However, saturation of initially loose material led to a reduction in shear strength of about 25% at an effective confining pressure of 400 kPa.

- A Sample 1-16.3 kN/m³, 3.9% m.c.
- - - B Sample 1-19.9 kN/m³, 3.9% m.c.
- · - C Sample 1-16.3 kN/m³, saturated
- D Sample 1-20.1 kN/m³, saturated
- E Sample 2-16.0 kN/m³, 5.3% m.c.

- (ii) From the results of the triaxial testing of poor quality rock fill it is concluded that initial density has relatively little effect on the strength of the rock fill. However, saturation significantly reduces the strength of initially loose material, the effect diminishing with increasing effective confining pressure. The lower strength obtained for sample 2 compared with that for sample 1 appears to be related to its greater susceptibility to particle breakage on testing.

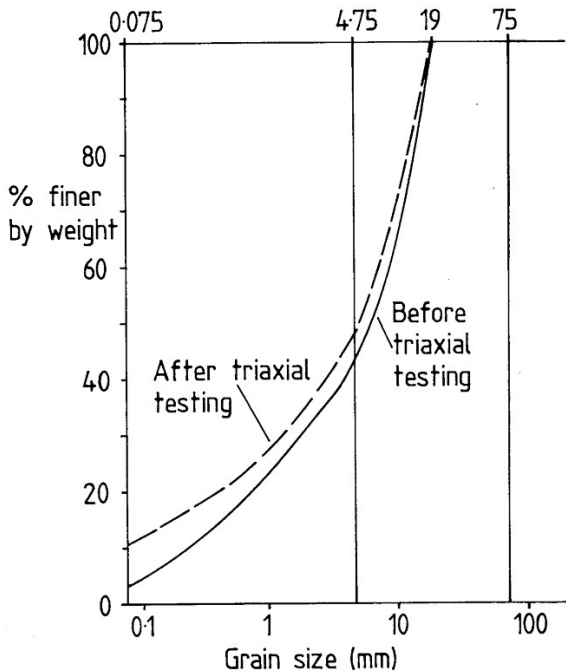
Figure 3 Particle size distribution curves for before and after triaxial testing of sample 1

This was aimed at giving some indication of the amount of particle breakage likely to occur on hauling, dumping and subsequent deformation of poor quality rock fill. The amount of particle breakage for triaxial samples from sample 1 was found to be small and largely independent of the initial test conditions, other than confining pressure. Typical particle size distribution curves for before and after triaxial testing at a confining pressure of 640 kPa are shown on Figure 3. The amount of particle breakage may be expressed quantitatively by summing the increases in the percentages retained on each sieve size after breakage compared with before to give the "B" factor. The B factor for the particle breakage indicated on Figure 3 is 12.5%.

Different degrees of breakdown are evident from Figures 3 and 4, but it is clear that a significant increase in the proportion of fines takes place on testing of the poor quality rock fill.

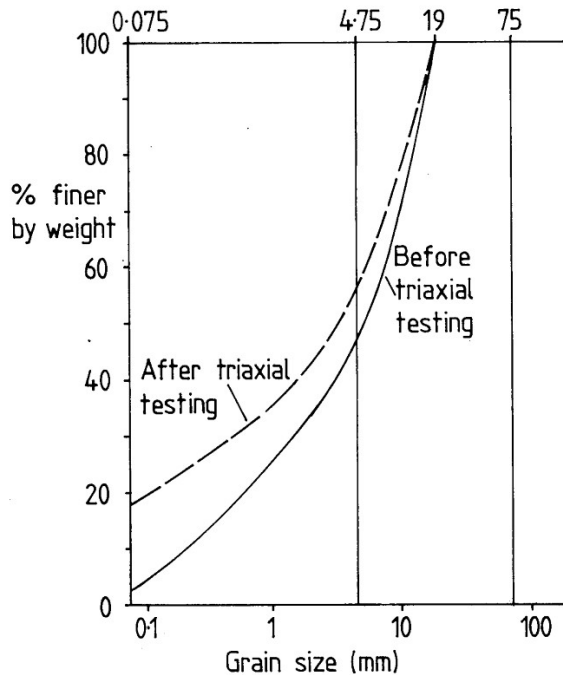
Figure 4 Particle size distribution curves for before and after triaxial testing of sample 2

Triaxial testing of sample 2 at a confining pressure of 640 kPa gave rise to significantly more particle breakage than did similar testing of sample 1. The before and after particle size distribution curves for sample 2 are shown on Figure 4, from which a B factor of 17.8% was calculated.

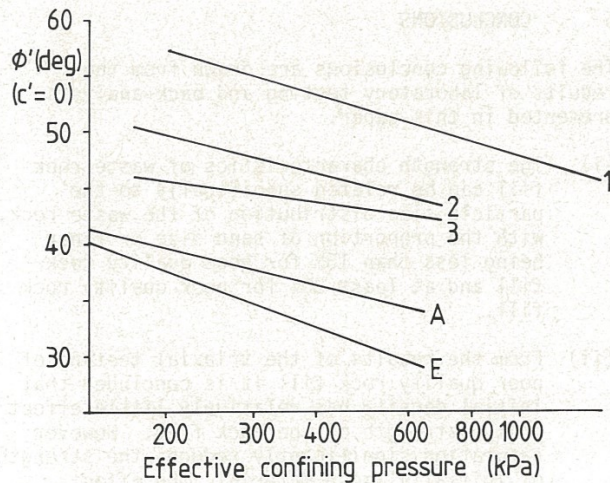
Figure 5 ϕ' versus effective confining pressure for Bougainville rock fill

The values of ϕ' obtained are plotted against effective confining pressure to a logarithmic scale on Figure 5. Included on Figure 5 are the ϕ' values for samples 1 and 2 tested under conditions prevailing in the waste dump. The results indicate that ϕ' decreases with increasing effective confining pressure and reduces substantially as the degree of weathering of the rock fill increases. It is noted that the ϕ' values obtained from the triaxial testing of samples 1 and 2 are substantially lower than those reported by Scott.

- 1 150 mm dia. triax., 24.5 kN/m³, 5.5% m.c., FRESH
- 2 570 mm dia. triax., 20.3 kN/m³, saturated, SW
- 3 570 mm dia. triax., 19.3 kN/m³, saturated, MW
- A Sample 1 - 16.3 kN/m³, 3.9% m.c., MW - SW
- E Sample 2 - 16.0 kN/m³, 5.3% m.c., MW - SW

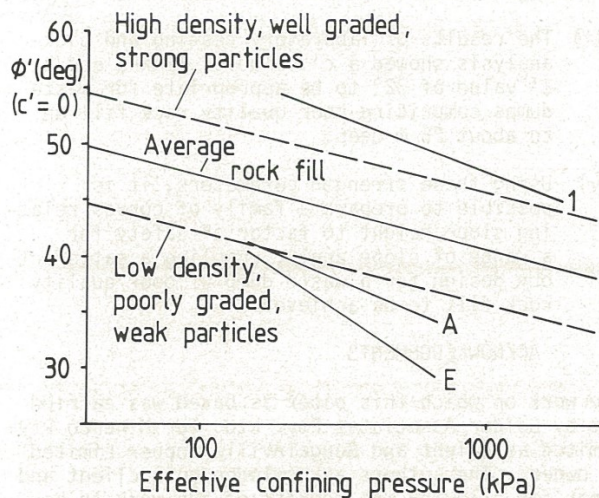
Figure 6 ϕ' versus effective confining pressure for other rock fill

Leps (1970) collected the results from a large number of triaxial tests on different rock fill types with maximum grain sizes in the range 19 to 203 mm. Based on these results, plots were made relating ϕ' and effective confining pressure for good quality (high density, well graded, strong particles), average and poor quality (low density, poorly graded, weak particles) rock fill. These relations are reproduced on Figure 6. More recent triaxial test results presented by Frost (1974) fall within the range defined by Leps. Also plotted on Figure 6 are selected results defining the range for Panguna andesite (lines 1, A and E from Figure 5). Line 1 plots above the relation for good quality rock fill defined by Leps, indicating negligible fines (passing 75 μm), a very high density and strong, well graded angular particles. Lines A and E plot below the relation for poor quality rock fill defined by Leps. This indicates that the poor quality rock fill from the area of the waste dump slips has a relatively high proportion of fines and comprises weak, more rounded particles. The relations defined by Leps are based on the testing of rock fill for dam construction, which would have negligible fines and therefore a higher strength than poor quality waste rock fill at Bougainville.

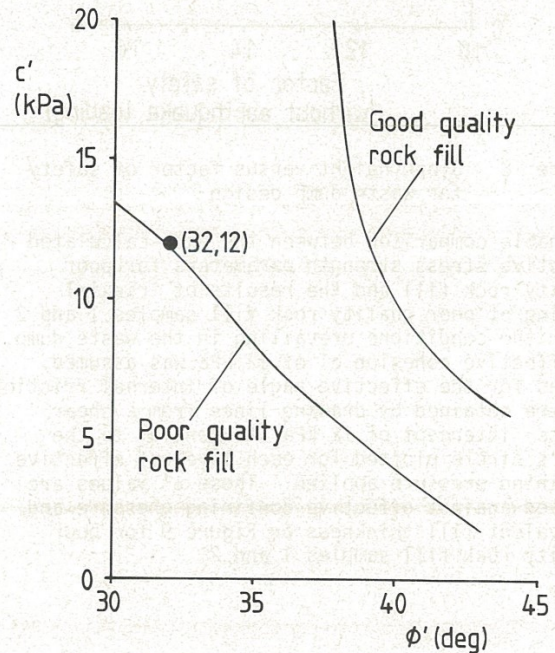
Figure 7 Back-calculated effective stress strength parameters

Observations of the post-slip surface profile of the waste dump indicated localised slope angles of up to 46.5° standing to a vertical height of up to 25 m. The overall slope angle of the waste dump face after the second slip was about 28° over a vertical height of about 200 m. A 25 m high slope at an angle of 46.5° therefore represented the critical stability condition post-slip. A back-analysis of this critical condition was made using the fully drained slope stability chart of Hoek and Bray (1977) to establish a range of effective stress strength parameters for the waste rock fill in the area of the slips. As material was continually ravelling off this steep slope it was assumed to have a factor of safety of about 1.0 without earthquake loading. A unit weight of 15.8 kN/m³, based on previous measurements at Bougainville (Scott, 1977), was assumed for the loosely dumped waste rock. The range of effective stress strength parameters for poor quality rock fill obtained from the back-analysis is shown on Figure 7.

By way of comparison, from experience on Bougainville it is known that waste dumps comprising fresh rock fill rill at a slope angle of about 37.5° and are stable at this angle to heights of up to 100 m under earthquake loading. Such slopes therefore possess a factor of safety without earthquake loading of at least 1.25. The range of effective stress strength parameters for good quality rock fill corresponding to this situation is also shown on Figure 7.

From Figure 7, an effective cohesion c' of 12 kPa and an effective angle of internal friction ϕ' of 32° were selected as being representative of the poor quality rock fill in the area of the slips. Using these values, plots of slope height against factor of safety without earthquake loading may be made for various slope angles, as shown on Figure 8. These plots then form the basis for assessing the stability of the overall slope and of localised

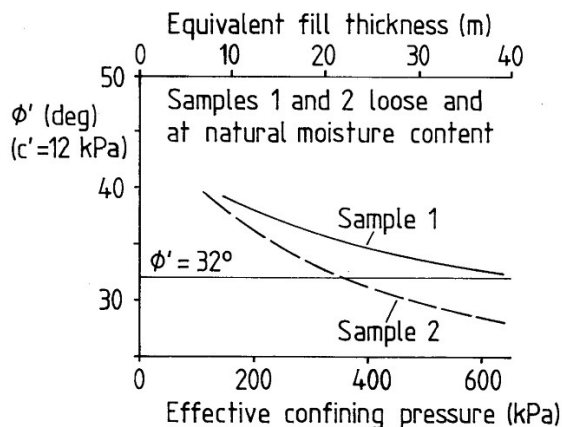
Figure 9 Strength versus effective confining pressure and equivalent fill thickness

To enable comparison between the back-calculated effective stress strength parameters for poor quality rock fill and the results of triaxial testing of poor quality rock fill samples 1 and 2 under the conditions prevailing in the waste dump, an effective cohesion c' of 12 kPa was assumed. Values for the effective angle of internal friction ϕ' were obtained by drawing lines from a shear stress intercept of 12 kPa, tangential to the Mohr's circle plotted for each level of effective confining pressure applied. These ϕ' values are plotted against effective confining pressure and equivalent fill thickness on Figure 9 for poor quality rock fill samples 1 and 2.

The results presented on Figure 9 show that a ϕ' value of 32° (for a c' value of 12 kPa) is appropriate for poor quality rock fill up to about 25 m deep. The close agreement between the laboratory and back-calculated effective stress strength parameters, as shown on Figure 9, gives considerable confidence to the use of Figure 8 for the design of waste dumps comprising poor quality rock fill.

- (iii) The results of laboratory testing and back-analysis showed a c' value of 12 kPa and a ϕ' value of 32° to be appropriate for waste dumps comprising poor quality rock fill up to about 25 m deep.
